M-KMA SIKANNI VALLEY REGION

Evaluating the Environmental Impacts of Well Site and Access Road Construction Methods

**EVALUATING THE ENVIRONMENTAL IMPACTS OF
WELL SITE AND ACCESS ROAD CONSTRUCTION METHODS
WITHIN THE M-KMA SIKANNI VALLEY REGION**

EBA Waberski Darrow Project No. 305-03944

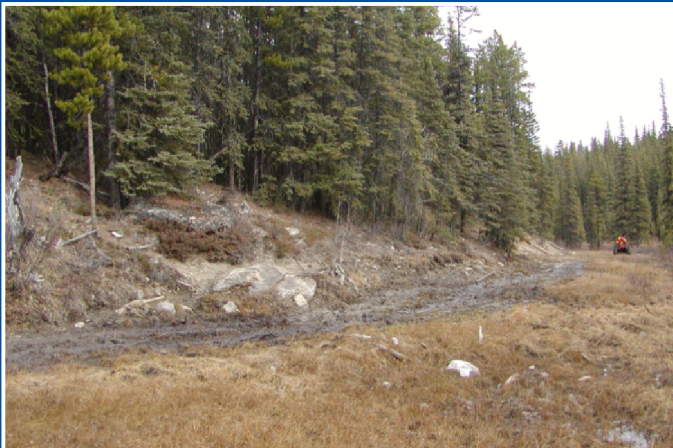
Seepage from upslope onto access road.

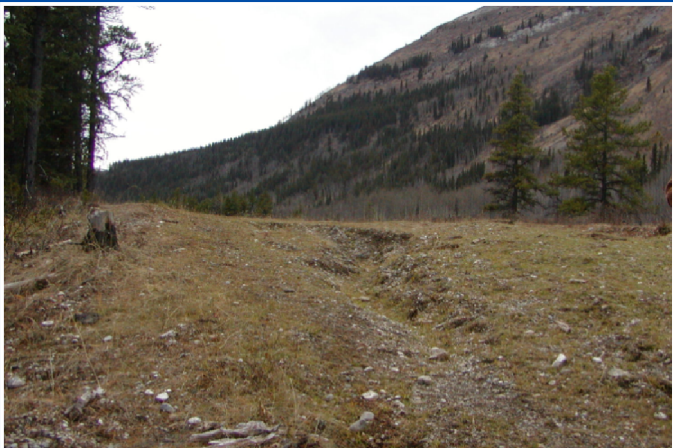
Erosion on slope down centre of access road.

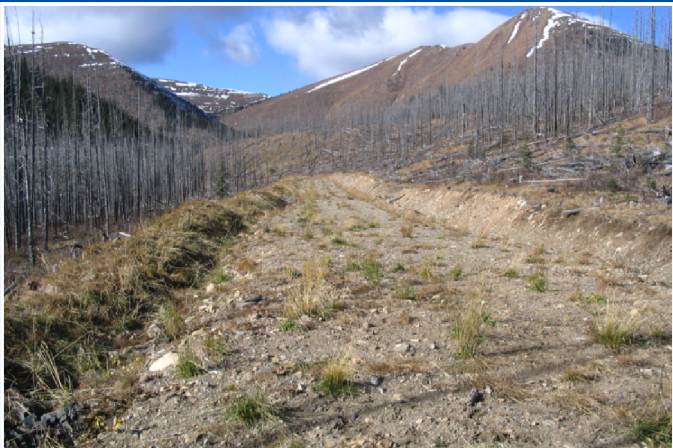
Removed surface duff layer along upland section of access road.

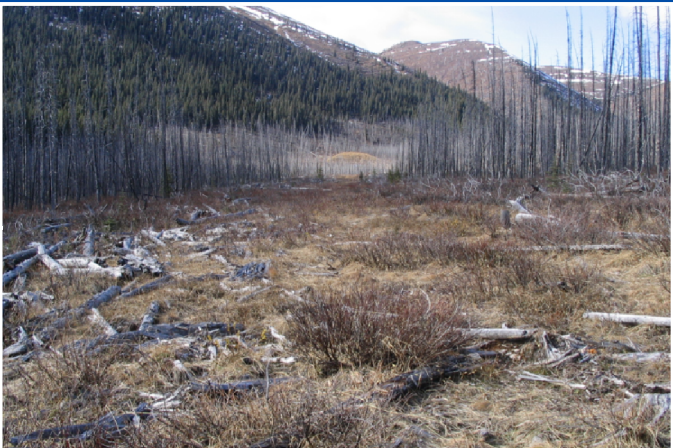
Coarse woody debris within right of way of access road.

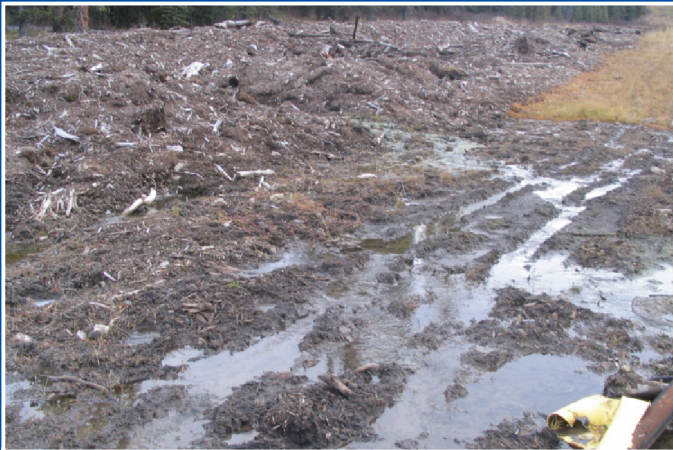
Water impundment within access road.

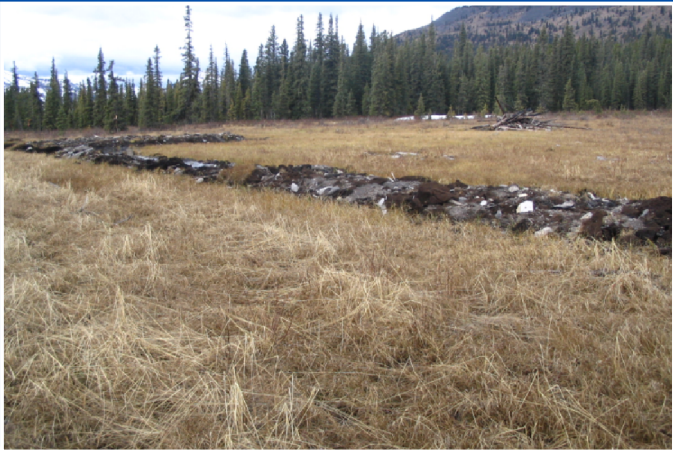
Pipeline trench within an open fen wetland.

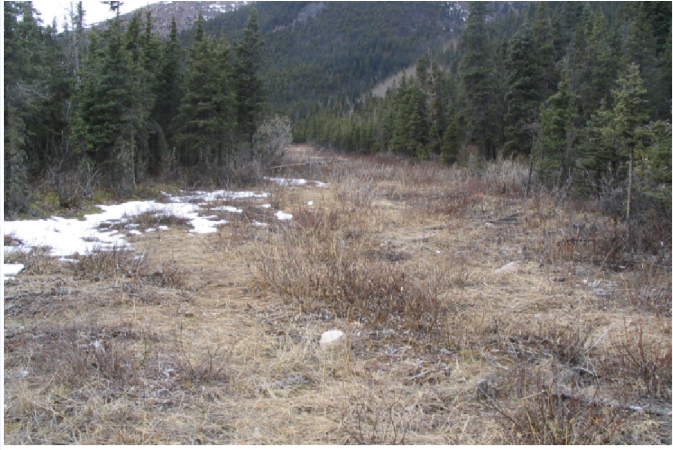
Low vegetation within upland portion of access road.

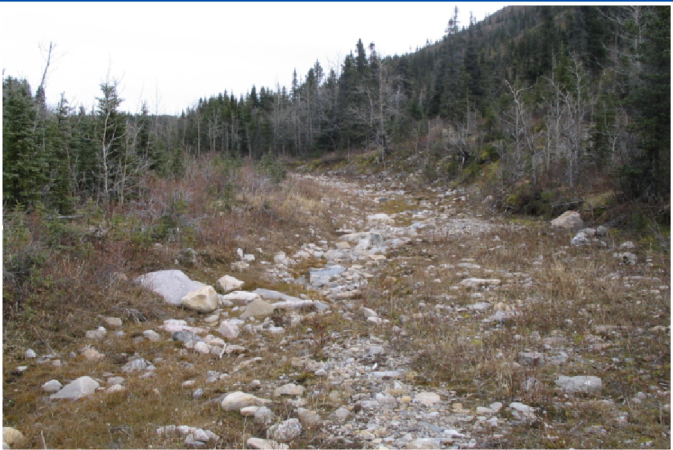
Erosion gully within access road down a slope, exposing rocks and cobbles.

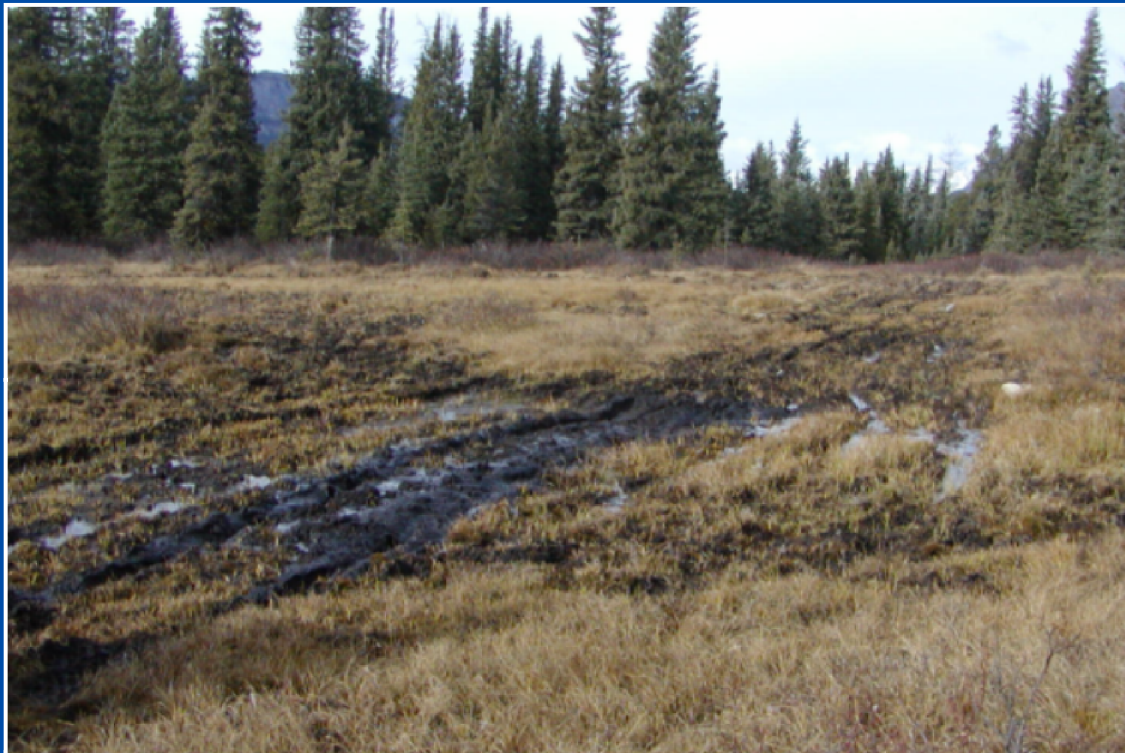
Example of water channelling down road which is used as access for recreational users. Road runs through fen resulting in drainage issues.

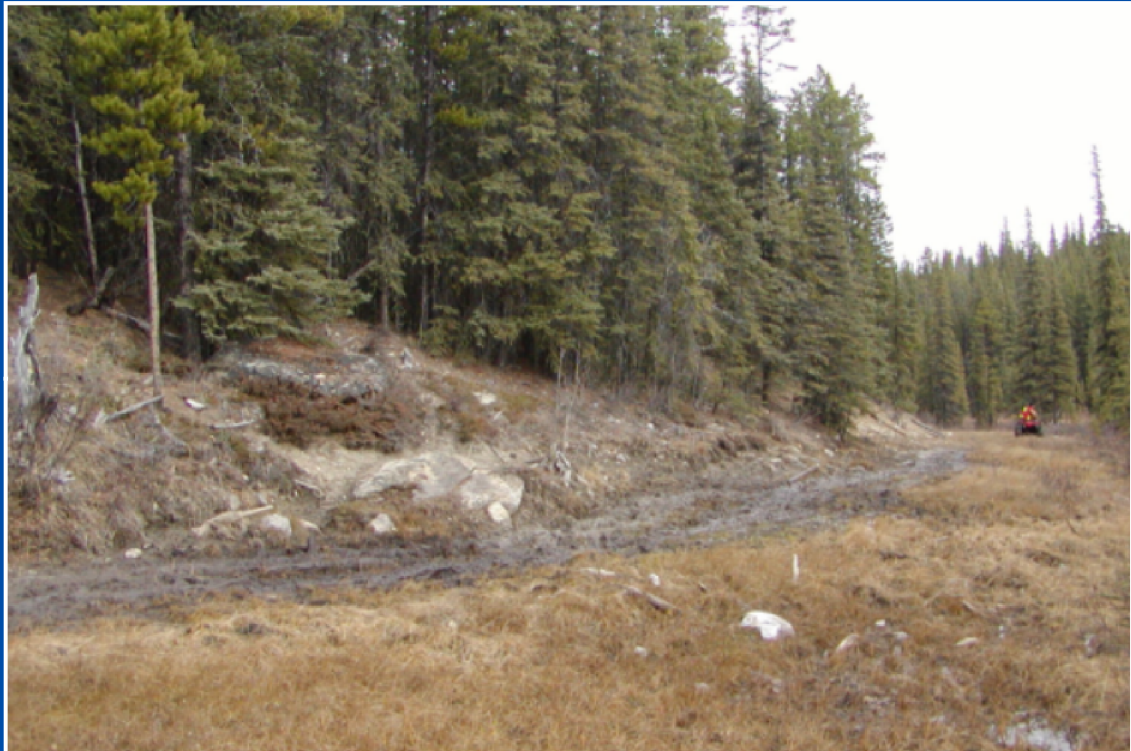
Example of road route selection through wetland when adjacent drier upland area would result in less ground disturbance (particularly with regard to ATV use).

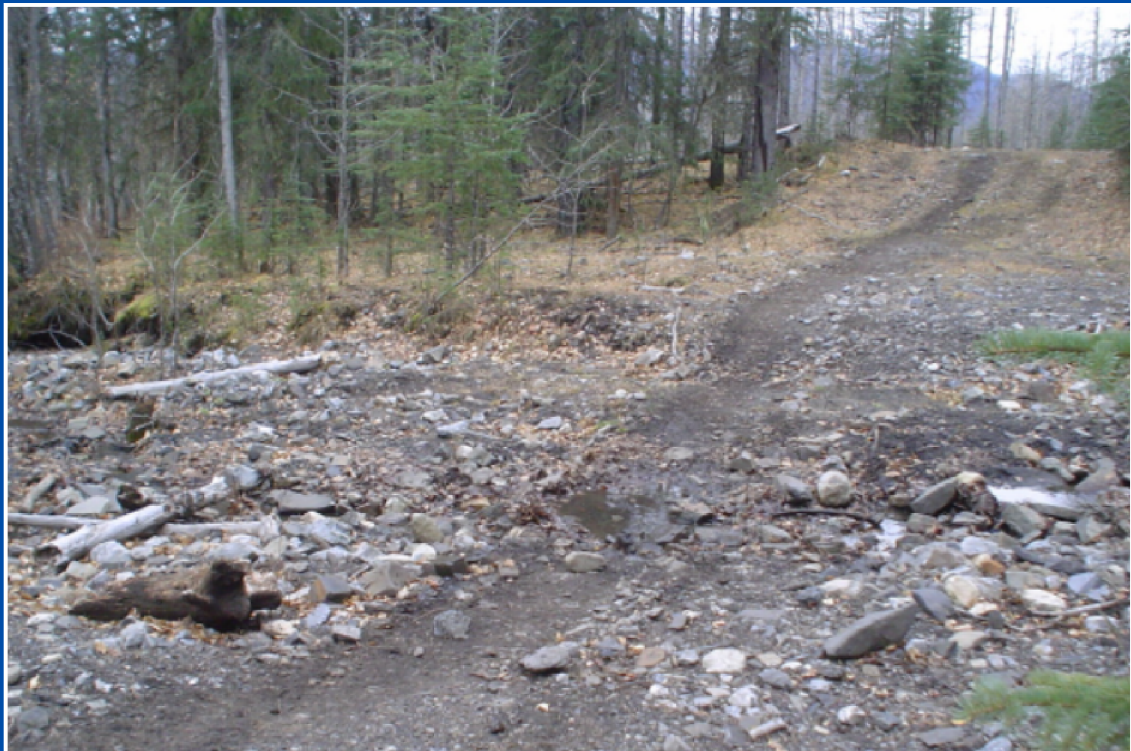
Effects of recreational access on road crossing dry stream bed.

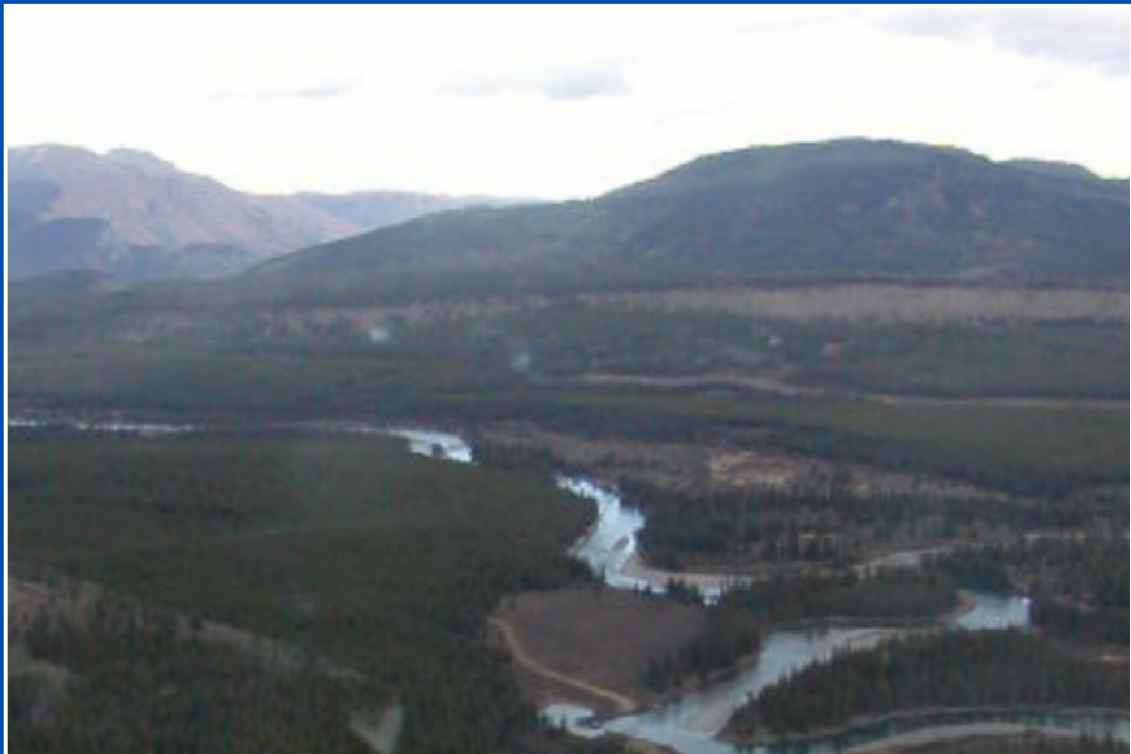
Aerial photo showing proximity of access road to Sikanni River. Note river erosion on access road.

ISSUE	CAUSE or EFFECT
Access road washout along Sikanni river	Road is washed out as a result of natural river channel movement at a developing meander. Road construction at this location appeared to consist of little more than brush clearing and minor fill placement, and it is unlikely that the road impede the meander development.
Successes – Road	
Stream crossings essentially unaffected by road	Likely winter road construction AMOCO is unique in that it is the only road of the four being used for hunting etc
No issues in river terrace areas (flat).	
No issues in decommissioned areas such as the last 0.5 kilometre to the well site from the main road (including the well site).	The fill has been pulled back, woody debris spread on the surface and water bars created
Absence of major scouring from surface run-off on road	Cross ditching is effective on sloped sections.
Decommissioning on south side of river where road crossed steep gradient slopes appears stable	Fill slopes have been pulled back on sections of road that cross steep gradient side hill slopes.

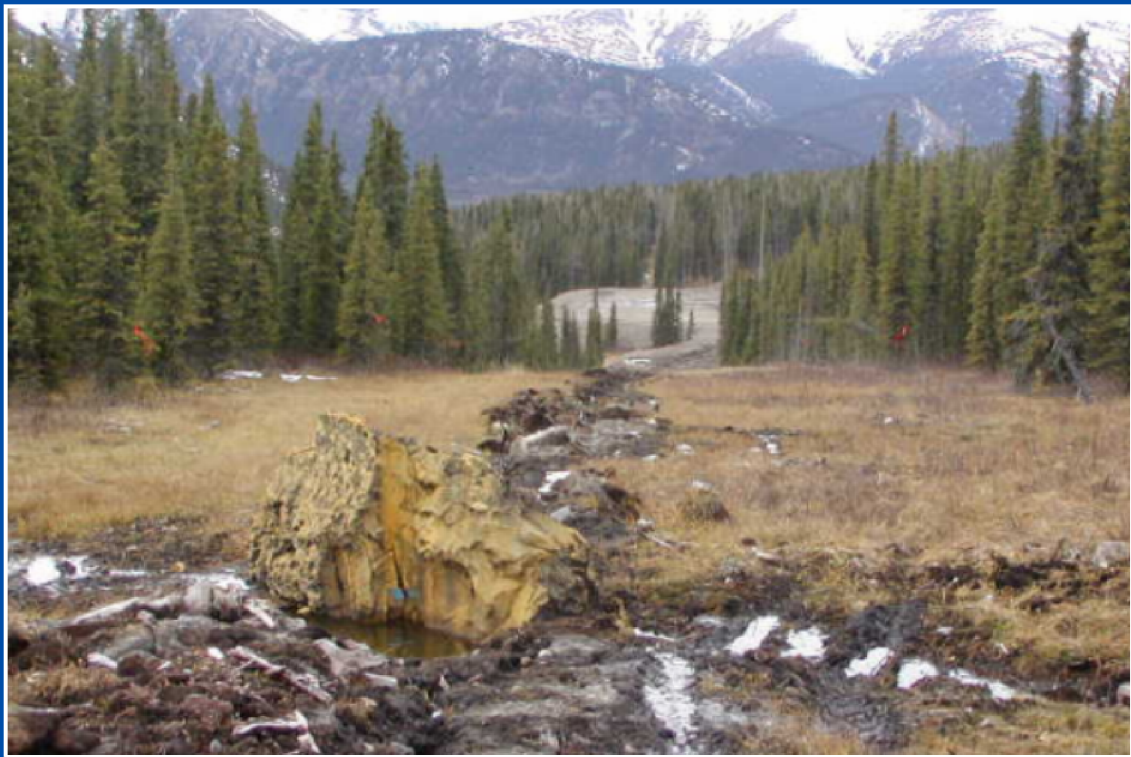
Ponding along access/pipeline due to poor drainage control. Foam berm used for drainage control ineffective and not properly installed.

There are drainage issues that are specifically attributable to the presence of the buried pipeline. The use of insulation foam as a water dyke/berm along the pipeline has proven to be ineffective, and the material is not biodegradable. As already noted, the pipeline was built through a very wet area with significant water infiltration from adjacent upslope areas. In addition, very poor drainage of water, resulting in the blockage of culverts and water ponding, was found along the length of the pipeline in wet areas.

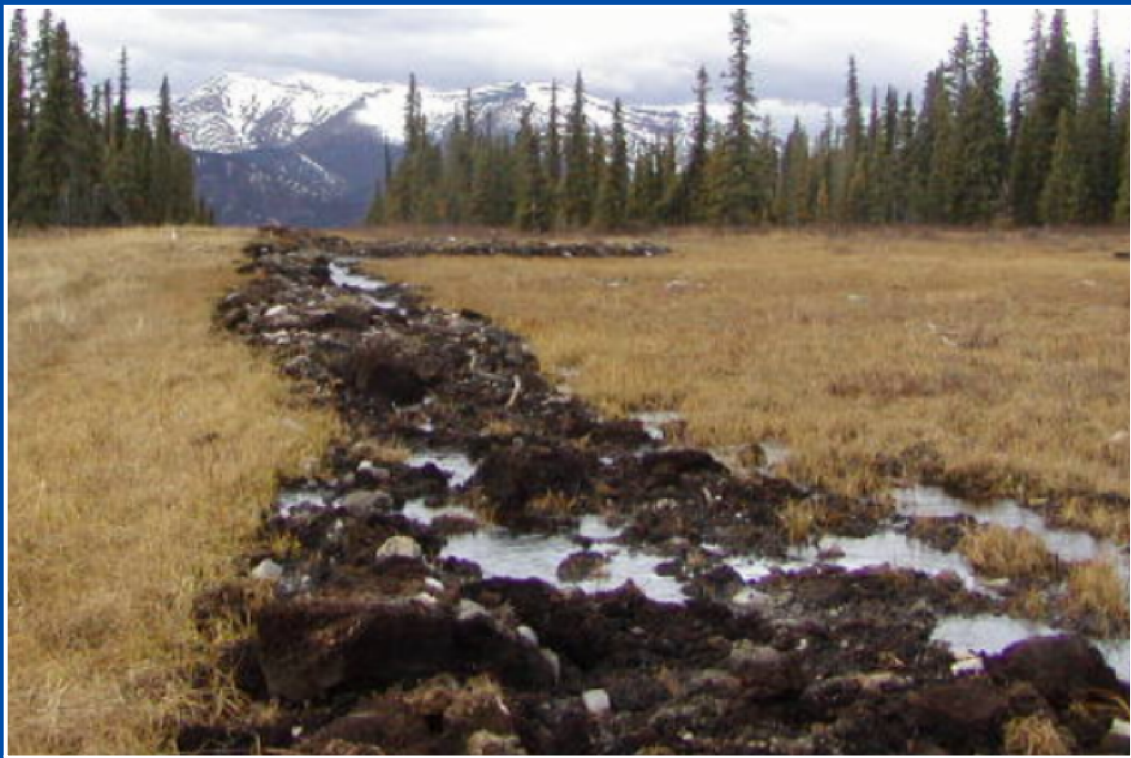
Installation of pipeline through fen without proper drainage management.

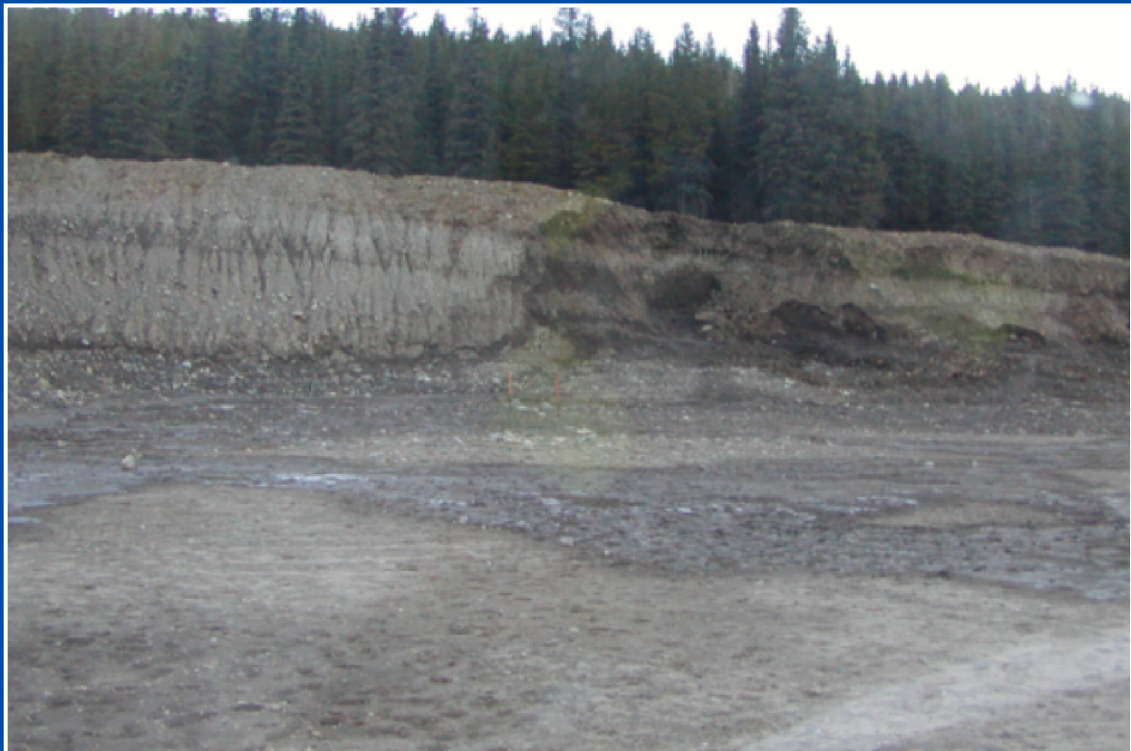
Well site showing cut and fill technique; including indication of groundwater seepage. Ungulate tracks present in wet areas.

The natural slope of the well site was downward, from northwest to southeast. Cut slopes up to 10 m in height and fill slopes of 8 m in height were estimated during our October 2004 field visit. It was observed at that time that the cut slope to the northwest of the site had undergone a large post construction failure. Sand and gravel were exposed on the cut slope. Seepage from the middle third of the cut slope probably contributed to the failure. Tension cracks have continued to form, as a result of lateral movement, at the downslope edge of the fill, which will likely lead to fill slope failures at some point in the future.

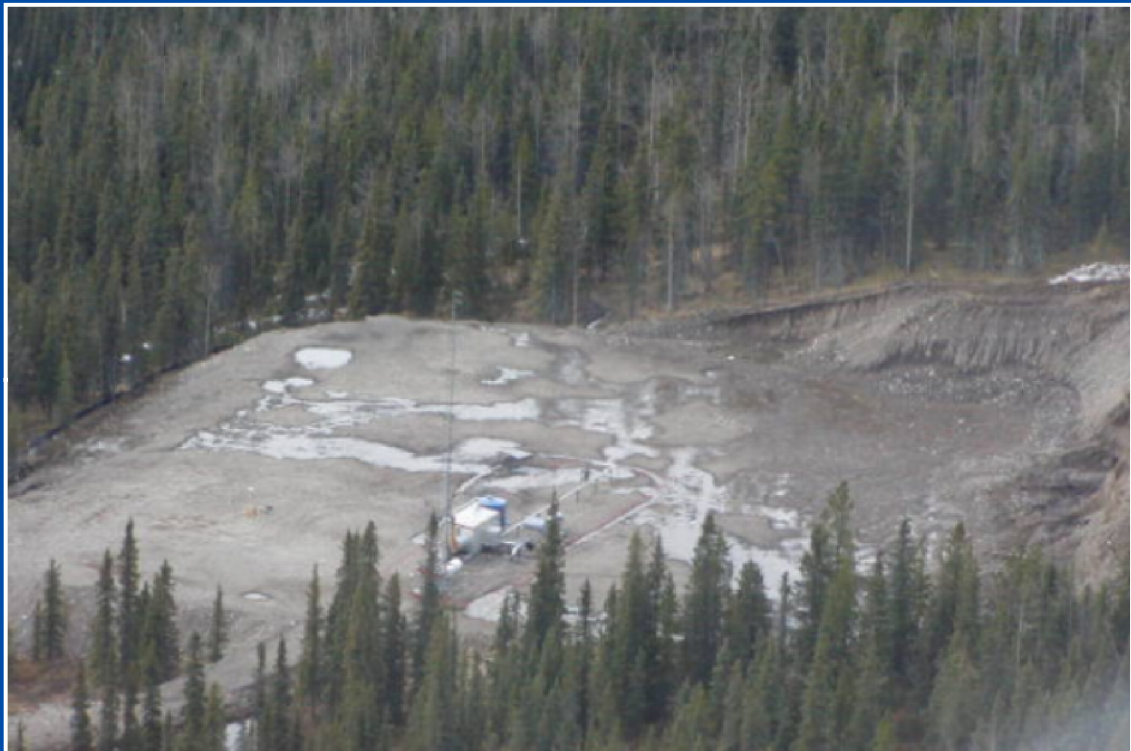
Upper slope failure, in spite of cutoff ditch being present. This suggests slope failure not due to surface runoff. Slope failure likely due to permeable soils and groundwater seepage.

Geomorphic effects of construction by the CNRL Sikanni project were particularly evident at the well site itself. Slope stability, groundwater seepage and surface erosion effects were observed; in particular, there were tension cracks, gulying, cut slope failures and unmanaged drainage including ponded water at the well site. Stability issues at the well site are consistent with the effects of inappropriate cut and fill slope gradients for the soil type and groundwater conditions.

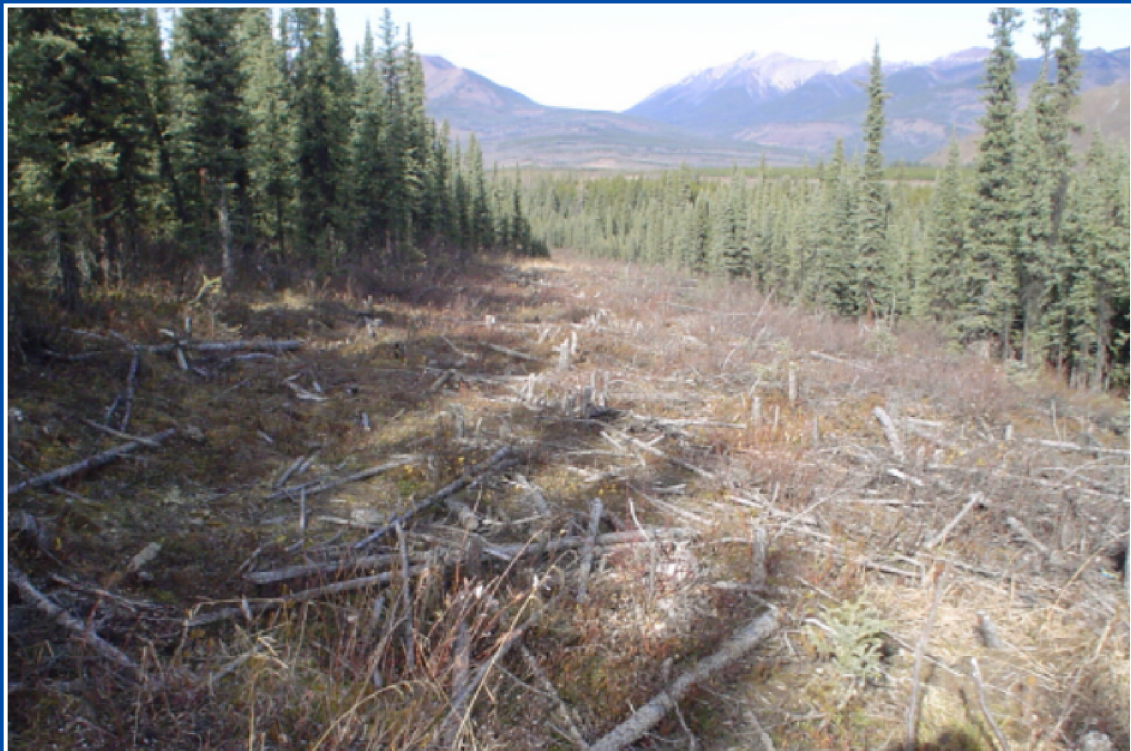
Example of low-impact road construction. Only noticeable disturbance is associated with vegetation clearing.

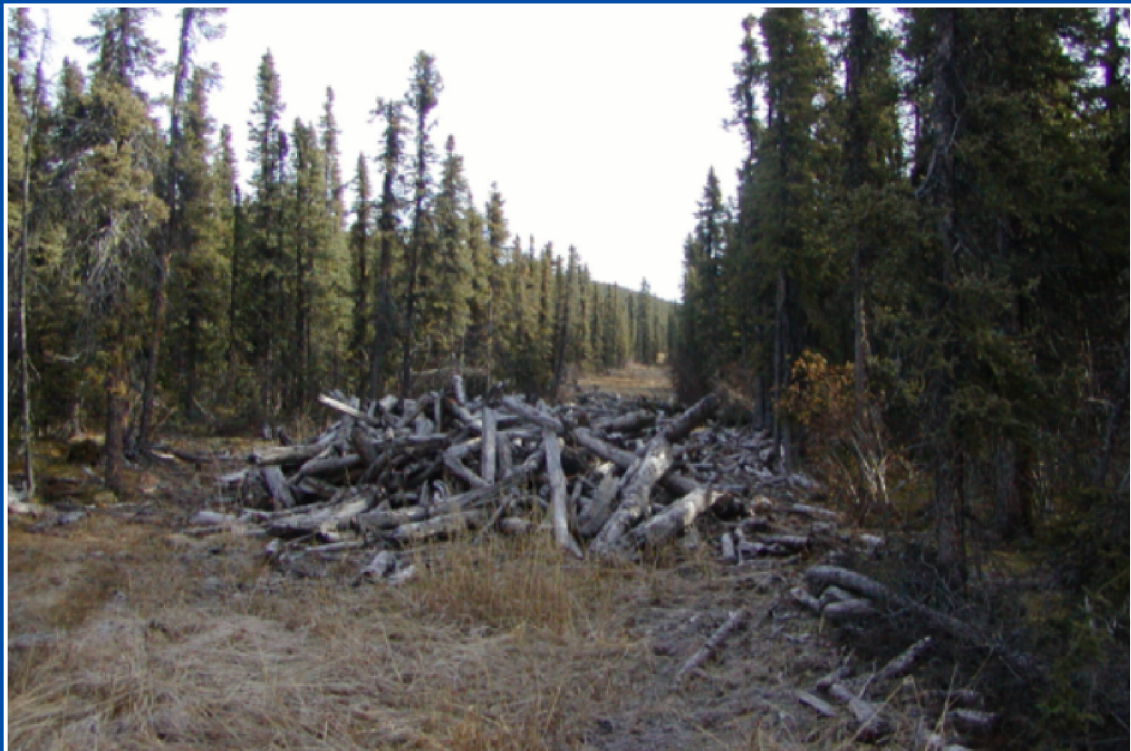
Conventional access via cutline. Slash placed to inhibit ATV access along cutline.

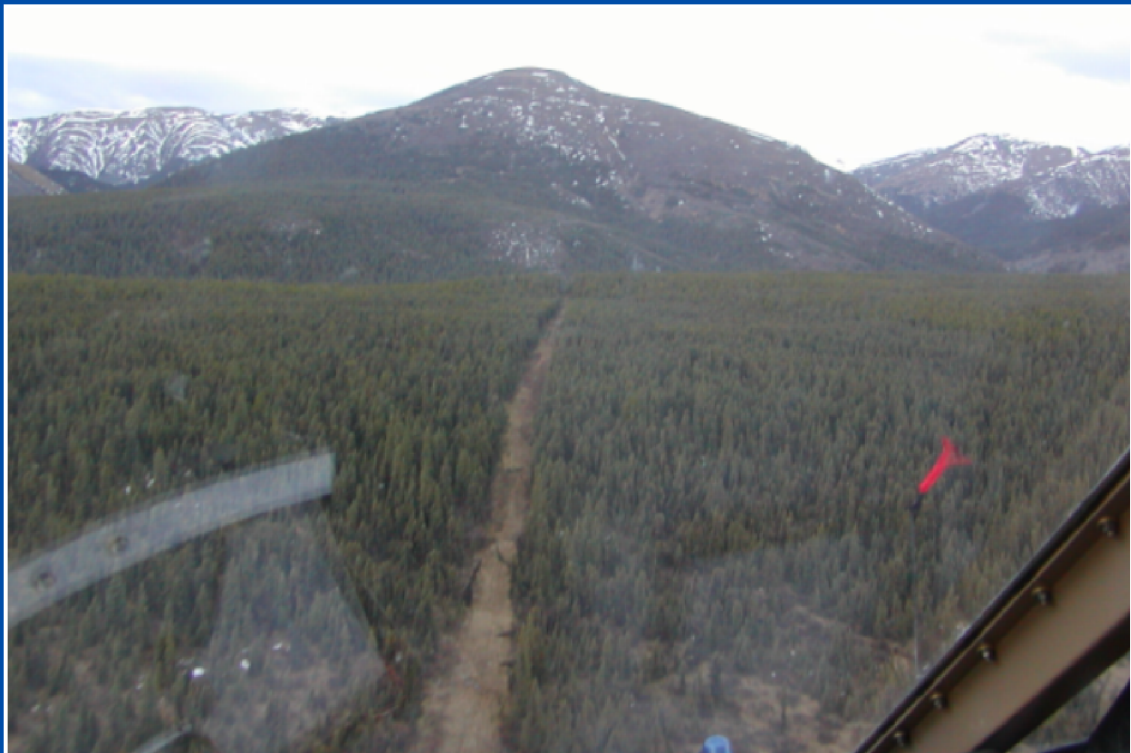
Use of existing cutline for access reduces footprint in the region. Cutline is very wet due to placement through forested wetland.

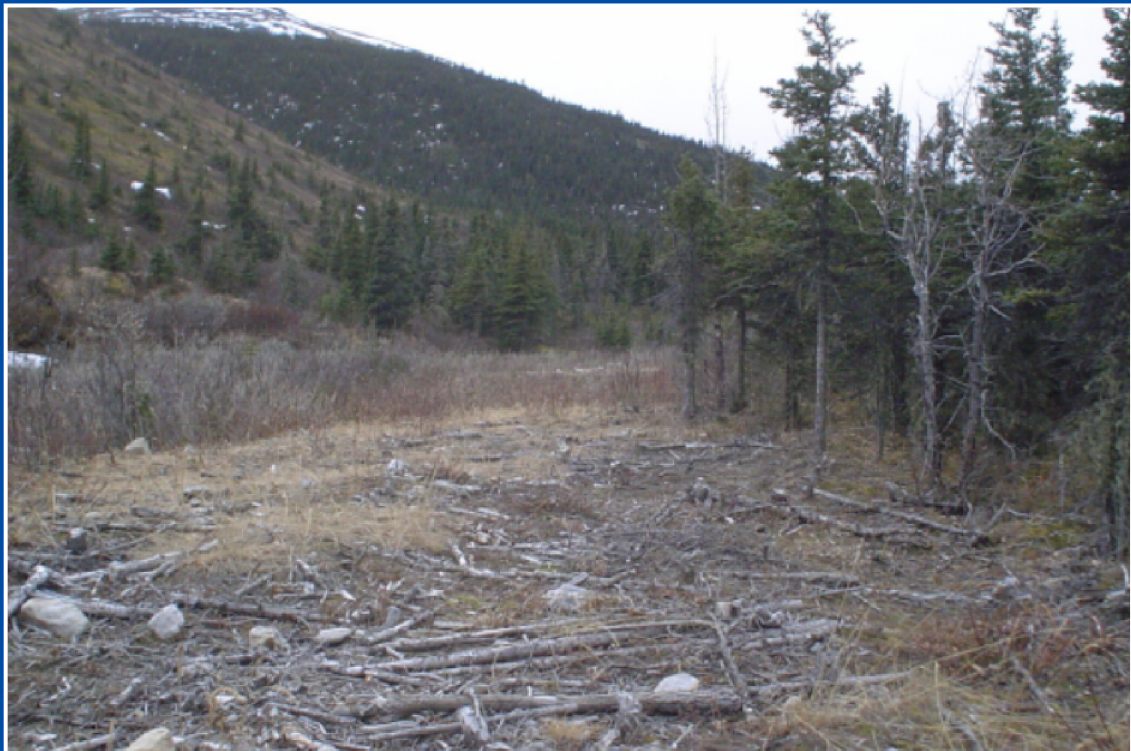
Clearing associated with access road construction in riparian area adjacent to Chicken Creek. Difficult to pick route without prior knowledge.

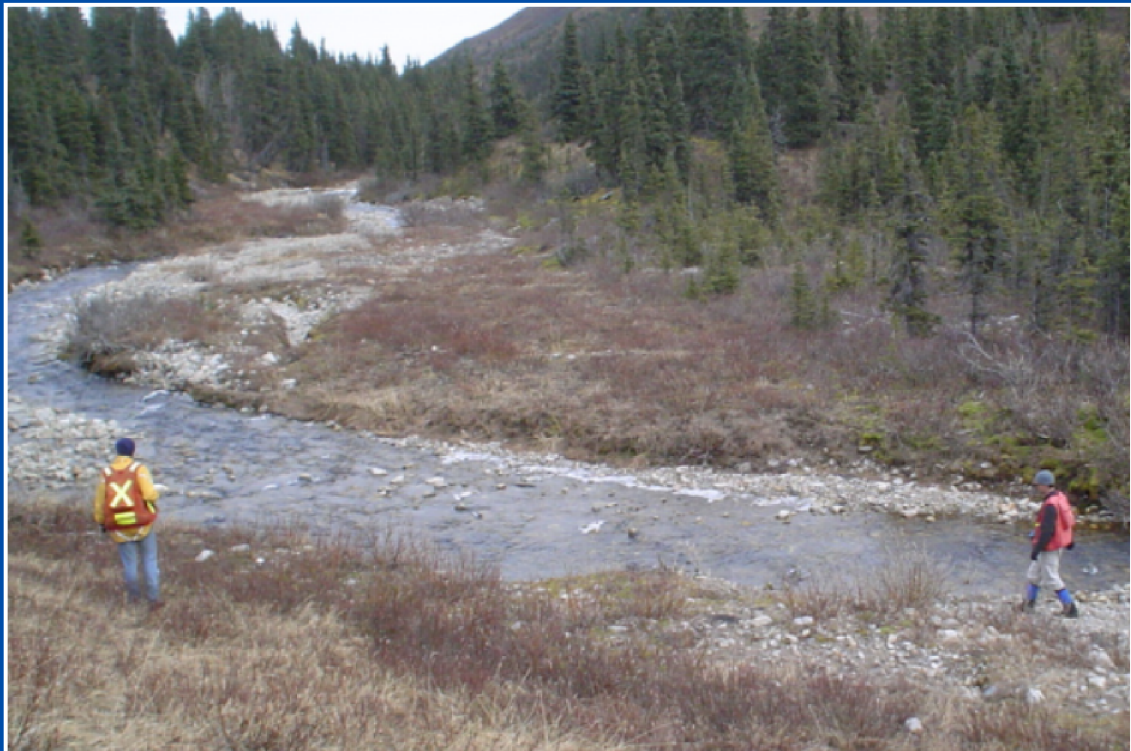
Location where access road crossed Chicken Creek . Minimal impacts through creek bed and along the bank.
