**Evaluation of a Low-Cost Drone
for Monitoring Restoration of Well Pads**

**submitted to
BC Oil and Gas Research and Innovation Society**

**by
Dwayne Tannant and Kalie Smith**

January 15, 2018

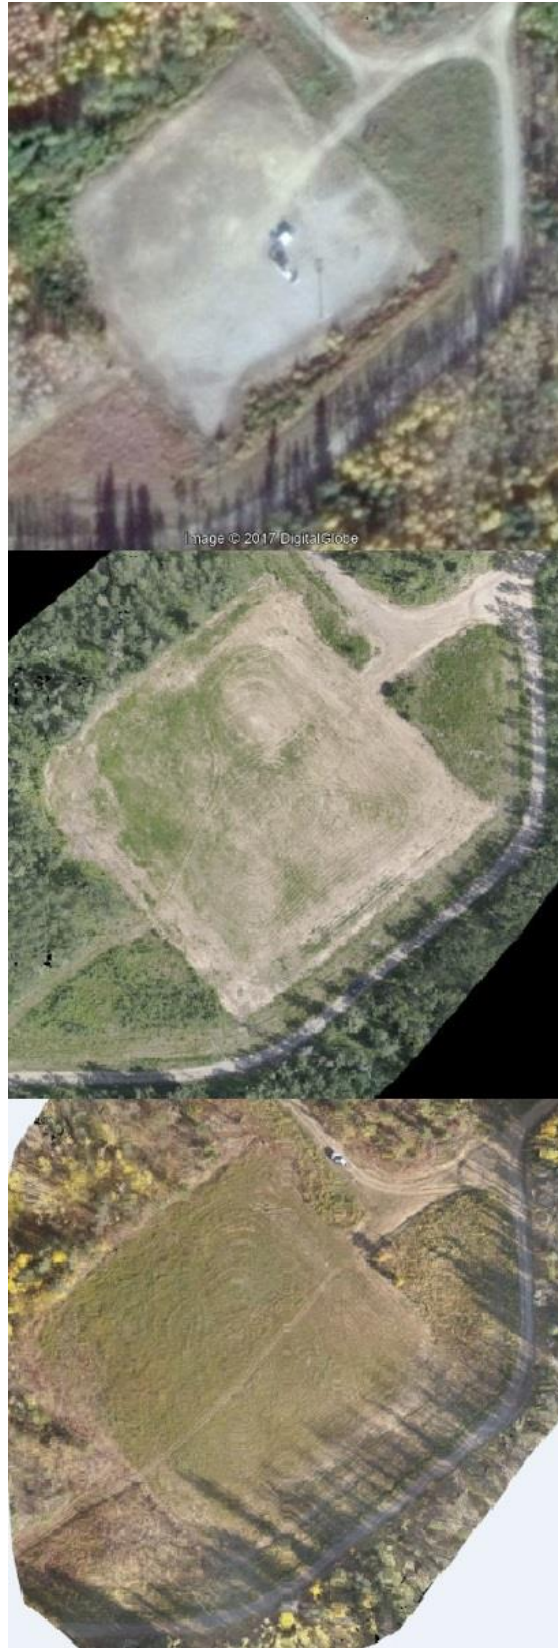
Figure 4 Restoration progress of well pad 19518 (2012, July 2017, and September 2017)

The approximate surface area of this well pad is 1.02 hectares (ha) as of July 2017. Figure 4 provides a comparison of this well pad site before reclamation began (top) in 2012, and after reclamation in July 2017 (centre) and September 2017 (bottom).

There is no visible slope movement, slumping, subsidence, or tension cracks on or around the well pad, and there are no remaining cut and fill slopes.

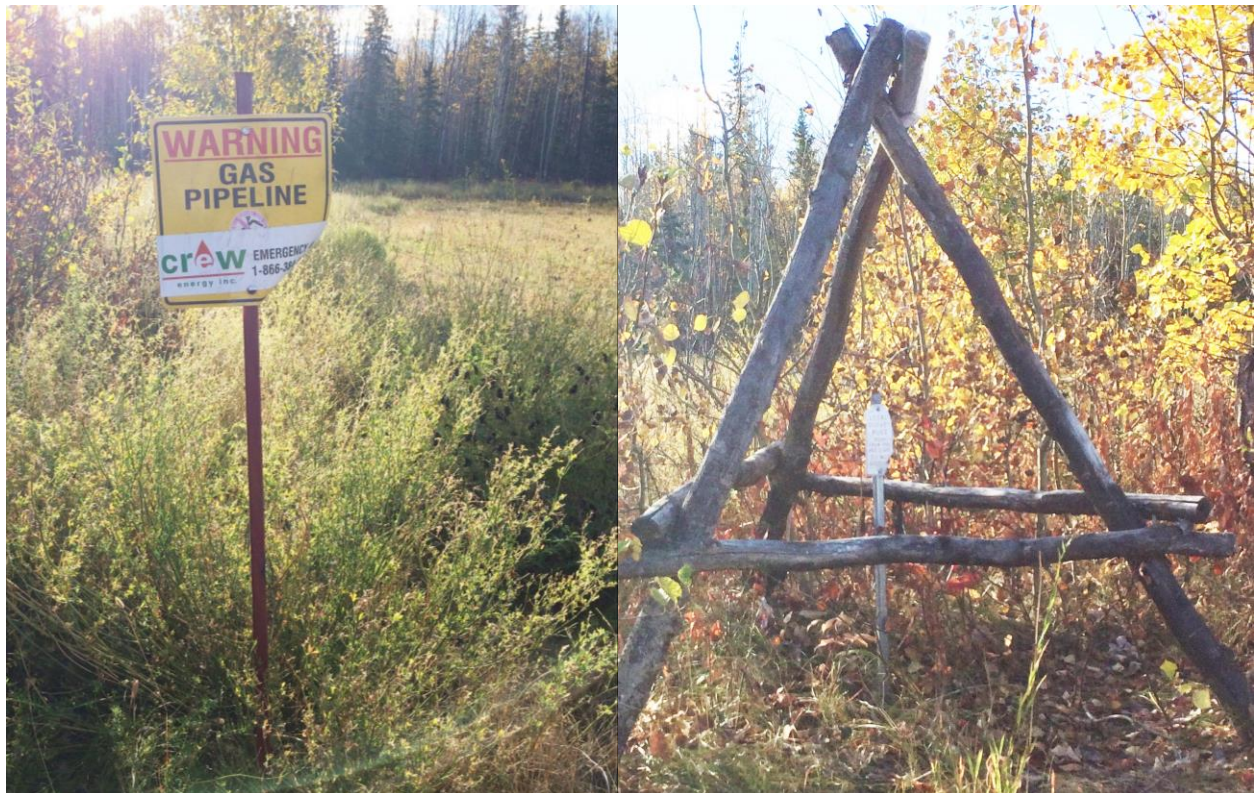
Figure 5 A sign indicating the presence of subsurface facilities and survey stake

There are no facilities remaining on the surface of the well pad from oil and gas production. However, there were signs indicating that a pipeline remains beneath the ground and some survey stakes at the surface as shown in the photographs taken on the well pad in Figure 5.

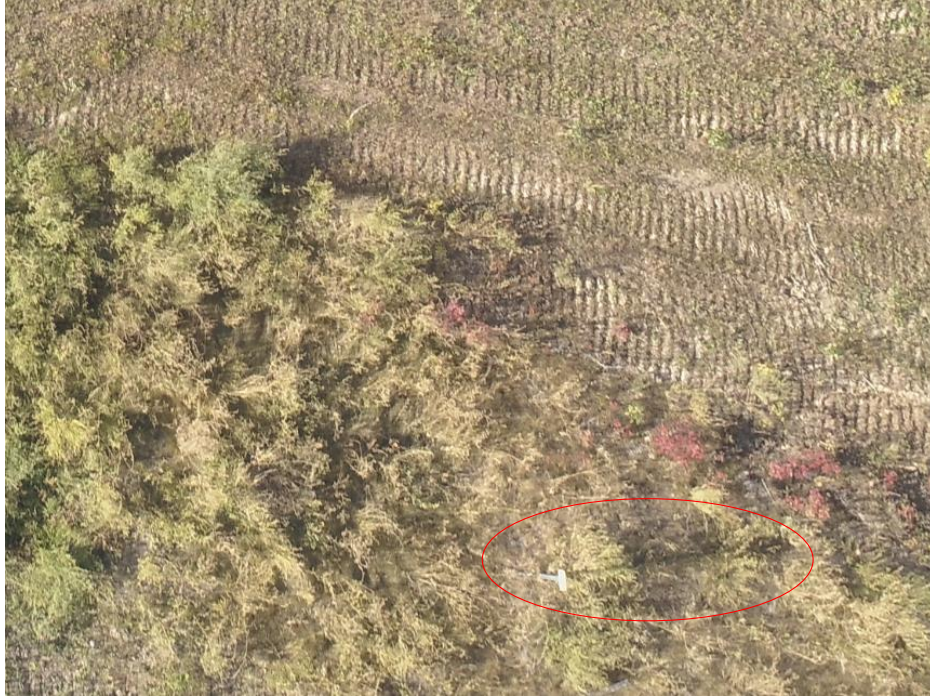
Figure 6 Sign indicating a pipeline seen in an aerial photo

It is not possible for the drone to provide evidence of subsurface facilities unless there is some indication of these facilities at the surface to be captured in photos. Even small signs like the ones shown in Figure 5 are difficult to see in aerial photographs unless their shadows are seen on the ground. Since this well pad was flown on a sunny day, the sign and its shadow can be seen easily in Figure 6. However, cloudy or overcast skies might limit what can be seen in aerial photos.

Pipelines may have been left behind on this well pad for numerous reasons. Leaving facilities is allowed if removing them would pose more risk or cause greater disturbance to the land area, which would impede or hinder reclamation activities more than having them remain.

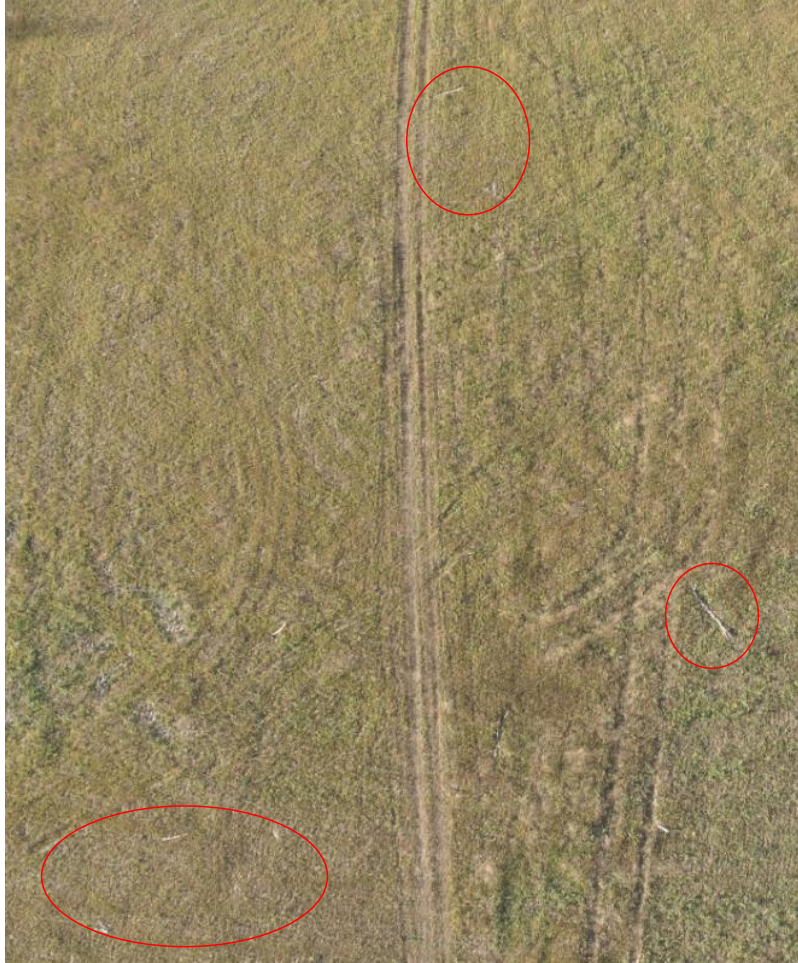
Figure 7 Woody debris on the well pad

There are no piles of gravel or rock on the well pad although there is some sporadic woody debris on the well pad itself, as seen in Figure 7. However, it is unknown if the wood on the well pad surface is intentional to assist with vegetation growth and reclamation or not. There is no evidence of industrial debris on or around the well pad.

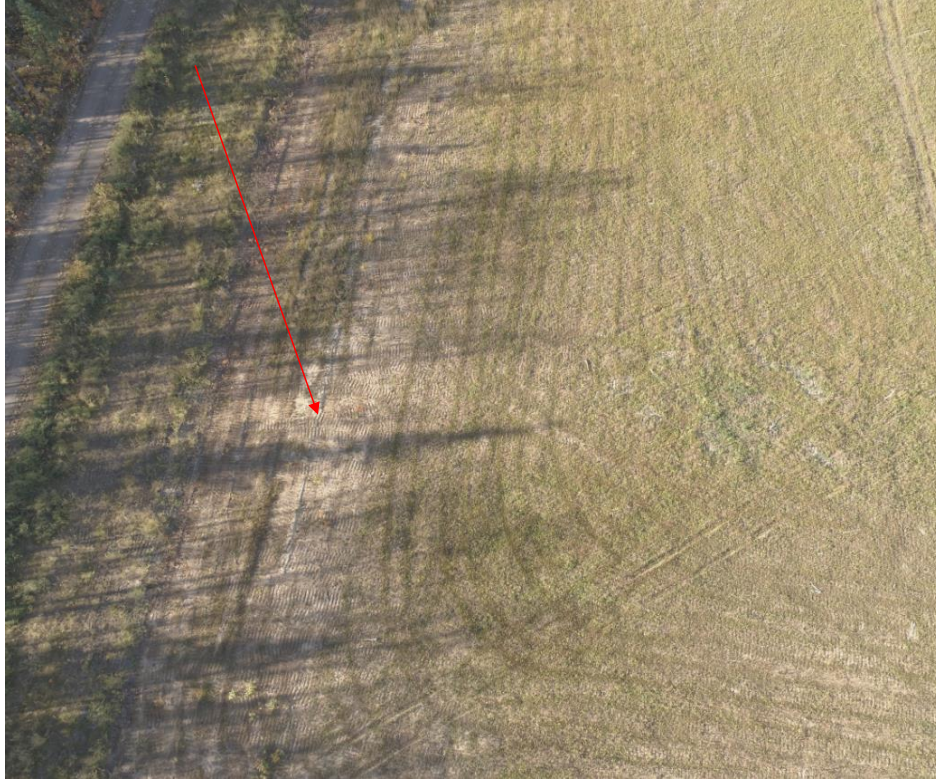
Figure 8 Reduced vegetation density where salvaged soil pile was located

Although it is difficult to discern from the September 2017 orthomosaic due to the shadows from trees, the vegetation appears less developed along the southeast edge of the well pad compared to other locations. This is highlighted in Figure 8. This could be because the salvaged soil was piled on this part of the well pad as shown in the 2012 GoogleEarth photo, causing the soil to be more compact in this area than on other parts of the well pad.

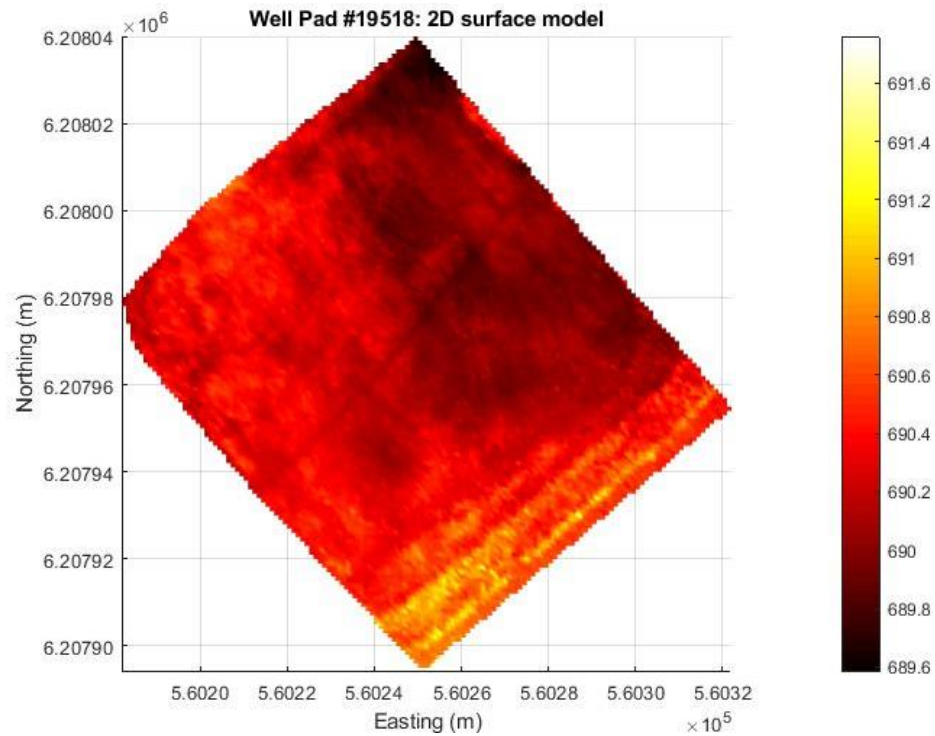
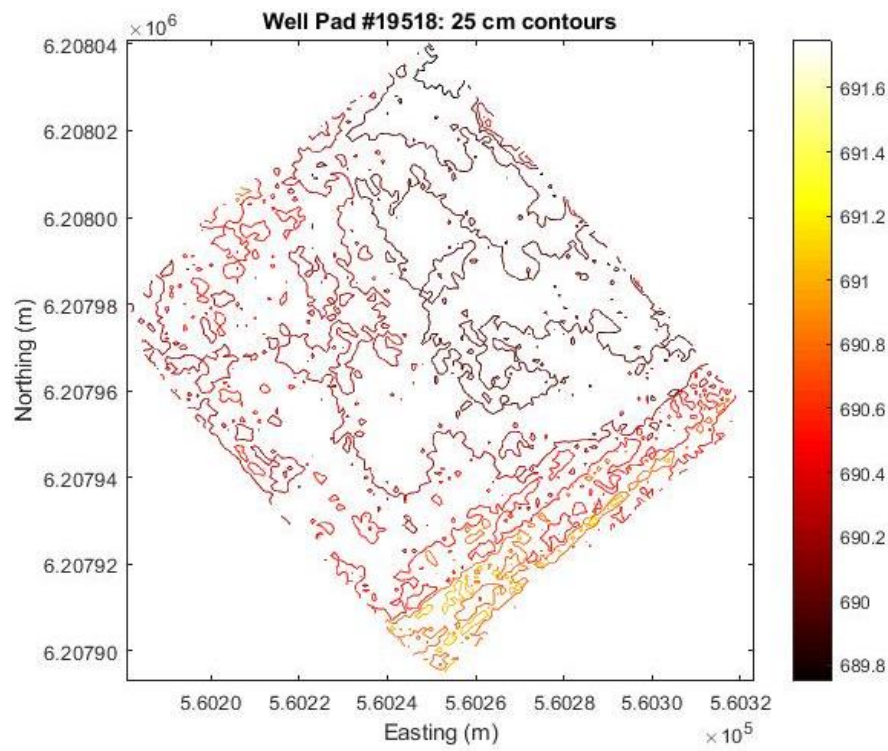
the highest to lowest points captured by the point cloud. The increased elevation at the southern corner could be the result of higher vegetation, as vegetation is captured in the point clouds as shown in Figure 11, or it could be that the access road going around the southeast edge of the well pad is higher than the well pad itself.

There are no drainage ditches around the well pad, although it is possible that water drains or ponds in the tire tracks going through the centre of the well pad. There is no other evidence of ponding or erosion in Figure 9 and Figure 10 or the drone photographs. This would suggest that the criterion of restoring drainage to its original condition or to a condition compatible with the surrounding land area has been met for the Certificate of Restoration.

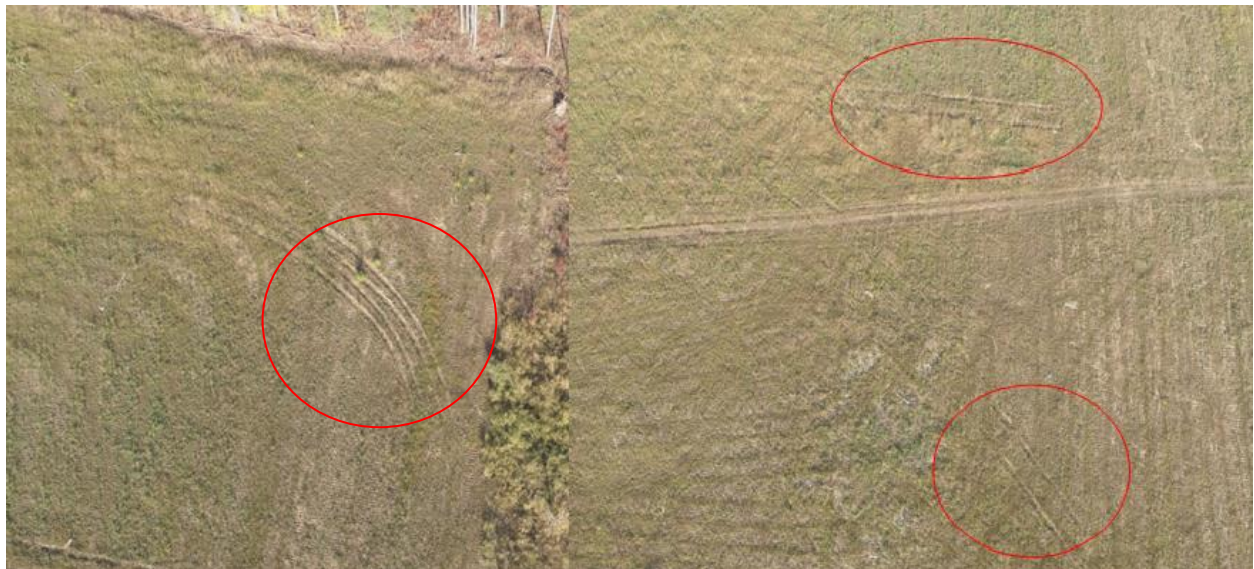
Figure 12 Reduced vegetation on soil compacted by vehicles

From the progression of the well pad over time shown in Figure 4 it is evident that salvaged soil has been spread throughout the site, and there is no evidence of impact from surrounding or adjacent land use. However, it is likely that soil that was compacted from oil and gas development activities may not have been fully de-compacted, due to the presence of the bare areas mentioned above. It is clear that this well pad has been driven over numerous times creating compacted soil along the tire tracks. Further evidence of this is given in Figure 12.

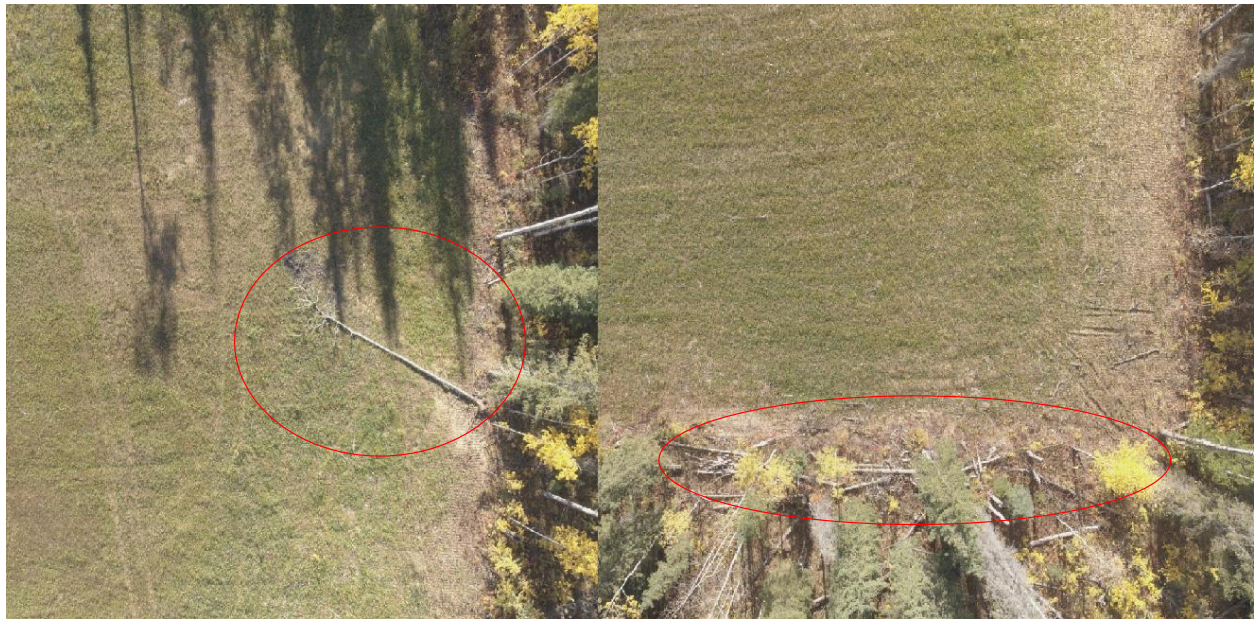
Figure 14 Woody debris on and around the well pad

There are no piles or rock or gravel on or around the well pad, and no industrial debris was found. However, some woody debris, including several fallen trees around the edges of the well pad, was identified in the aerial photos. These are highlighted in Figure 14. Certificate of Restoration criteria require these to be removed if they are not part of the reclamation activity.

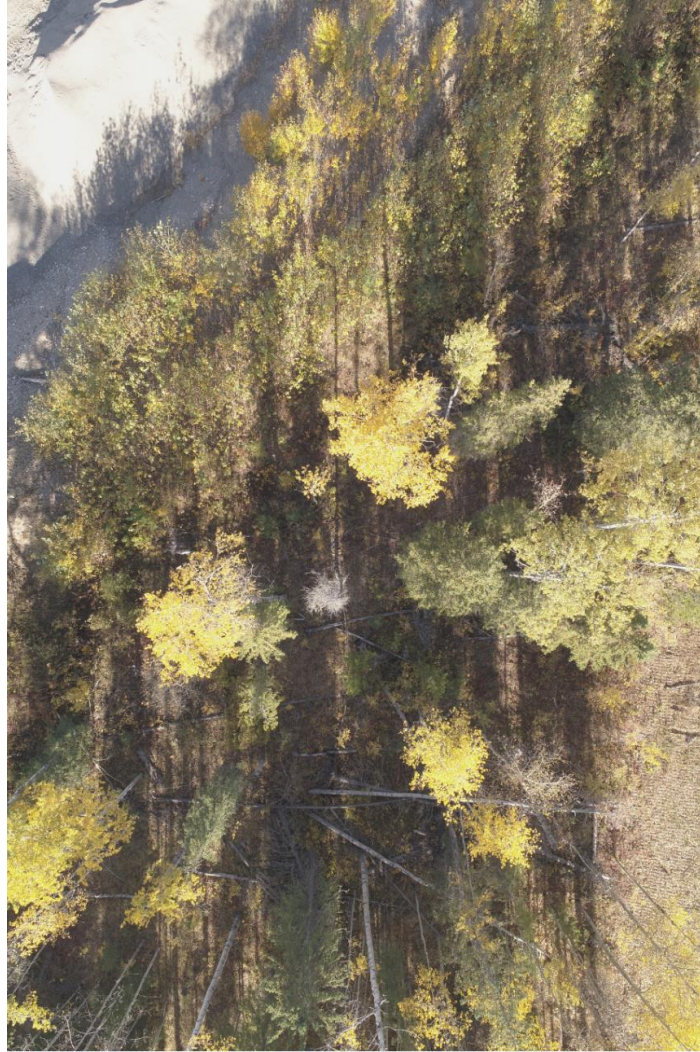
Figure 15 Aerial photograph showing edge of a gravel quarry 40 m northwest of the well pad

Approximately 40 m northwest of the well pad there is a large gravel quarry. This is not shown on GoogleEarth where the 2012 image was obtained, but it was detected by aerial photographs while flying the drone over the well pad. The northwest edge of the well pad and the southeast edge of the gravel quarry are both captured in the aerial photograph shown in Figure 15.

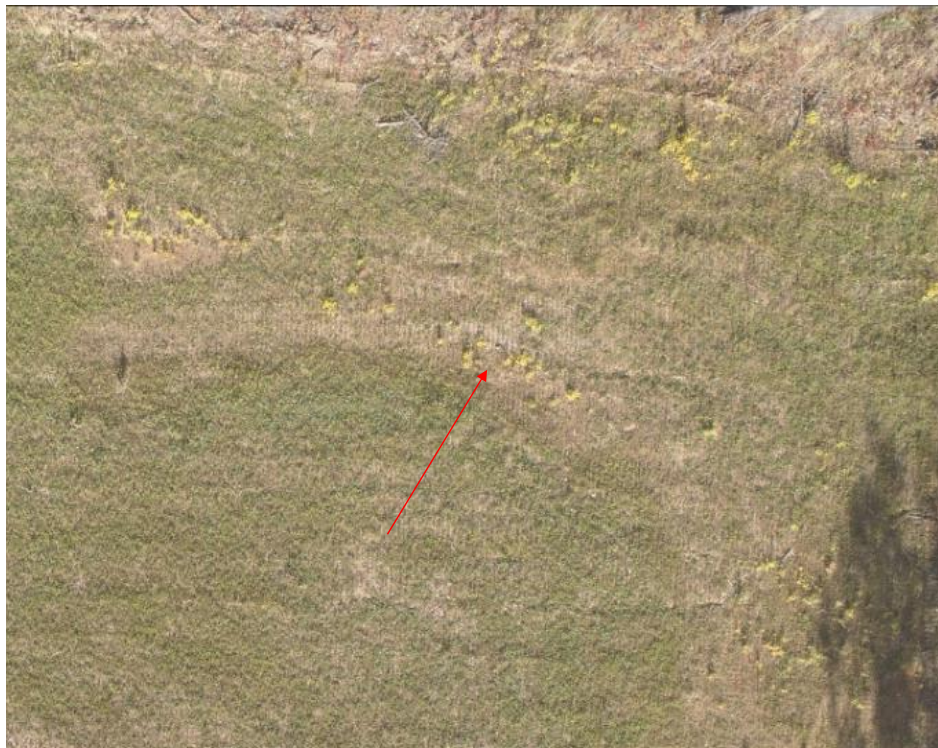
Figure 16 Reduced vegetation density where salvaged soil pile was located

Another area of reduced vegetation growth is in the northern corner of the well pad. In the 2012 photograph, it can be seen that salvaged soil was piled here and along the northeastern edge of the well pad. The boundary of the soil pile is still distinguishable in both of the 2017 orthomosaics. Similar to well pad 19518, it is possible that this soil pile resulted in increasingly compacted soil beneath it, which is impeding vegetation growth in this area. A closer view of the reduced vegetation density in this area is shown in Figure 16. It is useful to have ground photographs to supplement the drone photographs when assessing plant species that are growing on the well pad.

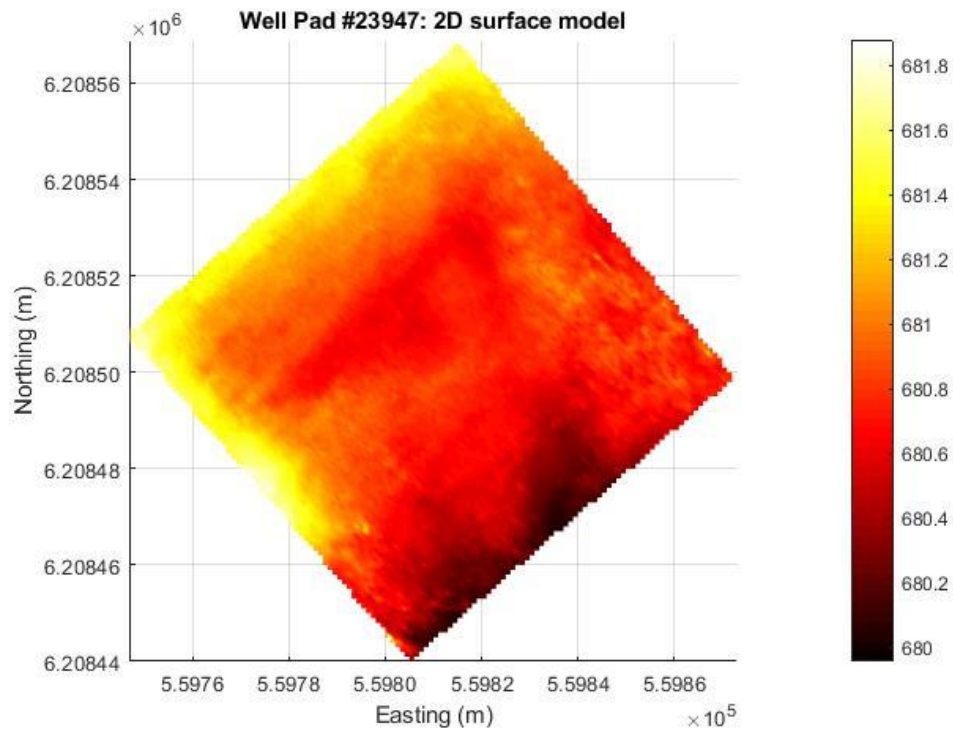
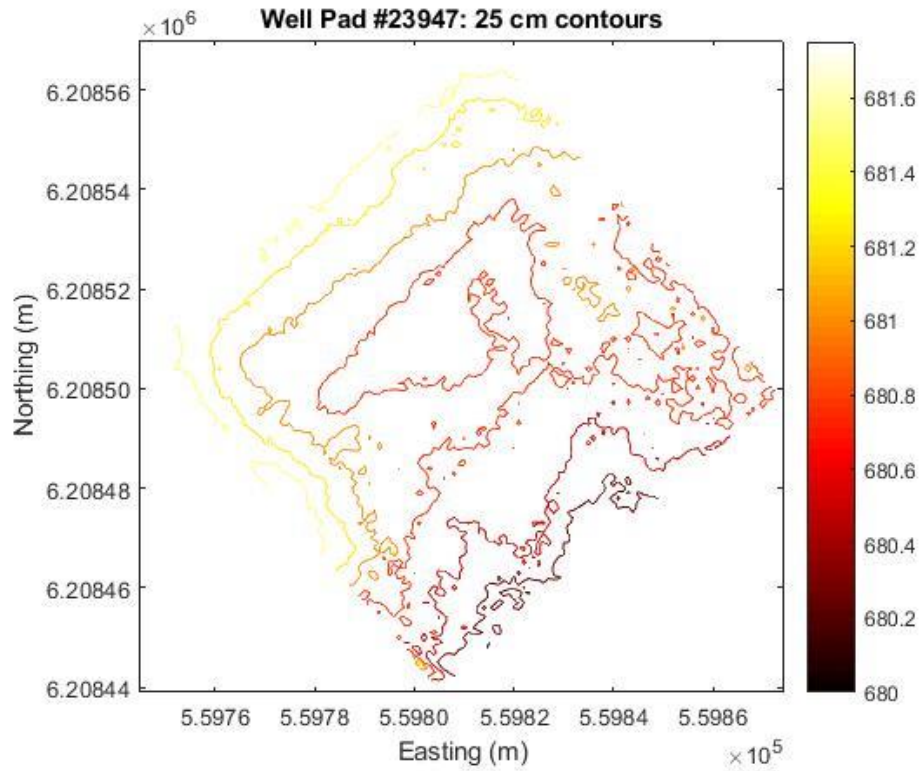
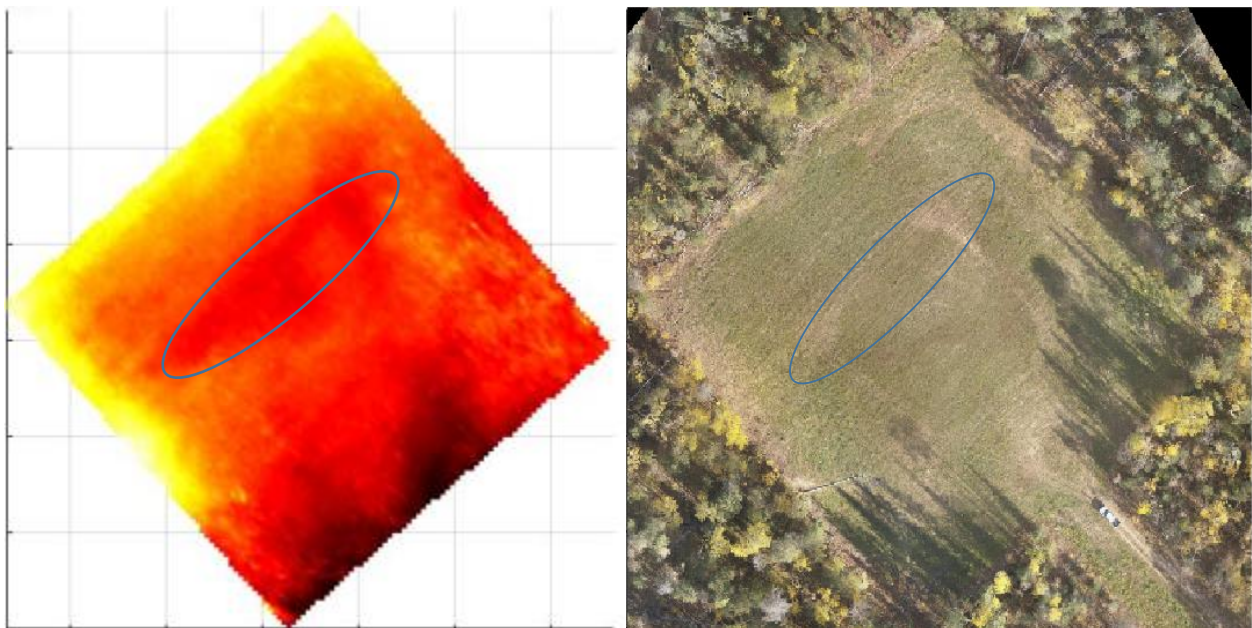
Figure 17 and Figure 18 shows possible minor water ponding could occur near the centre of the well pad where there is a slight topographic low area. Contour lines at a smaller interval than 25 cm would be necessary to examine this further, but this area of potential ponding is consistent with a defined bare outline in the September 2017 orthomosaic. Possible ponding and lack of drainage in this specific area could be hindering growth since there is no evidence that the vegetation pattern is caused by heavily compacted soil or any other cause. The area of possible ponding is shown in Figure 19.

Figure 19 Potential ponding identified which may impede vegetation growth

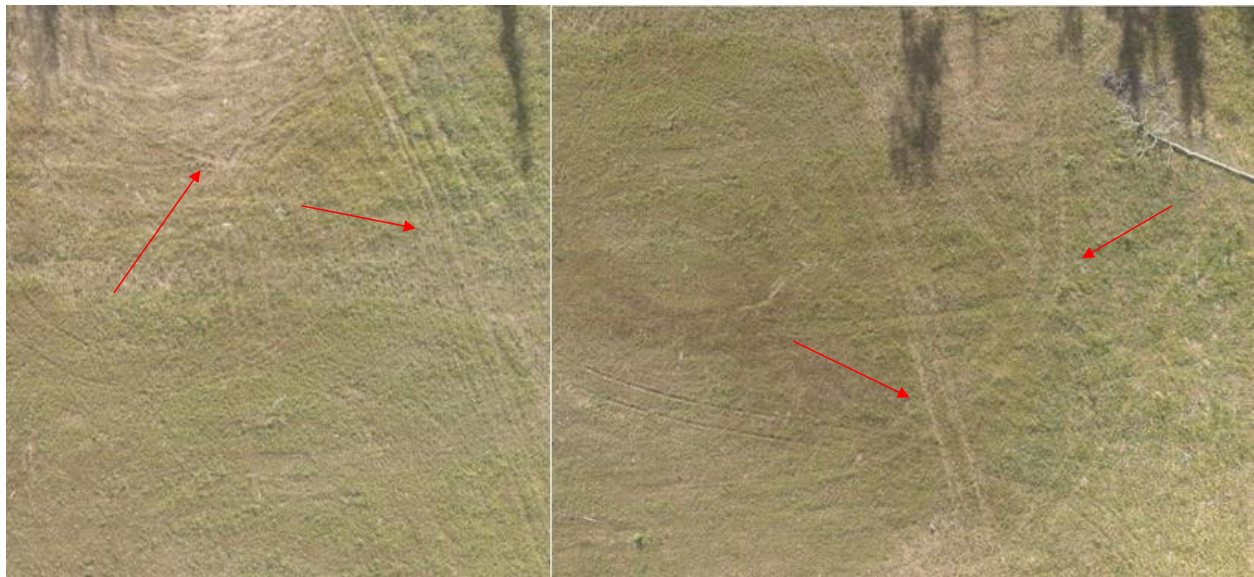
Figure 20 Evidence of vehicles driving over the well pad

In the 2012 photo, it can be seen that salvaged soil was piled on the northeastern side of the well pad. This appears to have been spread throughout the site. While the gravel quarry was excavated nearby, there is no evidence to suggest that it has affected the soil of the well pad area. However, it is not clear whether the soil which was compacted from oil and gas development activities was fully de-compacted as required for a Certificate of Restoration. Evidence that it was not de-compacted is suggested in the northern corner beneath the former salvaged soil pile as mentioned, and the well pad itself has been driven over by numerous vehicles, as shown in Figure 20.

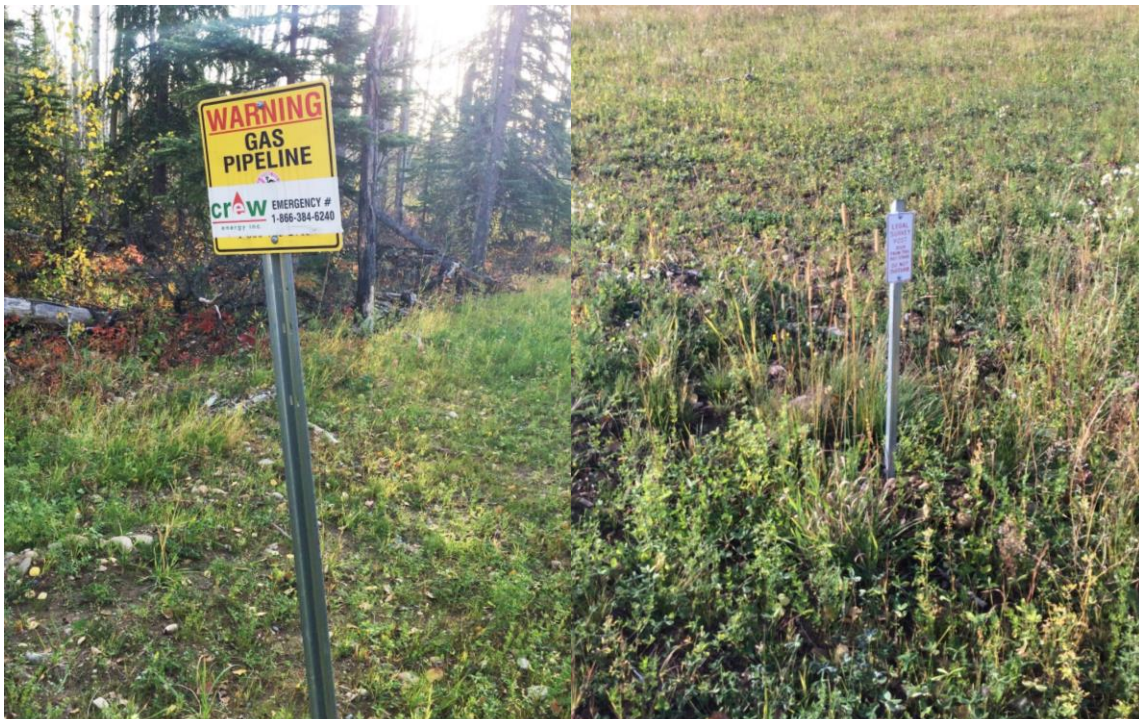
Figure 22 Indication of subsurface facilities from ground photos

There are no facilities remaining on the surface of the well pad from oil and gas production. However, there were signs present that indicate a pipeline remaining beneath and some survey stakes at the surface as shown in the photographs taken from the ground surface in Figure 22.

These signs are similar to the ones found on well pad 19518. However, because of trees blocking the sun, these signs cannot be identified by their shadows in the aerial photographs taken by the drone as they could be on 19518. As these facilities are subsurface, they do not affect the surface drainage.

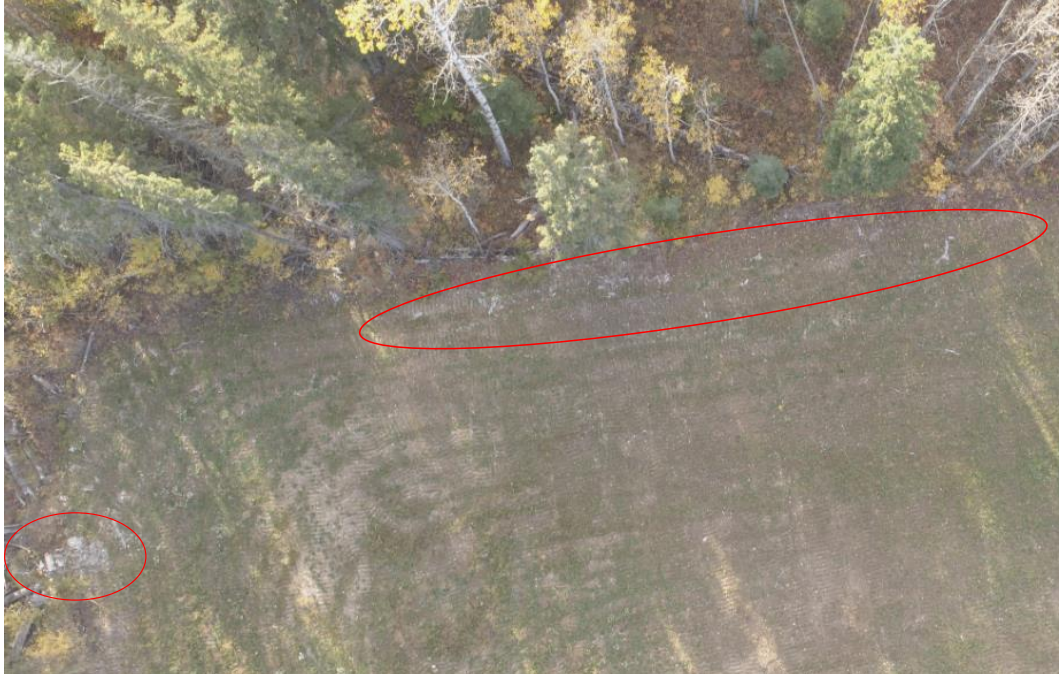
Figure 23 Woody debris around the edges of the well pad

There are no piles of gravel or rock or industrial debris remaining on or around the well pad. However there was a noticeable amount of woody debris, particularly around the edges of the well pad. The debris was in the form of logs and branches, and occasional rocks. The debris was easily seen in the drone photographs, and an example is shown in Figure 23.

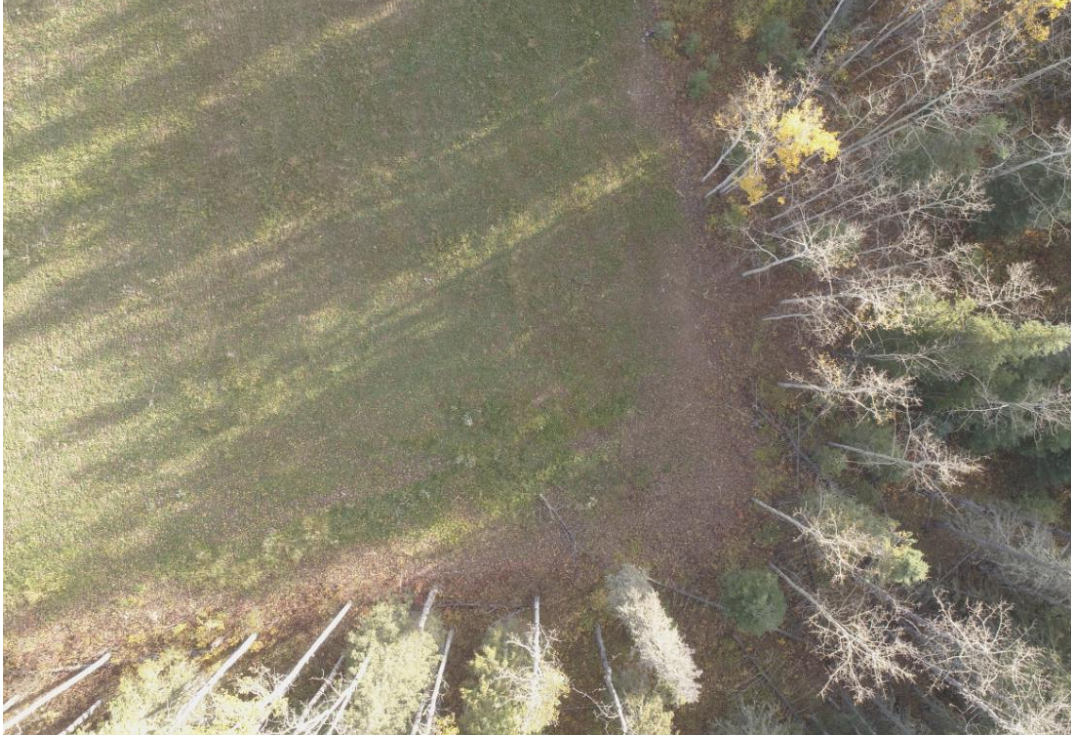
Figure 24 Reduced vegetation density at the south corner of the well pad

As seen in the 2012 photo, the salvaged soil was piled around the edges of the well pad while oil and gas development activities were taking place. Unlike on well pads 19518 and 23947, this does not appear to have drastically impacted vegetation growth due to increased soil compaction. There is a minimal impact that can be observed, particularly in the southern corner of the well pad, as highlighted in Figure 24. However, it is also a possibility that the planted seed mixture for reclamation was not extended this far.

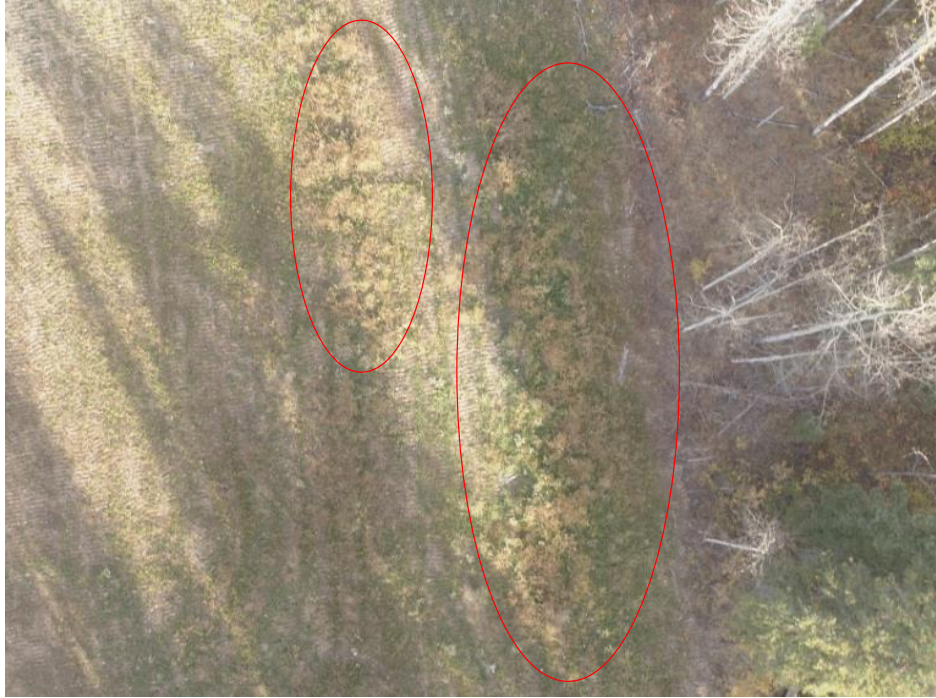
Figure 25 Shrubs or small trees growing on the northeast edge of the well pad

One area of interest that the drone did pick up is on the northeast edge of the well pad where shrub or small trees are growing (Figure 25). There is no reason to believe that they are unintended or invasive species, but their growth in this area is dense.

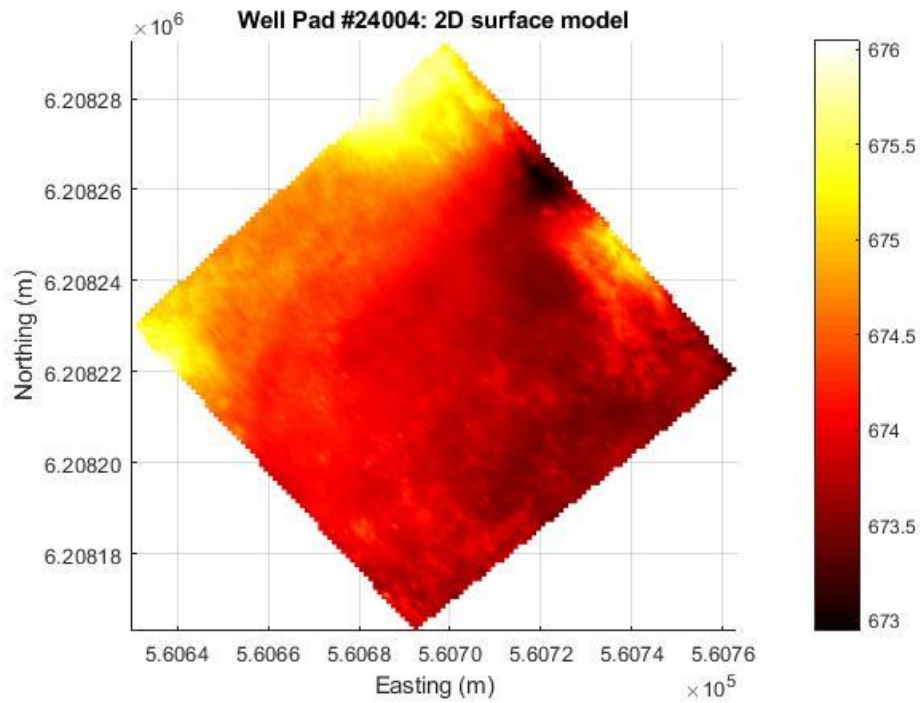
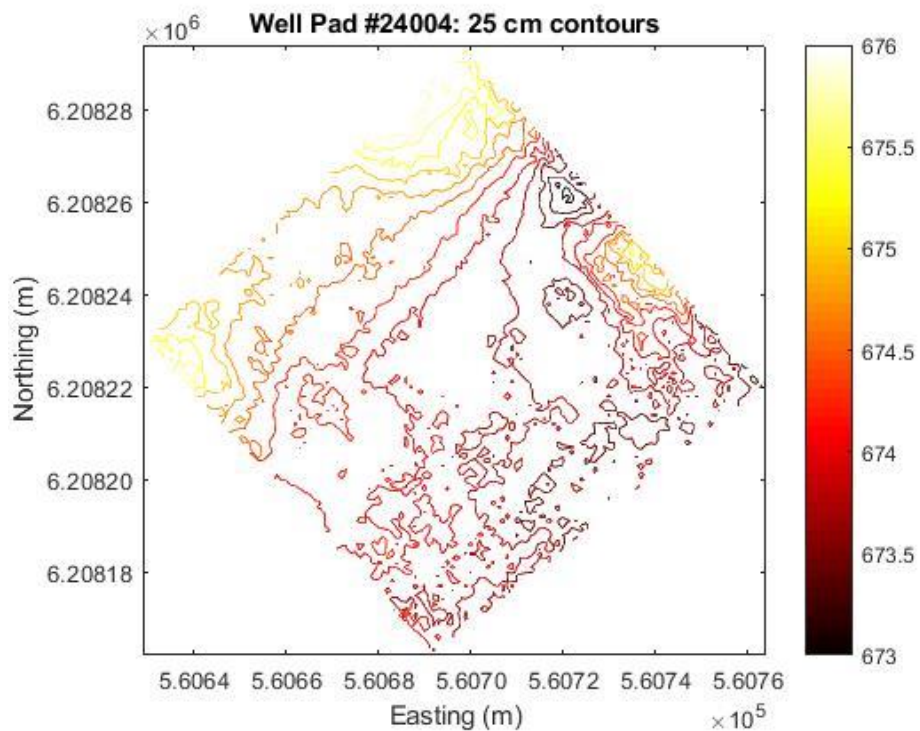
A 2D digital surface model of the well pad and a contour plot showing contours at 25 cm intervals were created in MatLab using low-density versions of the point clouds generated in Pix4D software. These are shown in Figure 26 and Figure 27 respectively.

The land area at this well pad is not quite as flat as well pads 19518 or 23947, with a 3 m elevation difference between the highest and lowest points and slopes that can be observed at the ground

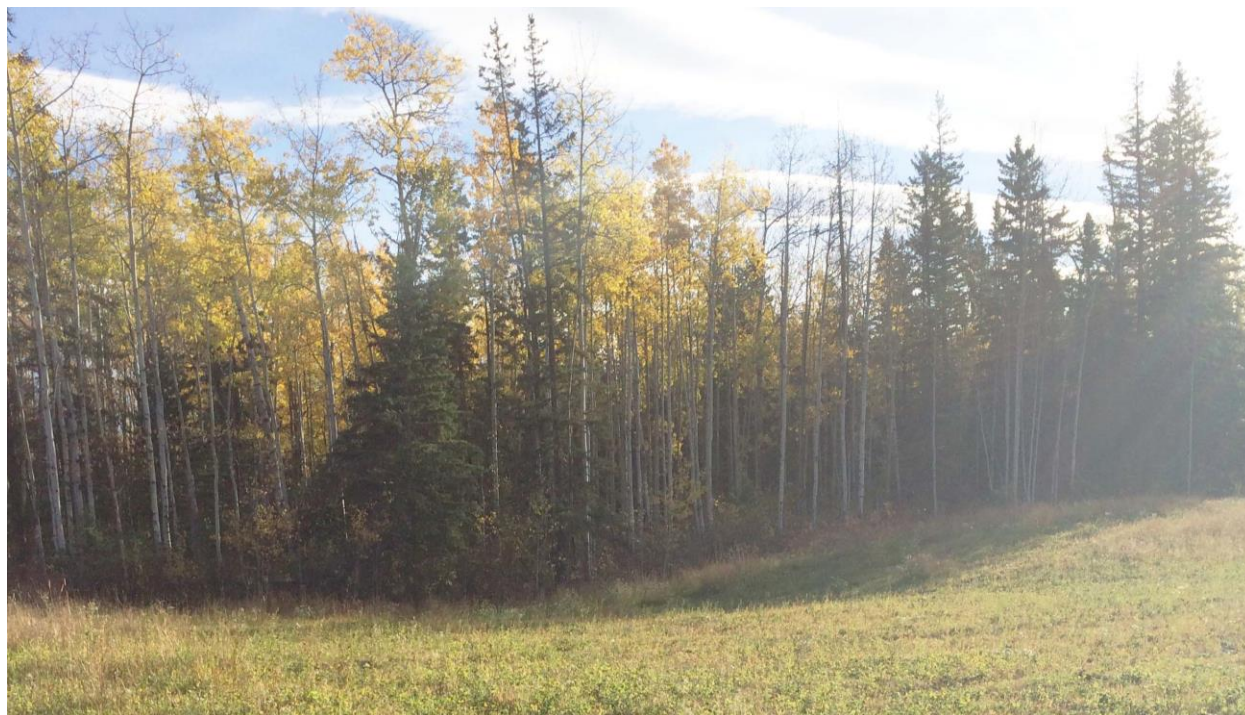
Figure 28 Contrasting surface elevations along the southeast edge of the well pad

surface. The land area drains to the east or southeast. There are three distinct high spots on the well pad the northern corner, the western corner, and an area along the northeastern edge. The drone photographs suggest that the land is actually higher in these spots and the results in Figure 26 and Figure 27 and are not affected by vegetation. This is confirmed in the photograph taken from the ground surface shown in Figure 28 which shows a distinct low spot between the northern corner and the high spot along the northeastern edge.

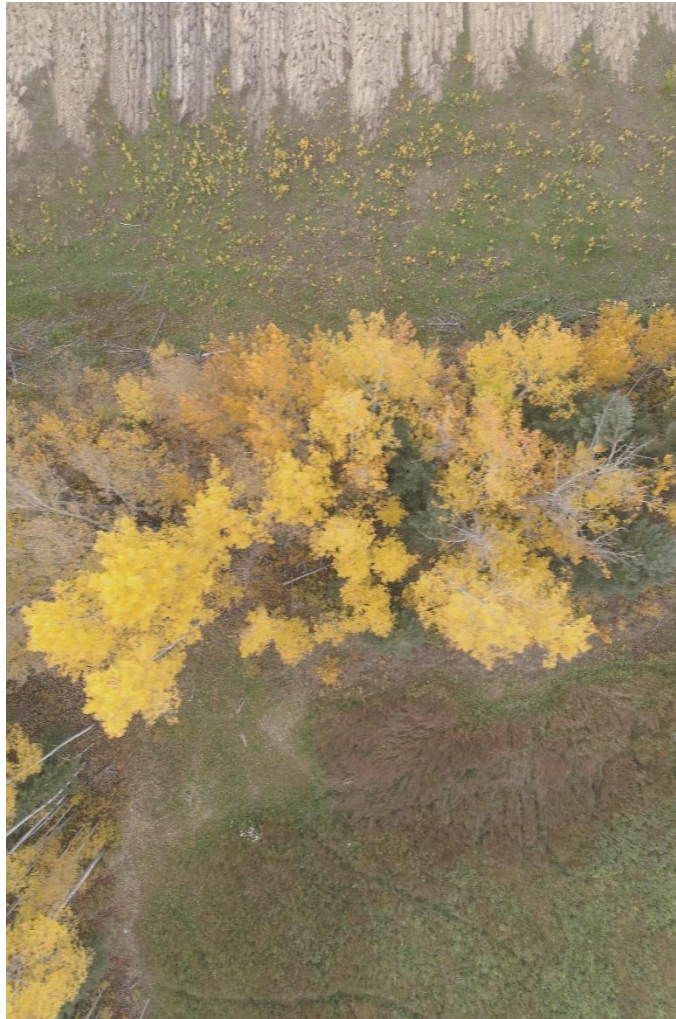
Figure 30 Strip of trees and agricultural land north of the well pad captured by the drone

Land near the well pad is used for agricultural purposes. This was picked up in aerial photographs taken by the drone, as shown in Figure 30. The agricultural land is at the top and the well pad on the bottom, with coniferous trees covering the 25 m separation of land use in between.

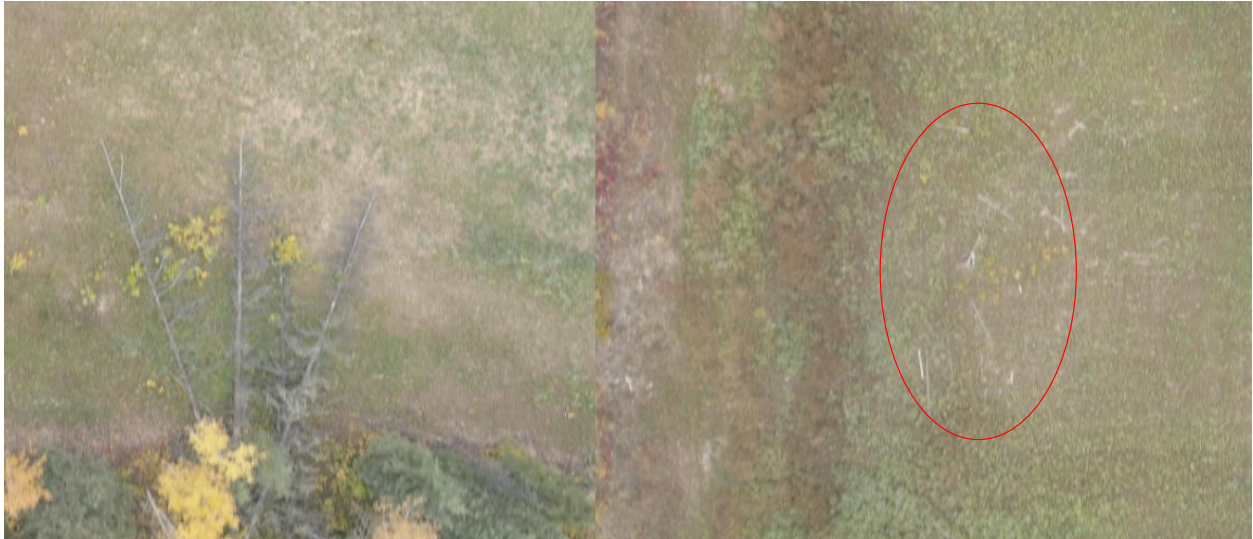
Figure 31 Woody debris and fallen trees on the well pad

removed. There is some minor woody debris and fallen trees as seen in the right and left photographs of Figure 31, respectively.

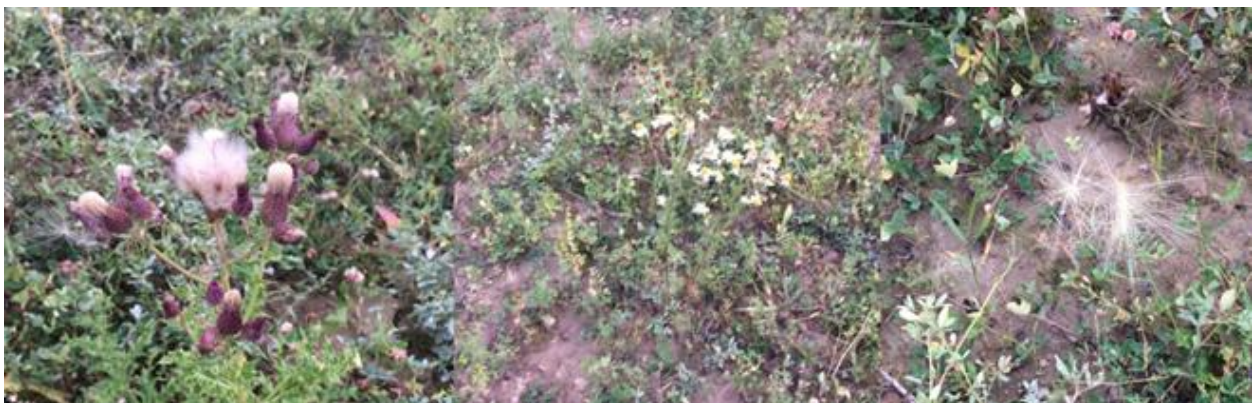
Figure 32 Variety of species found on the well pad including thistle

Some species such as thistle, which is present, are not native to the area. The thistle does not appear to be causing infestation on the well pad or hindering reclamation. However, these weeds should be monitored and Certificate of Restoration criteria should be consulted to determine if they are prohibited or not. Examples are shown in photographs taken at the ground level in Figure 32.

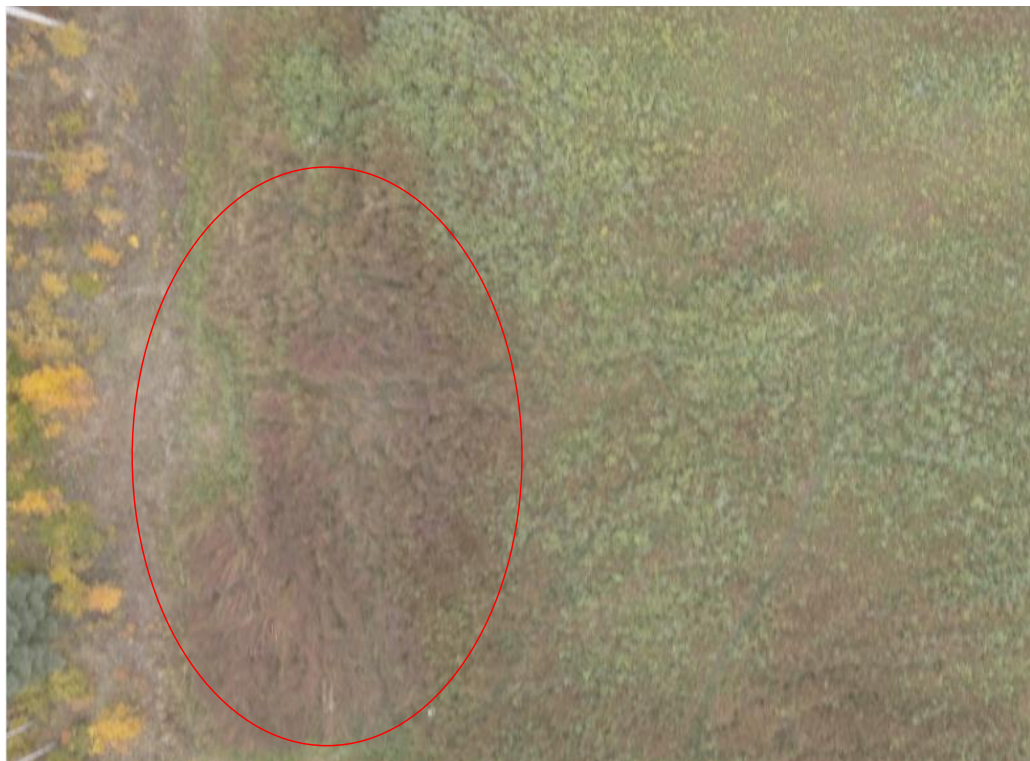
Figure 33 Different coloured vegetation along the northeastern edge of the well pad

Further evidence of the lack of uniformity in the vegetation on the well pad can be seen along the northern edge. In the July 2017 orthomosaic, this is where the most green and the highest vegetation density is observed. While the vegetation is still dense in this area in the September 2017 orthomosaic, it seems that while the rest of the well pad has become greener, this previously green vegetation has become brown. This is highlighted in Figure 33.
