**Evaluation of a Low-Cost Drone
for Monitoring Restoration of Well Pads**

**submitted to
BC Oil and Gas Research and Innovation Society**

**by
Dwayne Tannant and Kalie Smith**

January 15, 2018

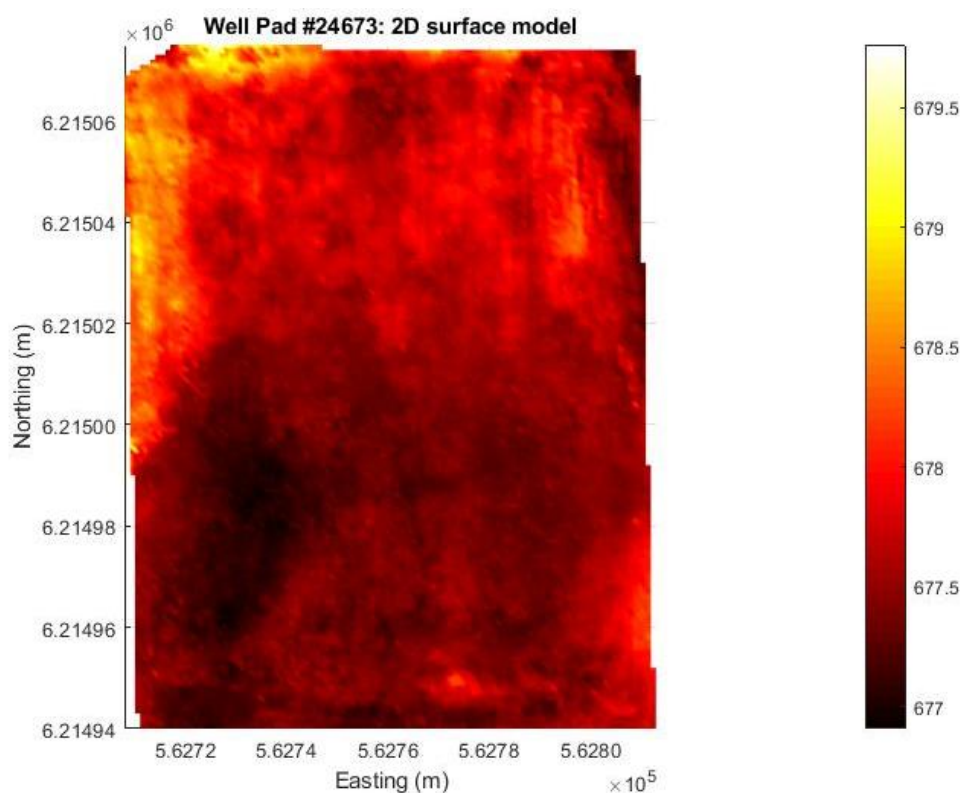
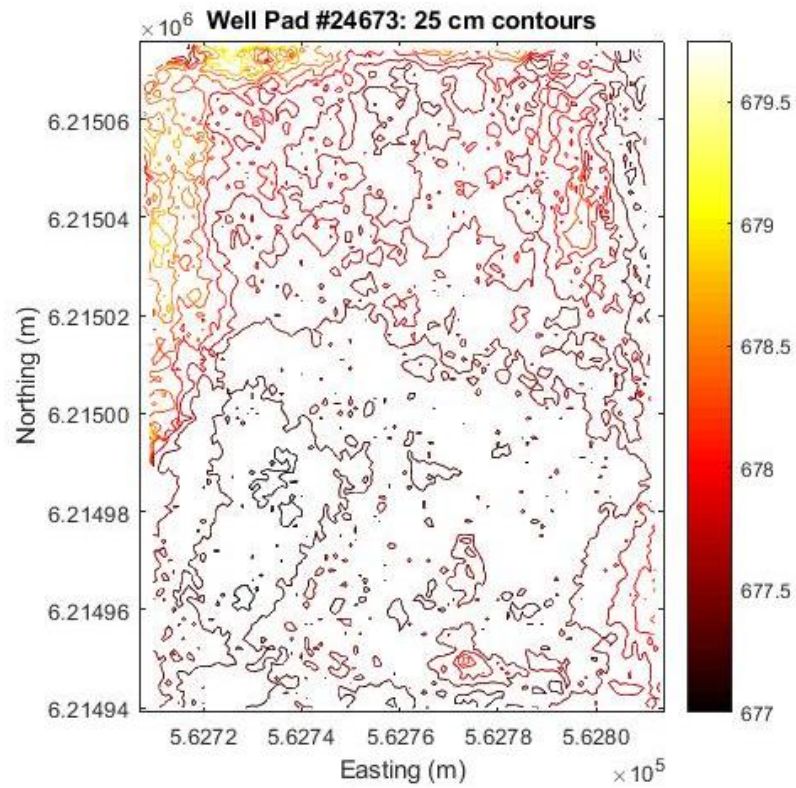
An important note is that the areas of higher elevation shown in Figure 34 and Figure 35 may be overemphasized due to the increased vegetation density in the northeast portion of the well pad, since the point cloud used to make these figures includes vegetation. Therefore, without examining the well pad from the ground surface, it is not possible to confirm with certainty that the “low spot” indicated in Figure 36 is actually due to lower land elevation, or lower vegetation. Therefore a limitation of using a drone is the inability to precisely determine the ground elevation when the vegetation is dense and tall.

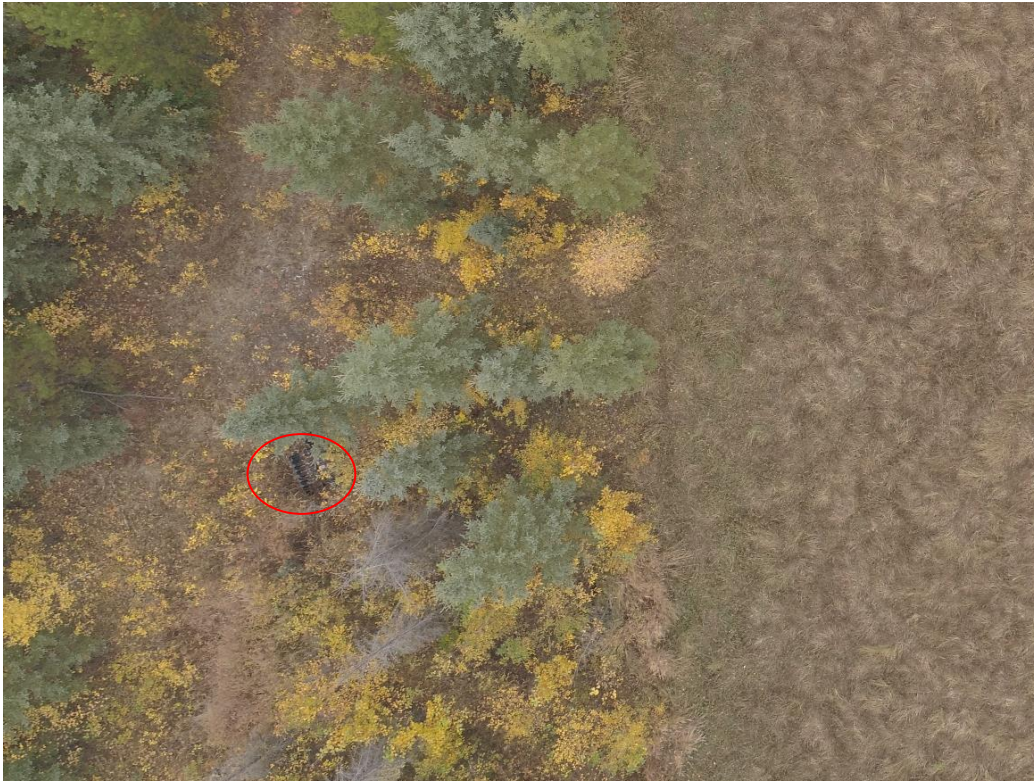
Figure 39 Unidentifiable industrial debris on a secondary access route west of the well pad

route wrapping around the south and west sides of the well pad, a piece of equipment or debris which is not natural to the area shows up in the aerial photos. This is indicated in Figure 39. While it is hard to identify what the black object is, it is clear that it is not a natural object.

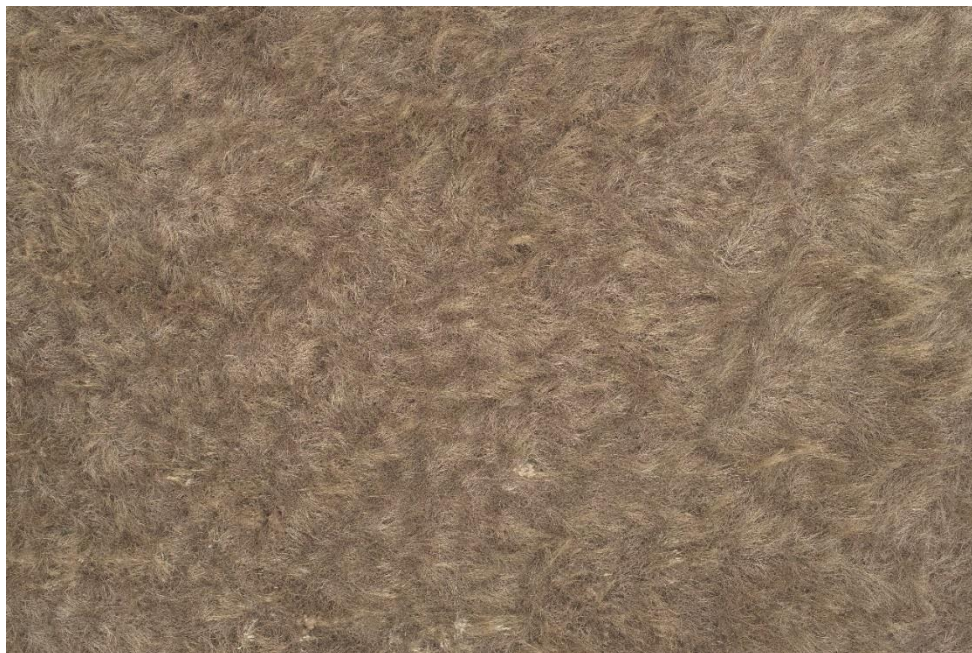
Figure 40 Vegetation on well pad 21726 in September 2017

Because the access road has been restored and the drone had to be flown into the well pad, photographs could not be taken of the vegetation on the well pad from ground level to supplement the aerial photos. However, the drone was lowered to capture a photograph of the vegetation growing on the well pad, shown in Figure 40.

The vegetation appears uniform in terms of both density and colour. There does not appear to be any infestation of weeds. The vegetation growing on this well pad is mostly brown, appearing slightly greener near the edges of the well pad, closer to where coniferous trees are growing. This is highlighted in Figure 41. Additionally, there are some shrubs growing on the eastern side as shown in Figure 42, which may or may not be part of the planted seed mixture.

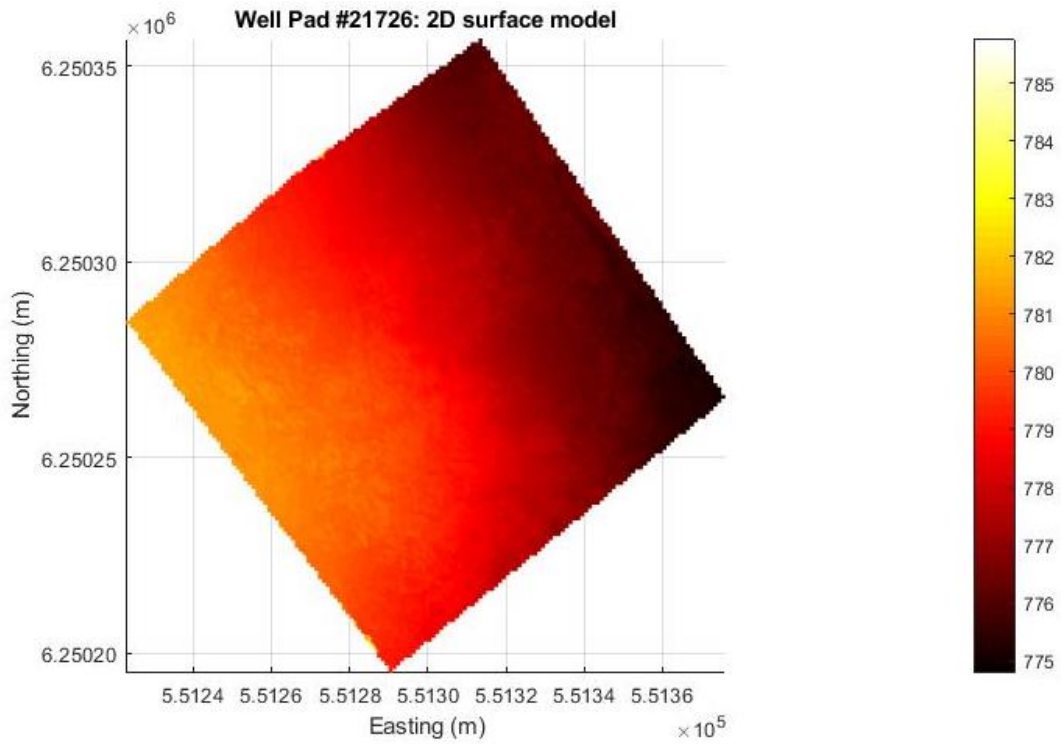
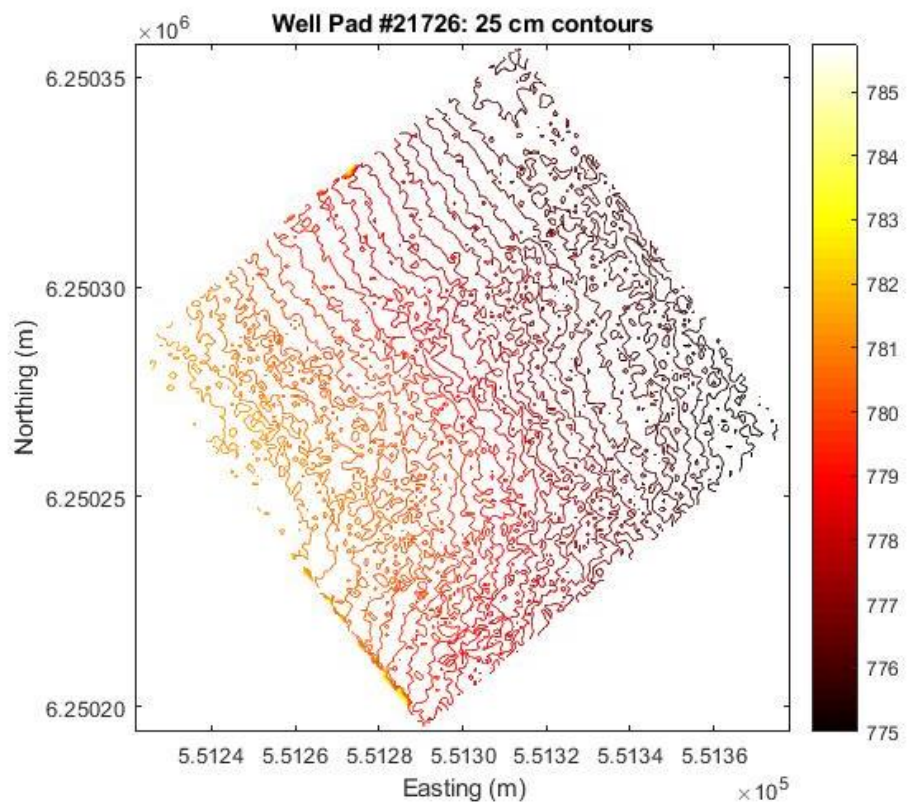
In comparison with the other well pads, 21726 has a much greater slope of approximately 9%. However, the well pad drains uniformly to the northeast. There are no drainage ditches remaining either around the well pad edges or along the access road, suggesting that the drainage pattern has been restored to the condition prior to alteration, or at least to a drainage pattern that is compatible with the surrounding area and land uses. There are no areas of potential ponding or erosion seen in the photographs or landscape models. The uniformity in vegetation height likely contributes to the uniformity in the land slope shown in Figure 43 and Figure 44, as vegetation is included in the point cloud. Figure 37 shows that the land is sloping as suggested by these figures.

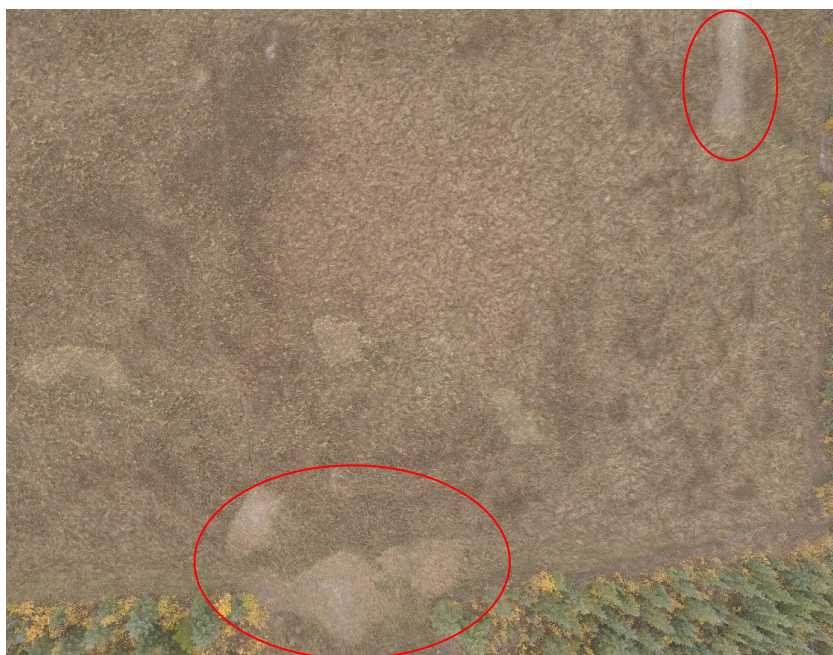
Figure 45 Areas with different vegetation type or density on the well pad

However, note that there are distinct patches or spots on the well pad which are not bare, but where the vegetation is visibly different from most of the surface area. These areas do not appear to have any correlation to where equipment was located on the well pad in 2012. They also do not appear to be areas where ponding occurs, as no low areas were observed in the surface model. These patches be seen from the orthomosaic in Figure 38 and also from the oblique photograph in Figure 37 and the aerial photograph in Figure 45.
