PNG Legacy Site Restoration Project – RFP_RMC_2022_01

Final Report

October 25, 2022

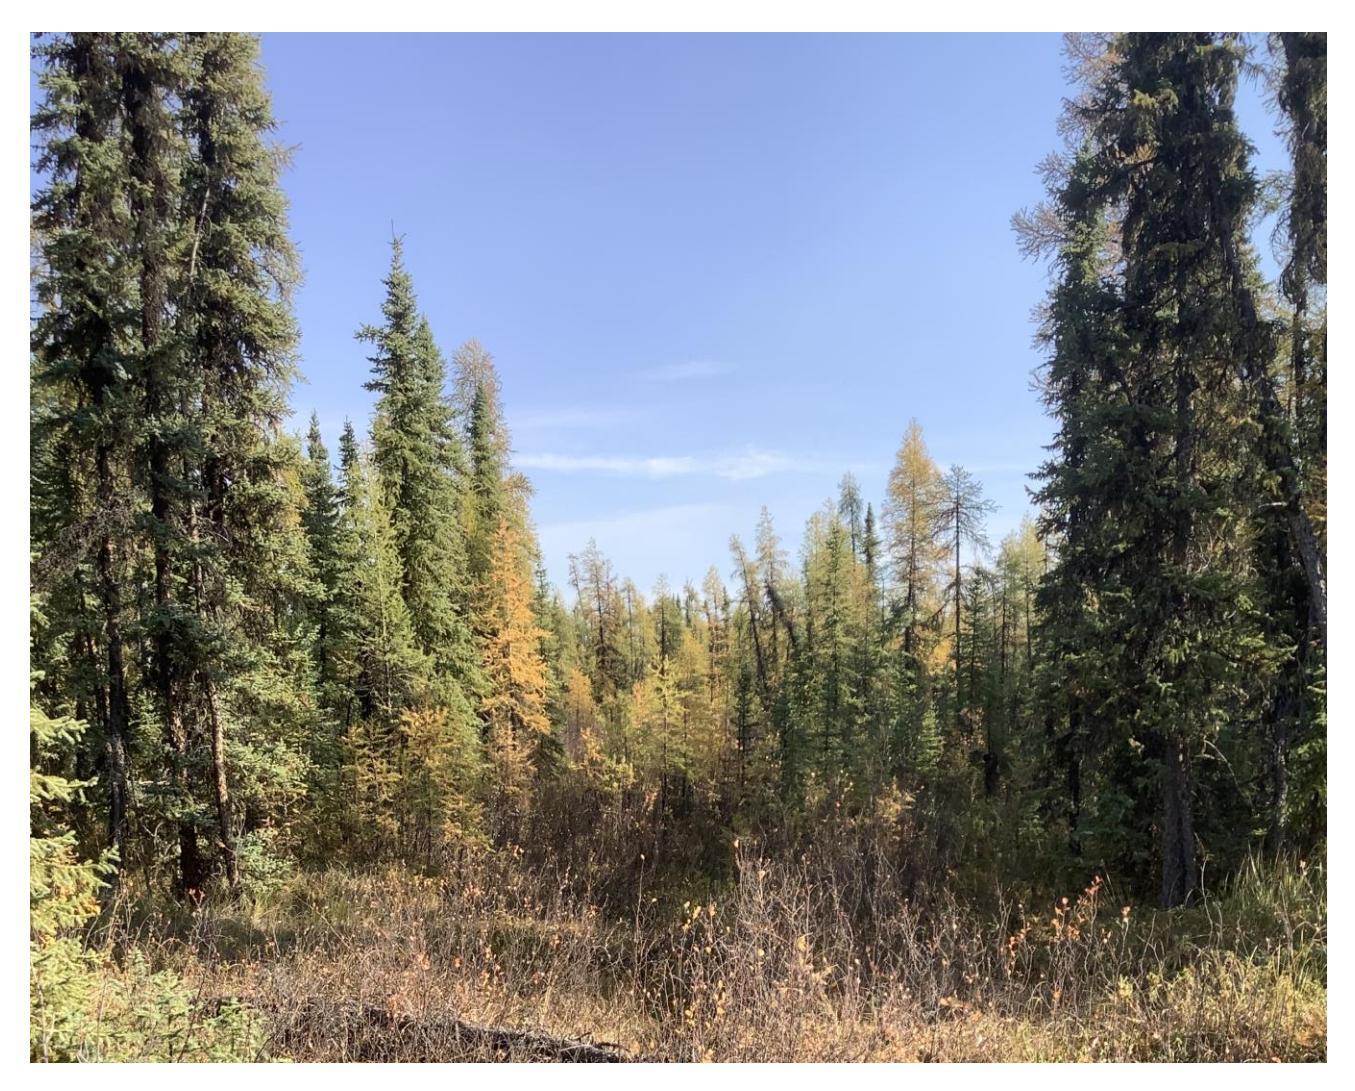
Figure 3. Assessment point #63, location where functional restoration is not required

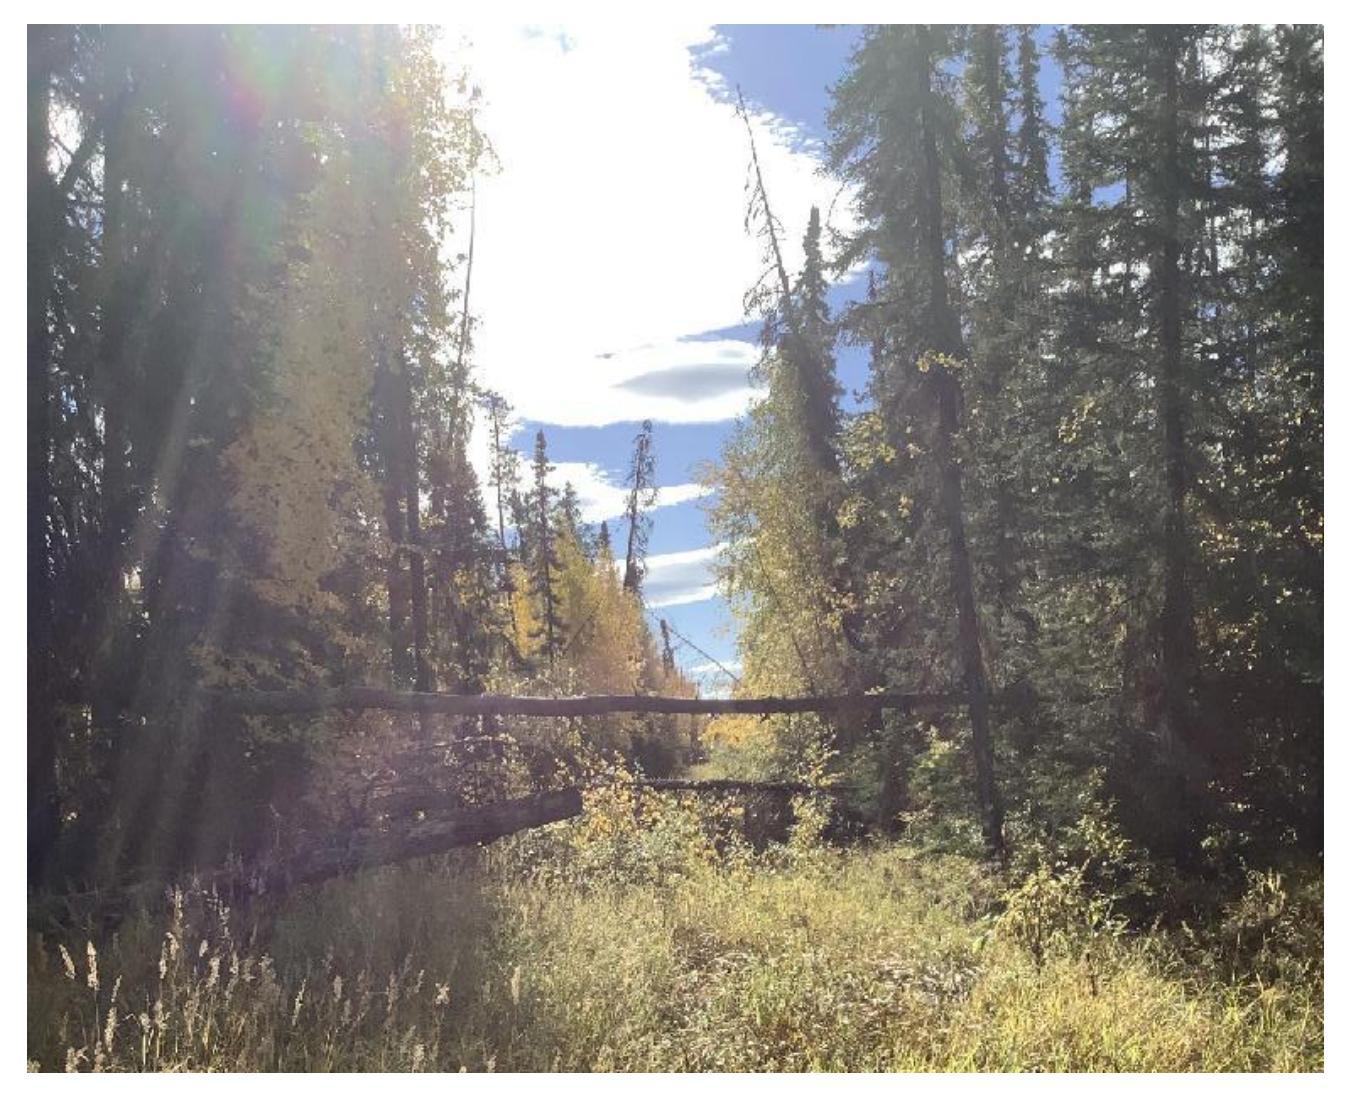
Figure 4. Assessment point #12, a location with high functional restoration potential

- Tree hinging / bending
- o Tree felling / piling of coarse woody debris
- o Screening panels
- o Mounding and winter planting (moist to wet sites) immediately adjacent to barriers
- o Summer planting (mesic to dry sites) immediately adjacent to barriers
- In areas where mulch is restricting natural regeneration, screefing or other site preparation prior to planting will be necessary

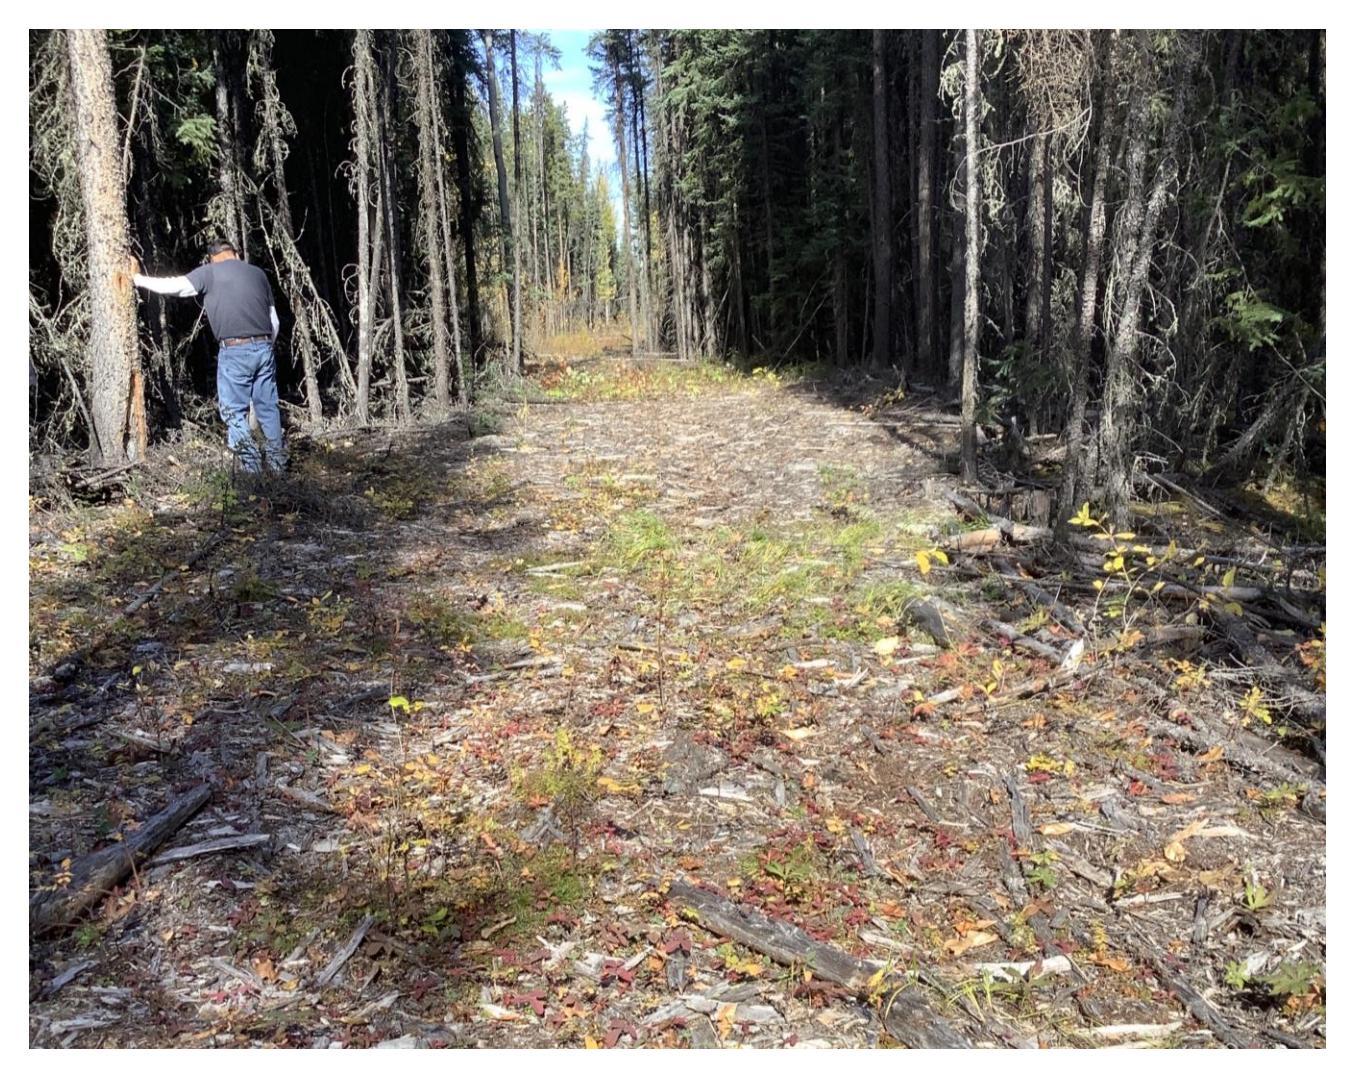
Additional observations noted during the field assessments included the difference in natural regen success based on mulch thickness (as shown in Figures 8 and 9 below) and how well larch (Tamarack) comes back on wetter sites when there is a viable seed source (as shown in Figure 10 below).

Figure 8. Assessment point #4, heavy mulch impeding natural regen

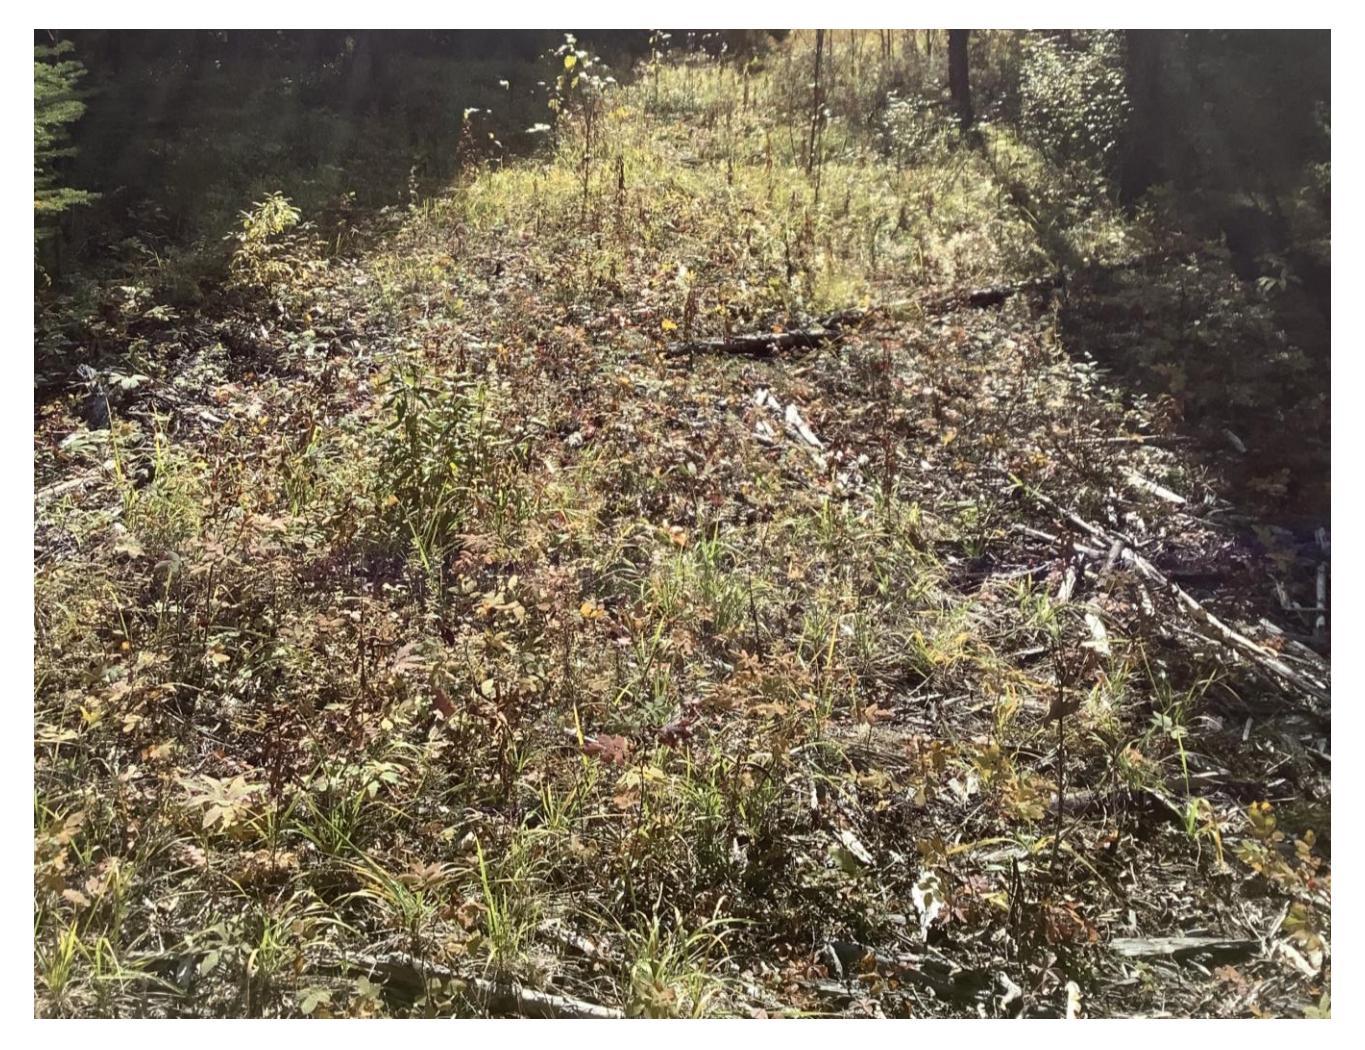
Figure 9. Assessment point #4, area of less mulch adjacent to the area of heavy mulch in Figure 8

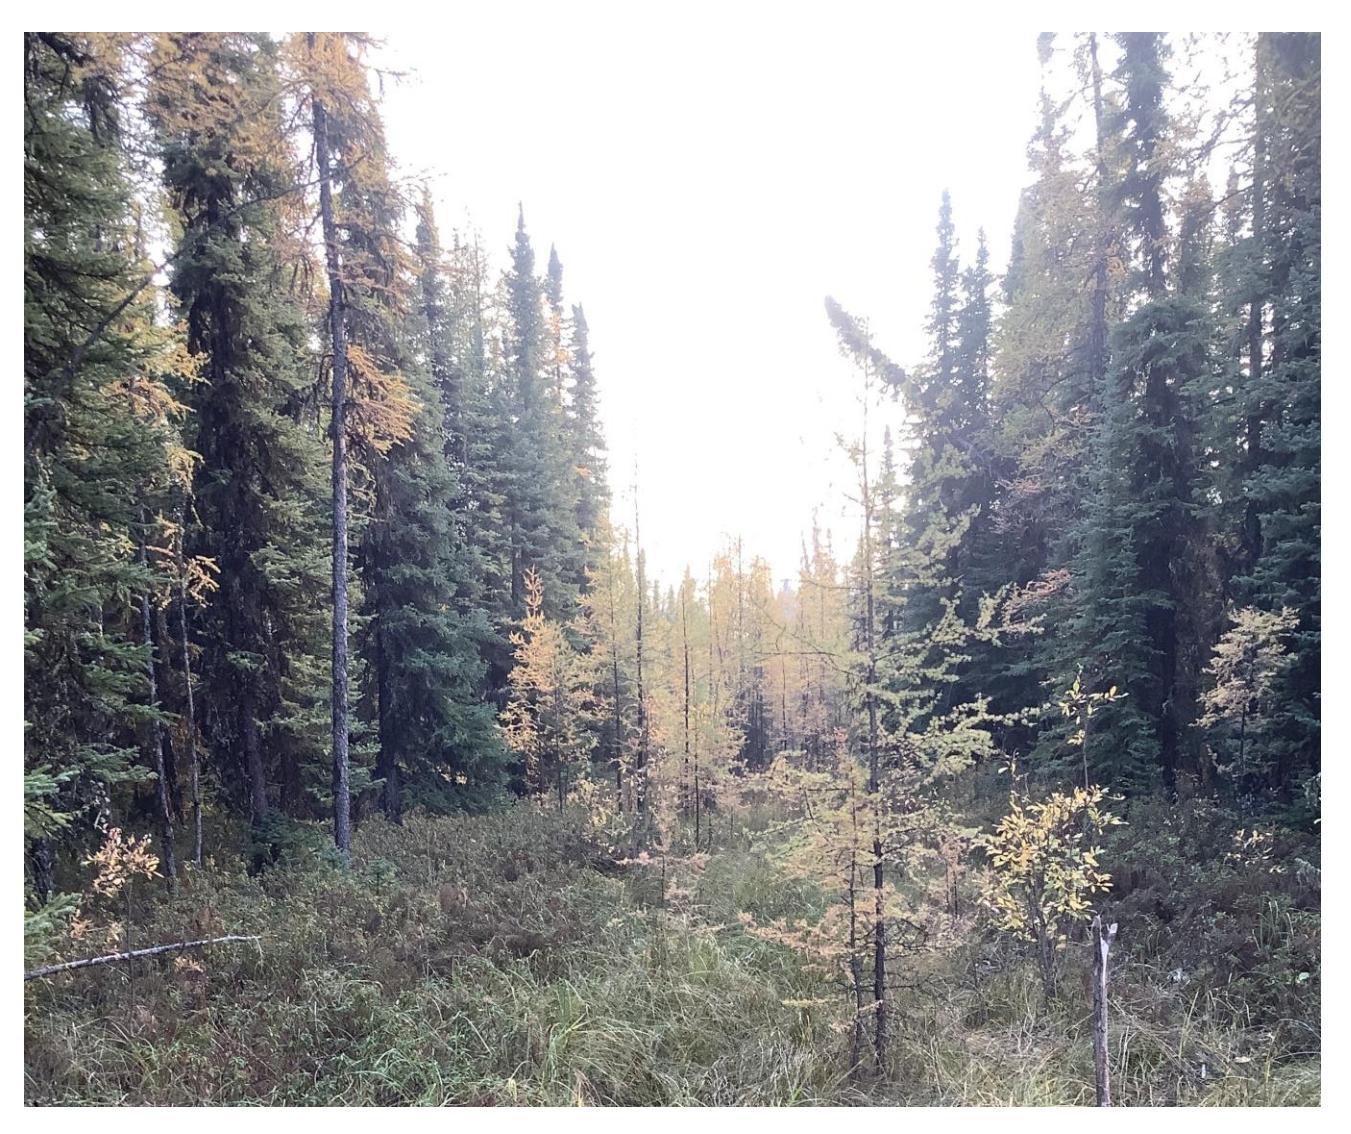
Figure 10. Assessment point #50, successful natural regen of Larch on wetter sites where a viable seed source exists
