Doig River First Nation

Uujō Aanaawudleh Eşē Linear Disturbance Vegetation Analysis (McMillan Creek)

Pre-Treatment Images of Candidate PNG Legacy Sites for Restoration

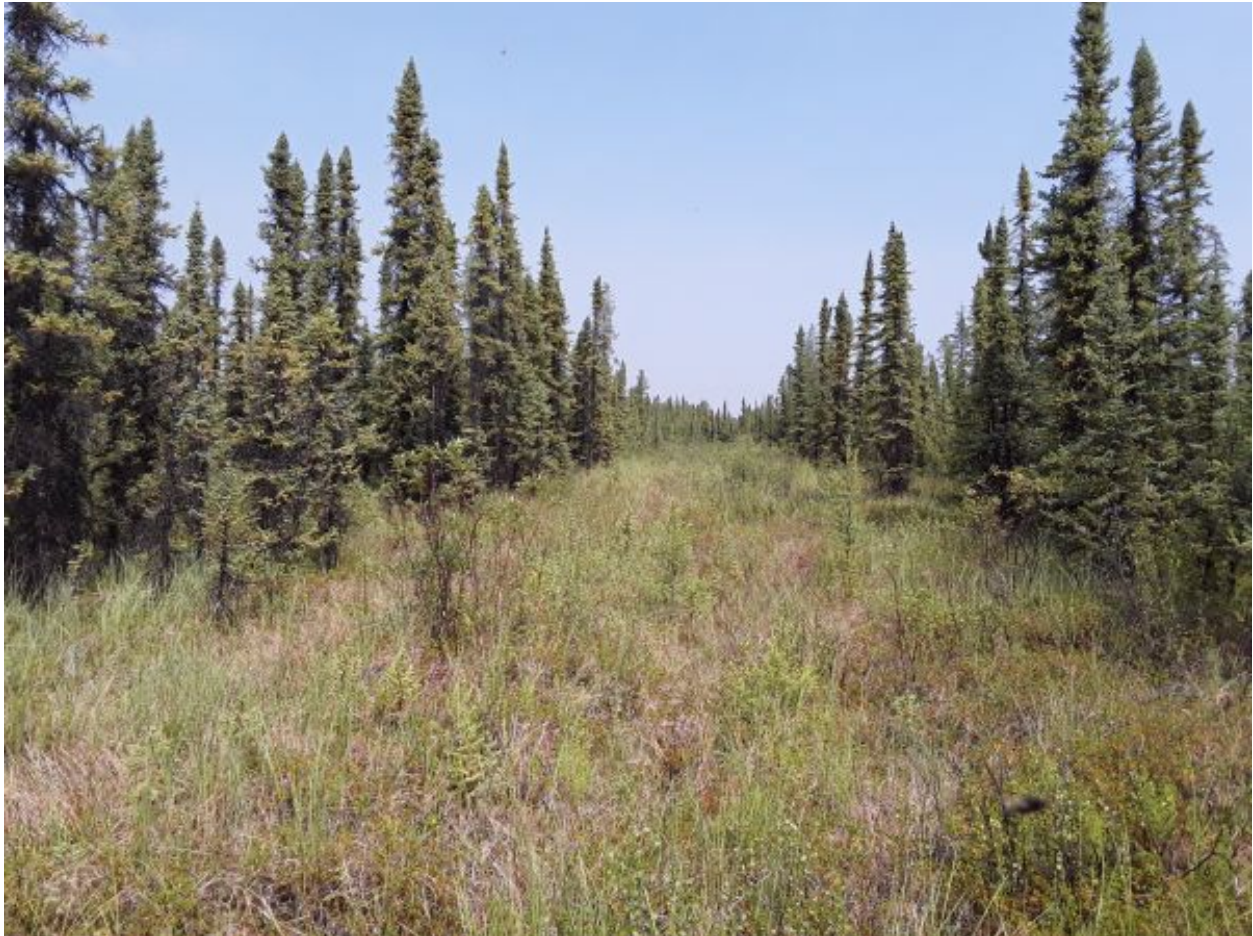
The images below are Petroleum and Natural Gas (PNG) legacy seismic lines that are good candidates for restoration under this project. Potential restoration treatments include the following:

- excavator mounding—to provide a suitable microsite for tree planting using the same conifer species found offsite.
- tree bending—of adjacent timber to obstruct sightlines and reduce ungulate and predator traffic.
