PARKER CARIBOU RANGE

BC OGRIS Zone 1 Habitat Restoration Implementation Vegetation Monitoring Program

REPORT

Report Number: 1778967-3000

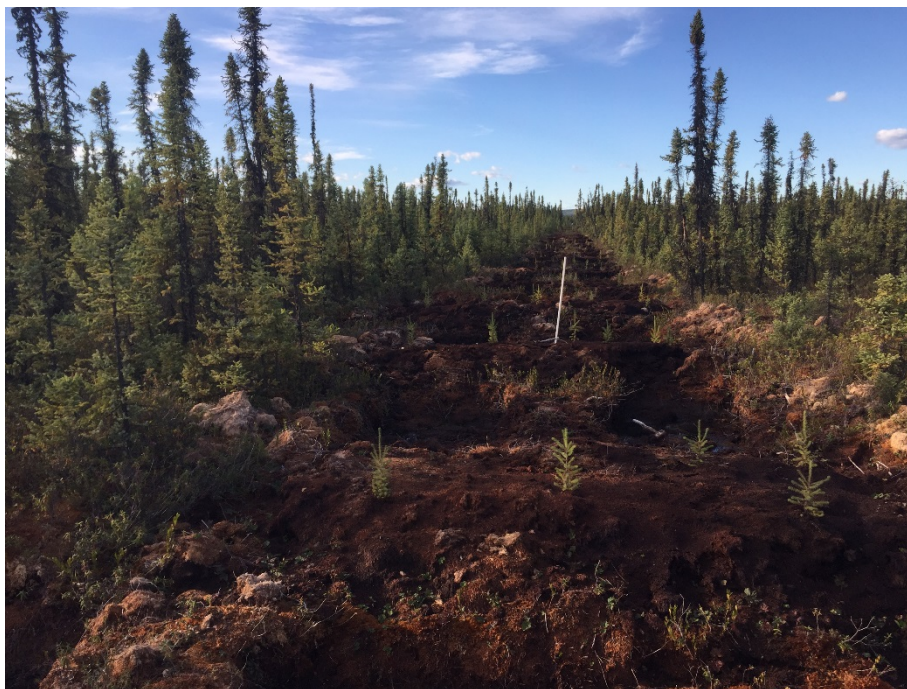
Photo 1: Looking north at plot 39 from middle plot at strong re-growth of winter planted black spruce (September 10, 2017).

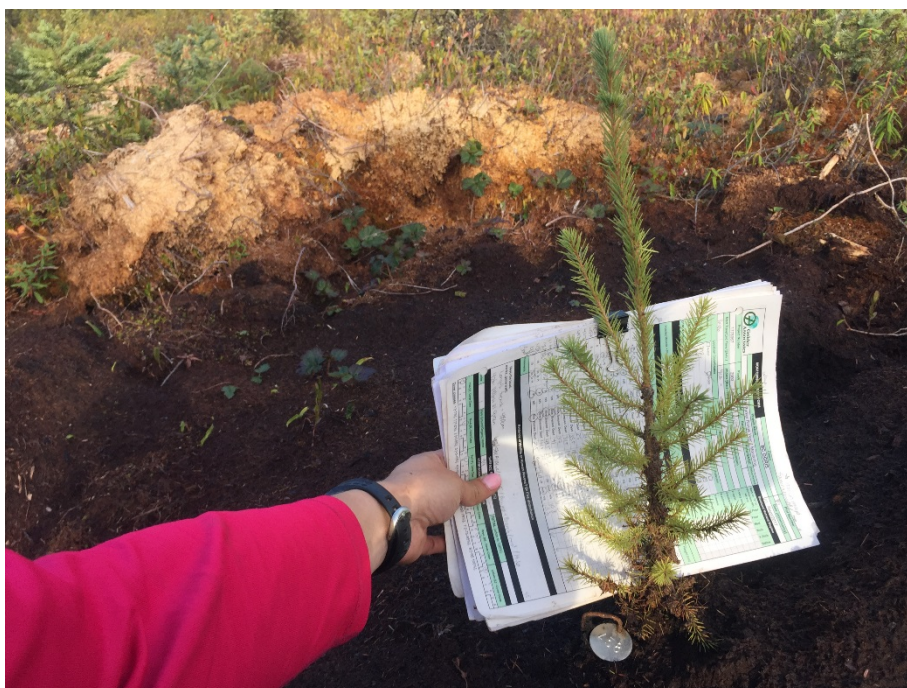
Photo 2: Looking at healthy winter planted black spruce seedling 458 in plot 39 (September 10, 2017).

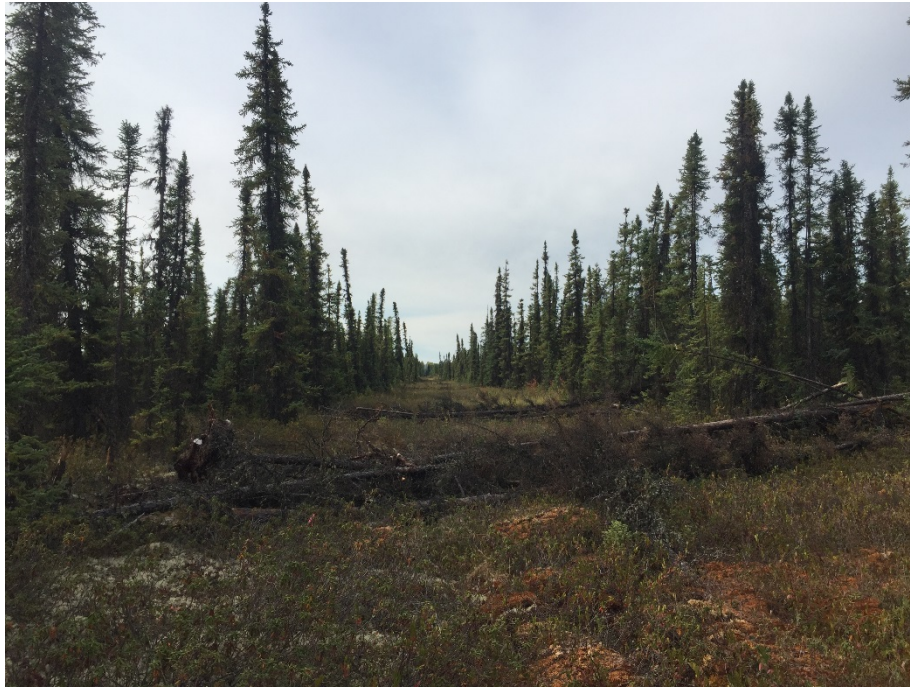
Photo 3: Looking south at tree felling implemented in winter 2016/2017 in a lowland (September 09, 2017).

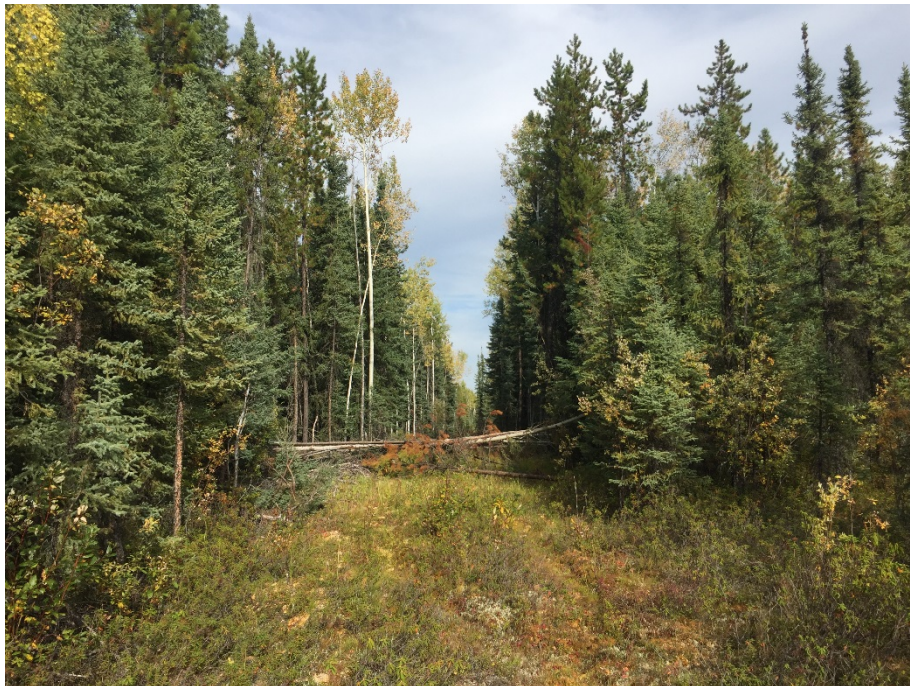
Photo 4: Looking west at tree felling implemented in winter 2016/2017 in an upland (September 09, 2017).

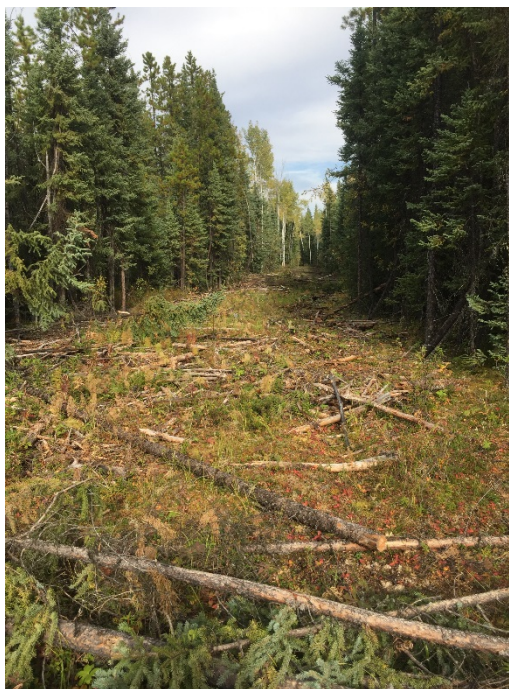
Photo 5: Looking northeast at slash rollback implemented in winter 2016/2017 (September 09, 2017).

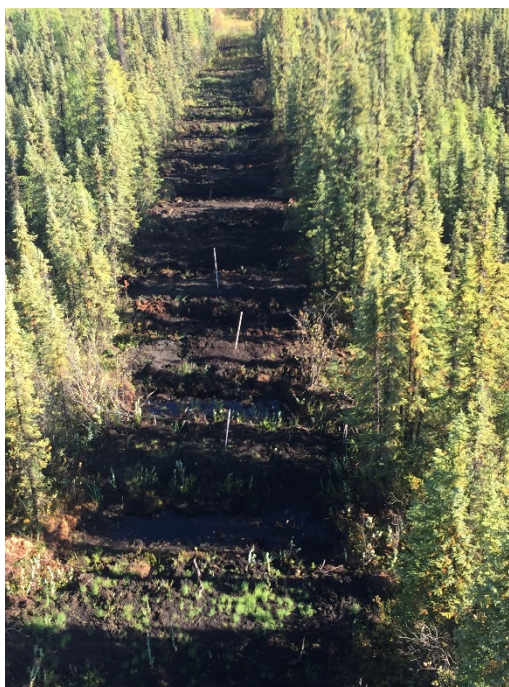
- Plot 79 was aerially surveyed which made it difficult to assess seedlings from air, and there is likely a larger number of seedlings that survived. Plot 80 is located south of Plot 79 and had a 92% survival rating which is more probable than the 57% that could be visually assessed.

Photo 6: Aerial view of plot 79, assessed seedling survival by air (September 10, 2017).

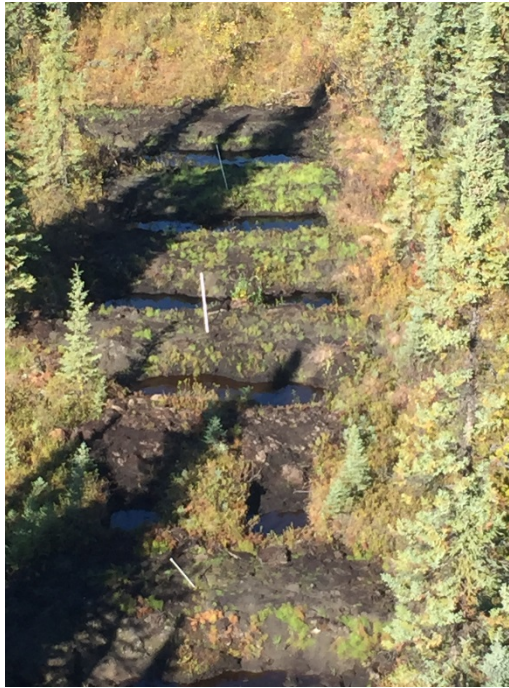
- Plots 29, 52, T66 had clay mixed with organic soils during treatment. Where clay was mixed into the mounds the seedlings appeared stressed or dead. If the site was a transitional site, the seedlings survived on the mound hinge.

Photo 7: Aerial view of plot 52 before ground-truthing, plot suffered from browsing and poor soil conditions (September 10, 2017).

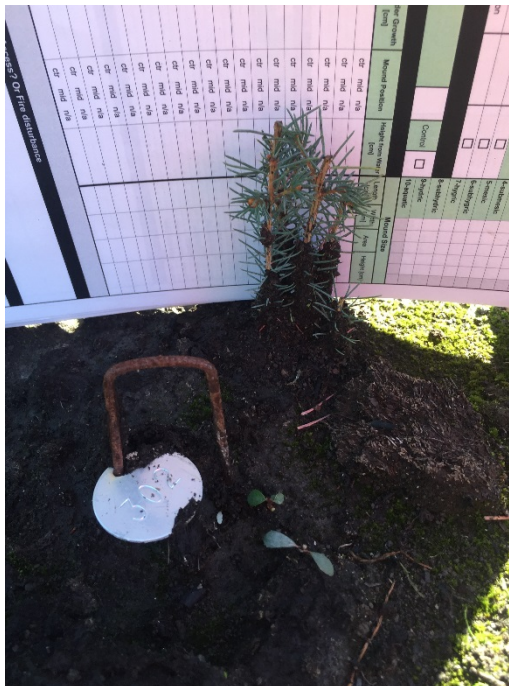
Photo 8: Looking at browsed winter planted black spruce seedling 302 in plot 52 and typical lateral growth after browsing (September 10, 2017).

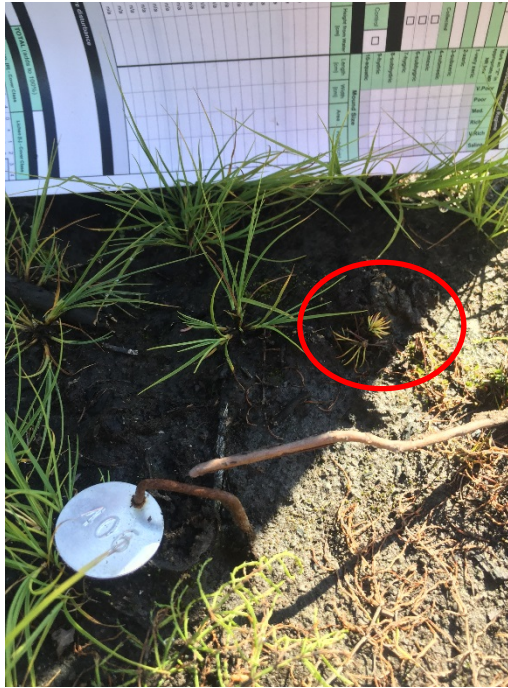
Photo 9: Looking at browsed winter planted black spruce seedling 406 in plot 52 which is dead (September 10, 2017).

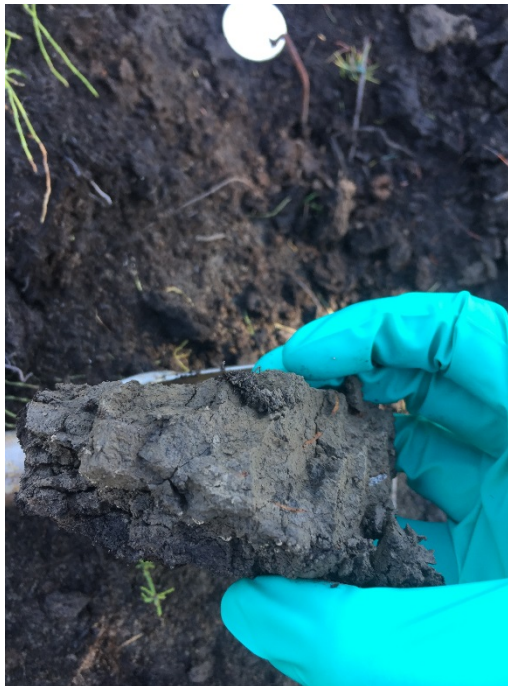
Photo 10: Looking at soil type in plot 52 which is expected to have inhibited seedling growth along with serious browsing (September 10, 2017).

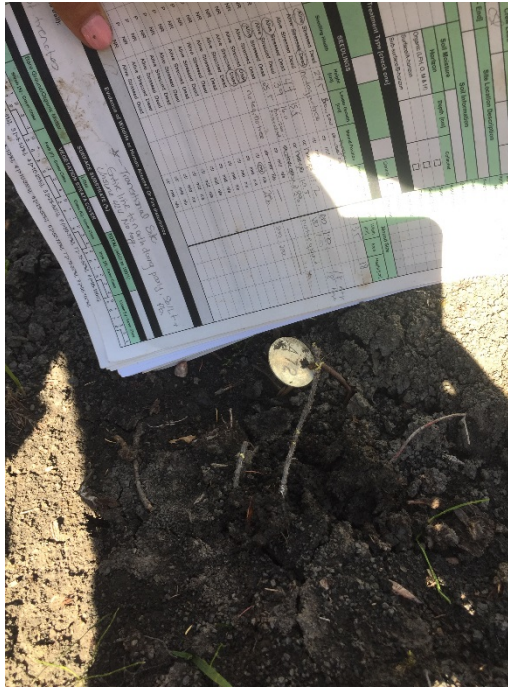
Photo 11: Looking at dead winter planted black spruce seedling 472 in transitional plot 29 on a mound (September 10, 2017).

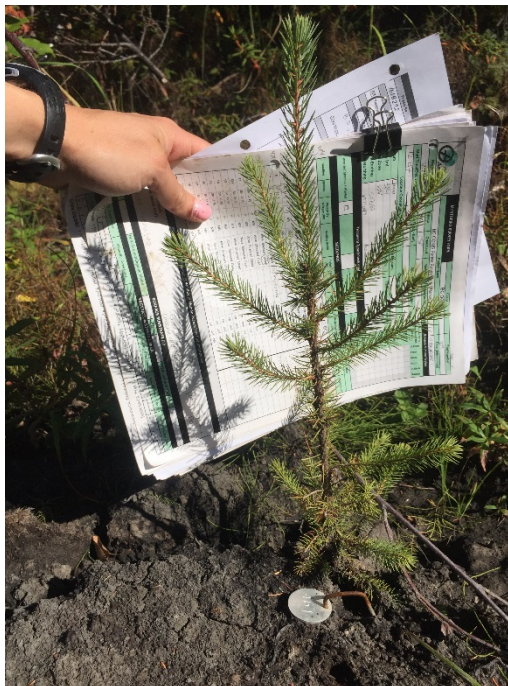
Photo 12: Looking at healthy winter planted black spruce seedling 461 in transitional plot 29 planted on a hinge of a mound
