# **PNG LEGACY SITE GROUND BIRCH-BRASSEY RESTORATION PROGRAM**

SUMMARY REPORT

SUBMITTED BY  
**ASKI RECLAMATION LP &  
SILVERBERRY PRO**

February 7, 2022

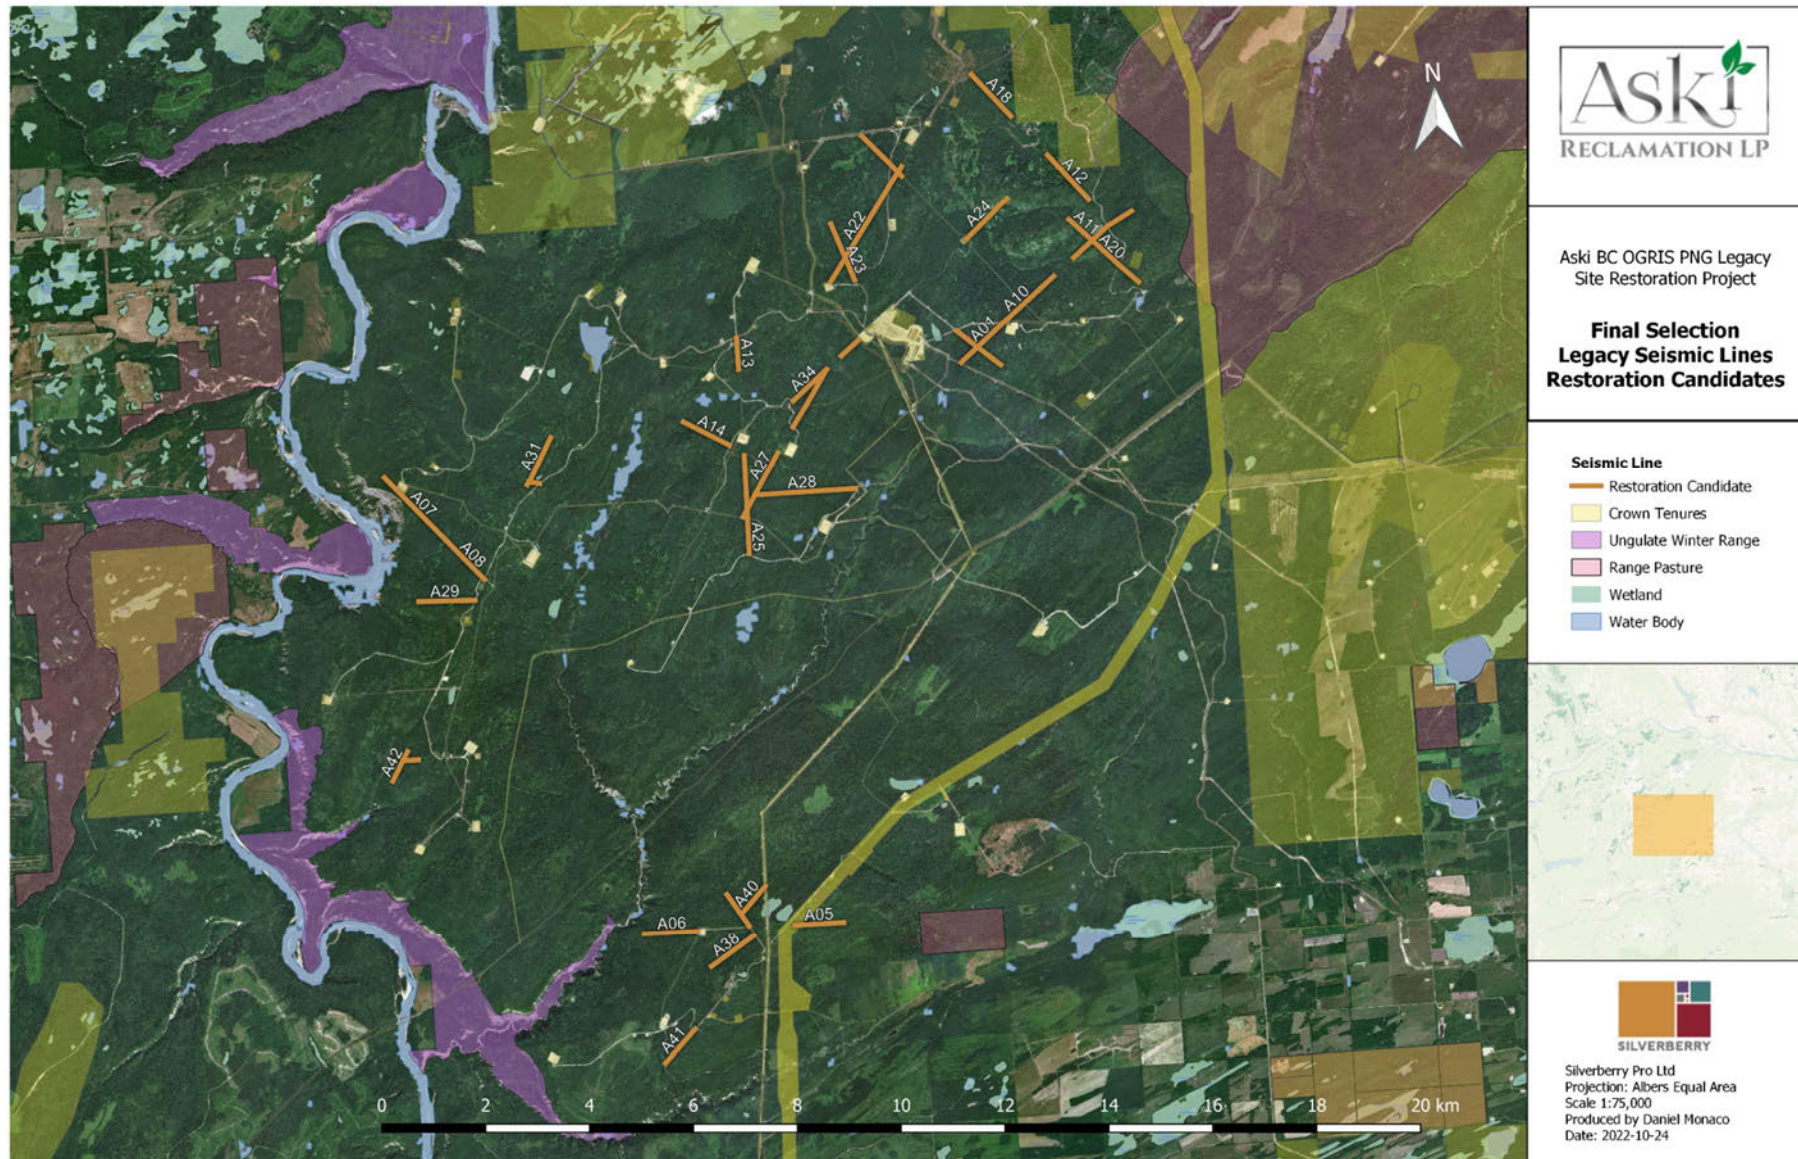
Figure 2. Final Selection of Legacy Seismic Lines Suitable for Restoration within the Groundbirch area and nearby Land Tenure Conflicts.

Following the desktop spatial analysis and the air and ground reconnaissance, 37 legacy seismic lines in the Groundbirch area were selected for treatment. Figure 2 shows the final selection of the legacy seismic lines to be restored.

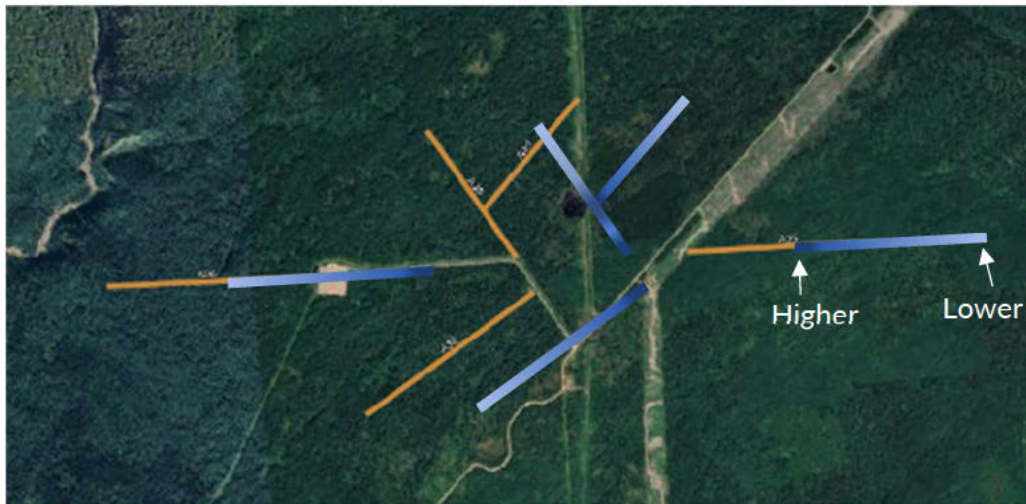
*Figure 3. Example of Plant Installation Density Along the Length of Legacy Seismic Lines.*

Planting density also varied along the length of each seismic line legacy seismic line, with higher density at the access points of the legacy seismic line and lower densities progressing towards the end of the line. The change in densities was to discourage line access and to promote revegetation in areas less likely to recover naturally. In Figure 3, the darker colors represent high density while lighter colors represent lower density.

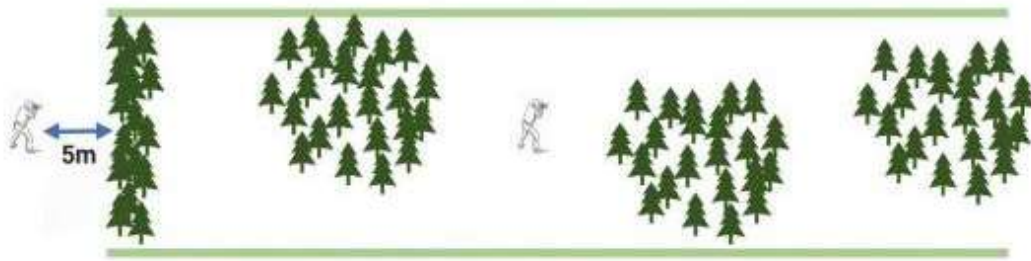
*Figure 5. Monitoring Plot Locations Along a Legacy Seismic Line.*

Photo Number	Location	Direction of Photo
1	Legacy seismic line access point.	Taken 5 m back from the edge of the legacy seismic line (e.g., where a legacy seismic line is accessed from a road right-of-way, the plot will be located within the road right-of-way to obtain a view of the end of the legacy seismic line). The photo was taken towards the legacy seismic line to give a full view of the access point.
2	Strategically selected location representative of the legacy seismic line treatment, at least 100 m from the access point.	Taken from the center of the line with a line of sight parallel to the edge of the legacy seismic line, facing <b>away from</b> the access point.
3		Taken from the center of the line with a line of sight parallel to the edge of the legacy seismic line, facing <b>towards</b> the access point.

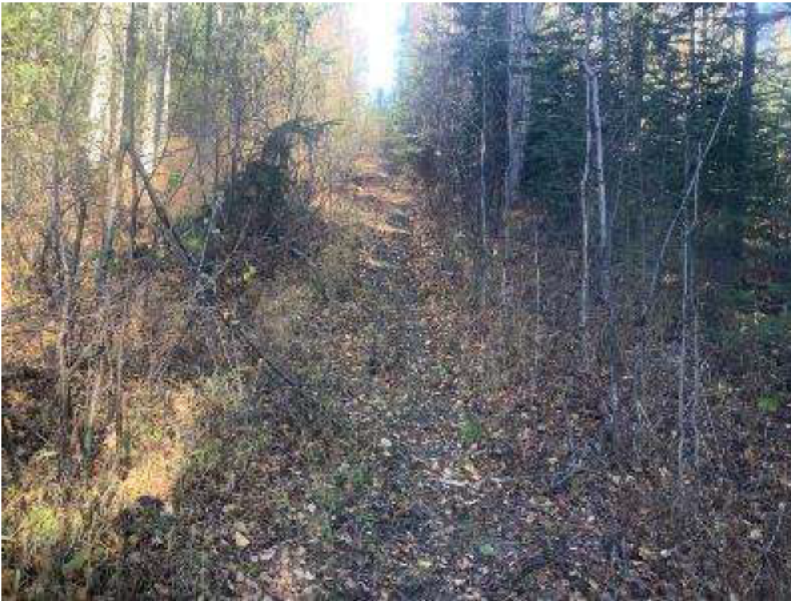
Figure 7. Legacy Seismic Line A01.

Length of Legacy Seismic Line	0.64 km
Approx. Width	3 m
OHV Trail Present	No
High-Density Staking at Line Access	Yes
Total Installed Stem Count	900

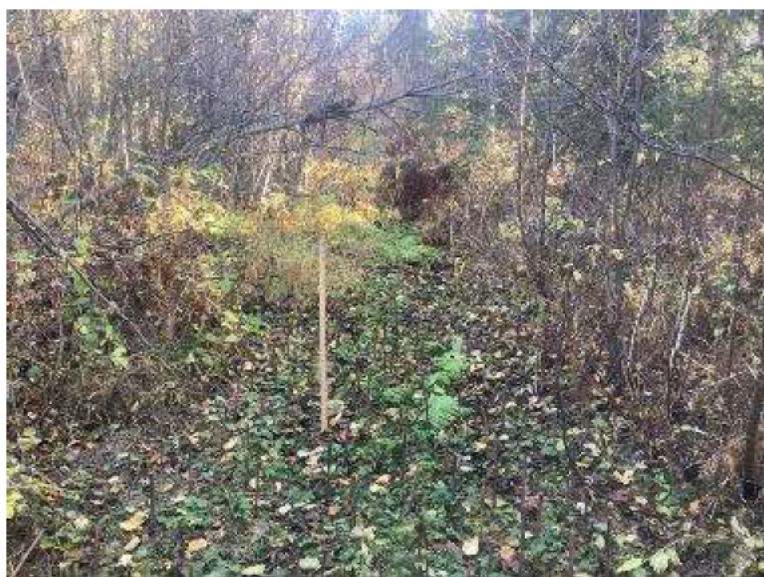
Figure 8. Legacy Seismic Line A02.

Length of Legacy Seismic Line	0.56 km
Approx. Width	3 m
OHV Trail Present	No
High-Density Staking at Line Access	Yes
Total Installed Stem Count	300

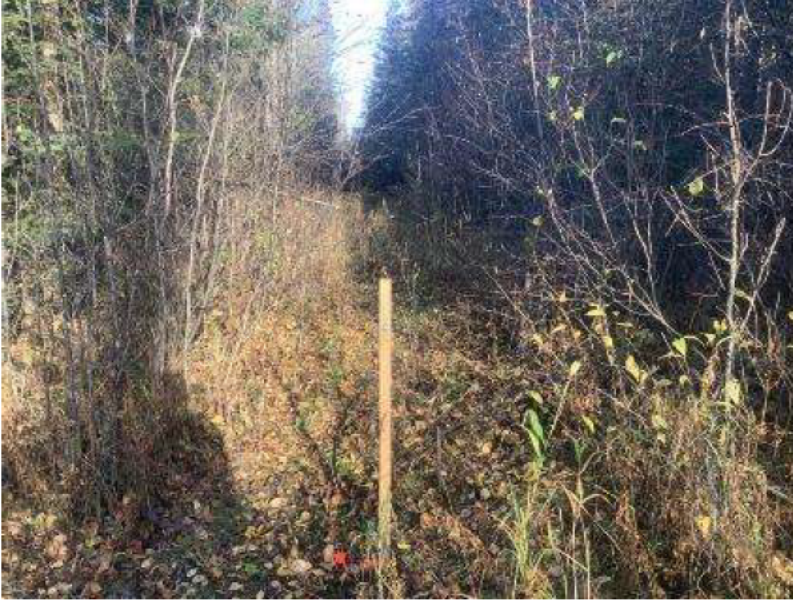
Figure 9. Legacy Seismic Line A03.

Length of Legacy Seismic Line	0.43 km
Approx. Width	3 m
OHV Trail Present	No
High-Density Staking at Line Access	Yes
Total Installed Stem Count	600

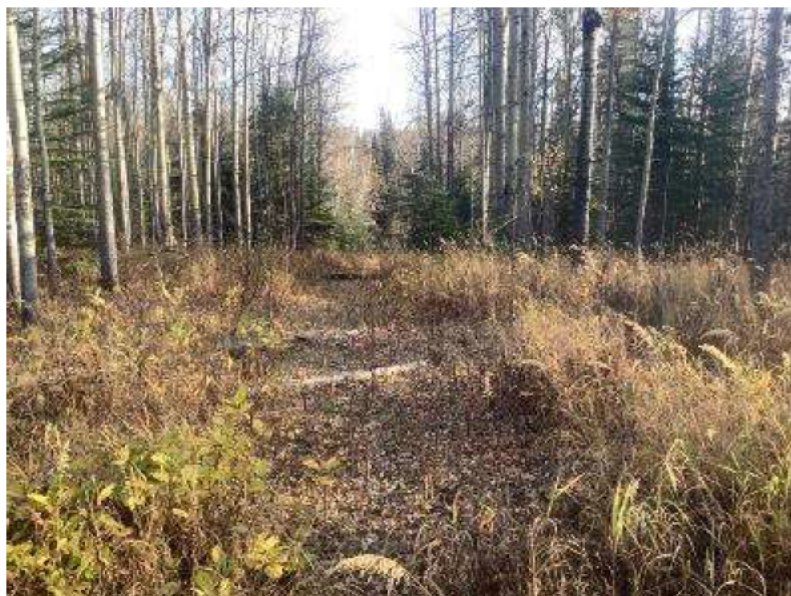
Figure 10. Legacy Seismic Line A04.

Length of Legacy Seismic Line	0.51 km
Approx. Width	3 m
OHV Trail Present	No
High-Density Staking at Line Access	Yes
Total Installed Stem Count	700

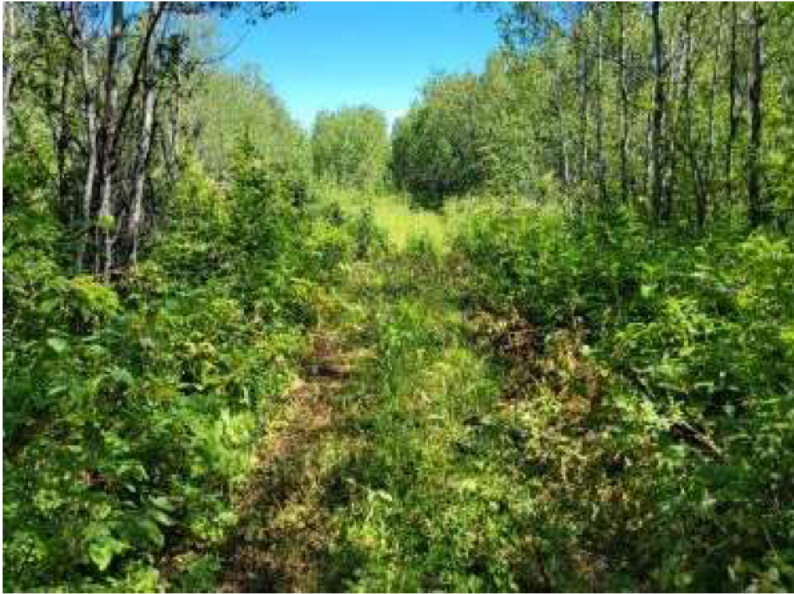
Figure 11. Legacy Seismic Line A05.

Length of Legacy Seismic Line	0.94 km
Approx. Width	3 m
OHV Trail Present	Yes
High-Density Staking at Line Access	Yes
Total Installed Stem Count	3590

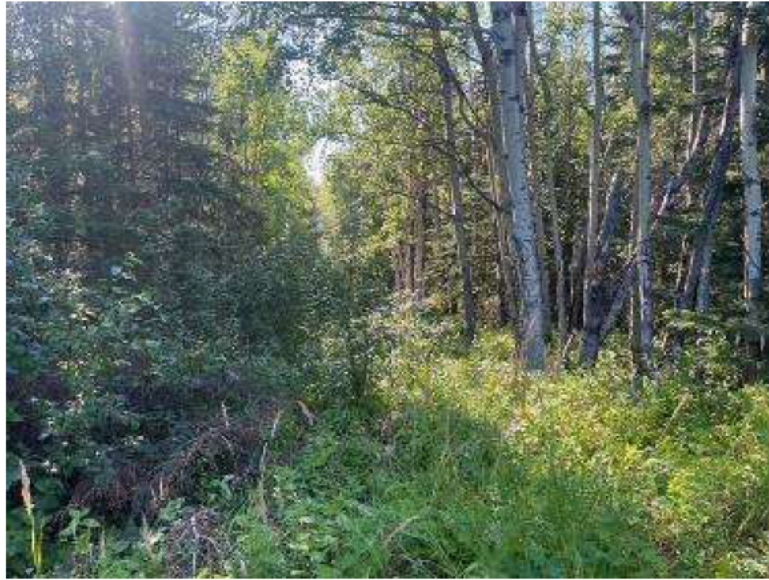
Figure 12. Legacy Seismic Line A06.

Length of Legacy Seismic Line	1.01 km
Approx. Width	3 m
OHV Trail Present	No
High-Density Staking at Line Access	No
Total Installed Stem Count	1440

Treatment	Common Name	Scientific Name	Quantity
Live Stakes	N/A	N/A	N/A
Planted Eco-Cultural Seedlings	mountain alder	<i>Alnus incana ssp. Tenufolia</i>	180
	balsam poplar	<i>Populus balsamifera</i>	810
	Bebb's Willow	<i>Salix bebbiana</i>	450

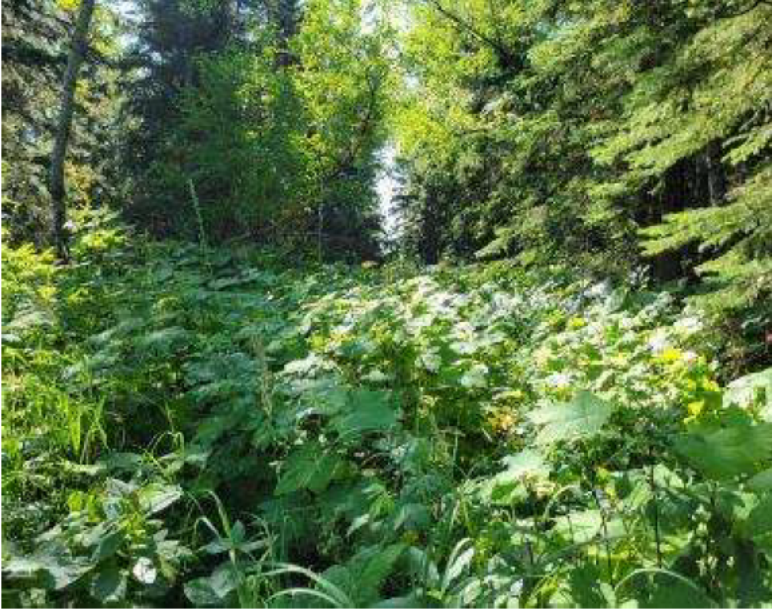
Figure 13. Legacy Seismic Line A07.

Length of Legacy Seismic Line	1.67 km
Approx. Width	3 m
OHV Trail Present	No
High-Density Staking at Line Access	No
Total Installed Stem Count	2100

Treatment	Common Name	Scientific Name	Quantity
Live Stakes	N/A	N/A	N/A
Planted Eco-Cultural Seedlings	lodgepole pine	<i>Pinus contorta</i>	2100

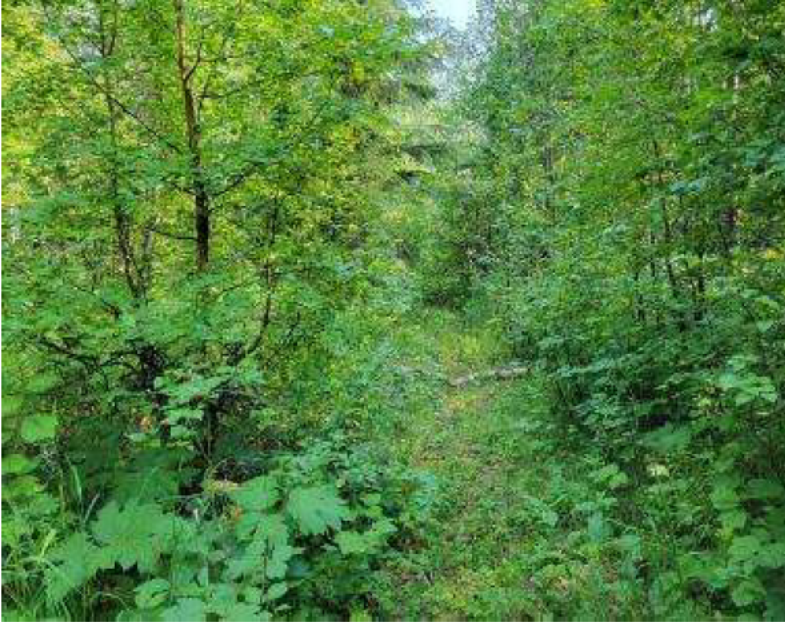
Figure 14. Legacy Seismic Line A08.

Length of Legacy Seismic Line	1.06 km
Approx. Width	3 m
OHV Trail Present	Yes
High-Density Staking at Line Access	Yes
Total Installed Stem Count	2754

Treatment	Common Name	Scientific Name	Quantity
Live Stakes	balsam poplar	<i>Populus balsamifera</i>	1500
	willow species	<i>Salix spp.</i>	400
Planted Eco-Cultural Seedlings	white spruce	<i>Picea glauca</i>	900
	lodgepole pine	<i>Pinus contorta</i>	810
	balsam poplar	<i>Populus balsamifera</i>	540
	serviceberry willow	<i>Salix pseudomonticola</i>	180

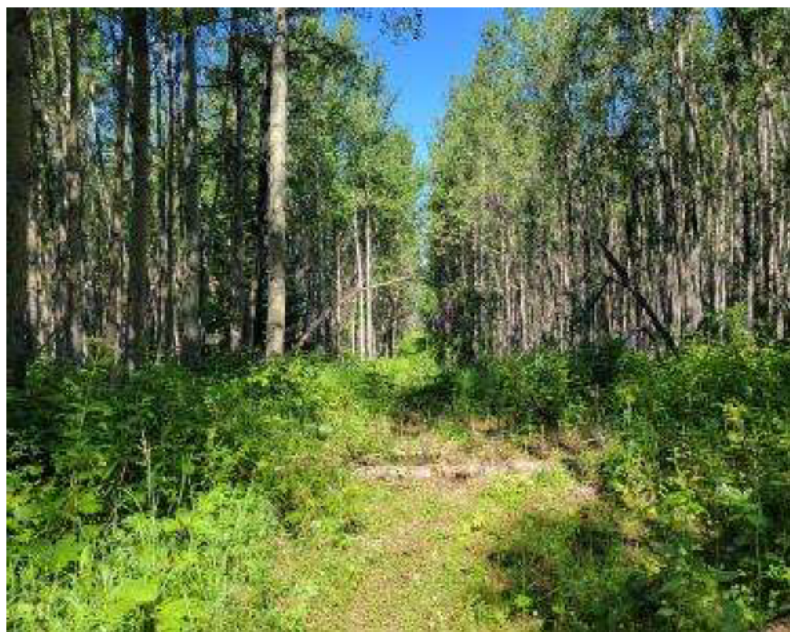
Figure 15. Legacy Seismic Line A12.

Length of Legacy Seismic Line	1.16 km
Approx. Width	10 m
OHV Trail Present	Yes
High-Density Staking at Line Access	Yes
Total Installed Stem Count	4330

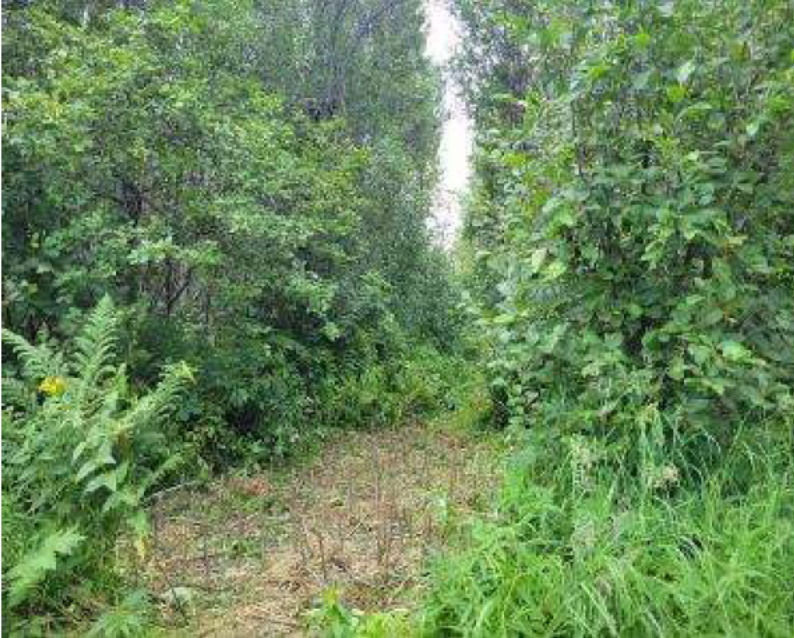
Figure 16. Legacy Seismic Line A13.

Length of Legacy Seismic Line	0.60 km
Approx. Width	5 m
OHV Trail Present	No
High-Density Staking at Line Access	Yes
Total Installed Stem Count	1740

Treatment	Common Name	Scientific Name	Quantity
Live Stakes	balsam poplar	<i>Populus balsamifera</i>	300
Planted Eco-Cultural Seedlings	white spruce	<i>Picea glauca</i>	1440

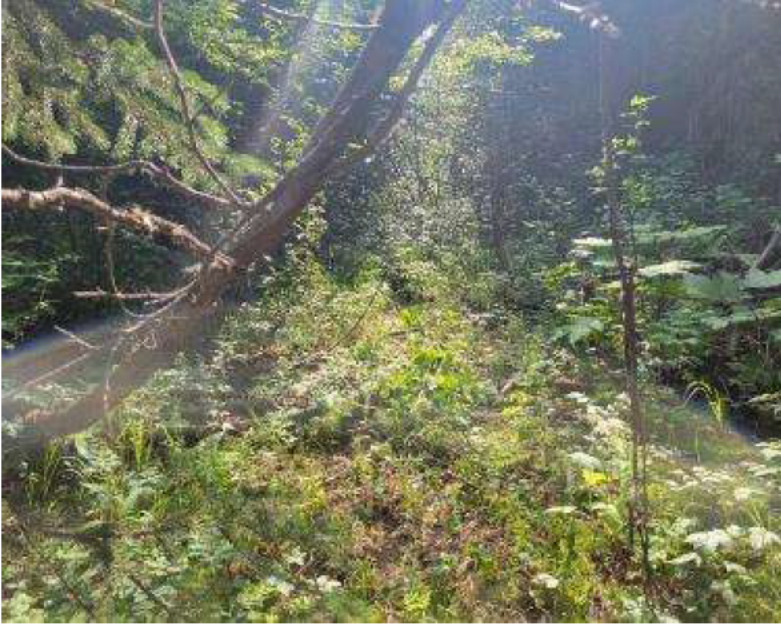
Figure 17. Legacy Seismic Line A14.

Length of Legacy Seismic Line	0.99 km
Approx. Width	3 m
OHV Trail Present	No
High-Density Staking at Line Access	Yes
Total Installed Stem Count	1890

Treatment	Common Name	Scientific Name	Quantity
Live Stakes	balsam poplar	<i>Populus balsamifera</i>	450
Planted Eco-Cultural Seedlings	white spruce	<i>Picea glauca</i>	1440

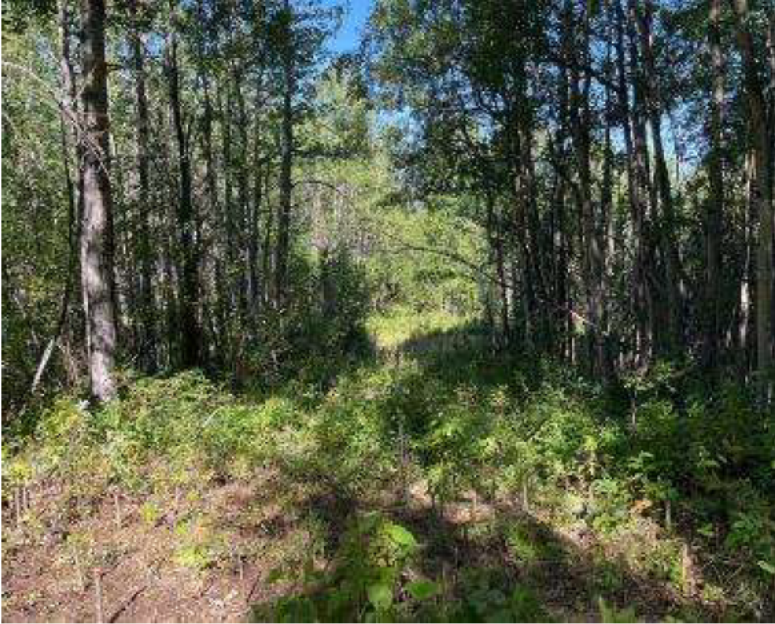
Figure 18. Legacy Seismic Line A15.

Length of Legacy Seismic Line	0.75 km
Approx. Width	5 m
OHV Trail Present	No
High-Density Staking at Line Access	Yes
Total Installed Stem Count	2570

Treatment	Common Name	Scientific Name	Quantity
Live Stakes	willow species	<i>Salix spp.</i>	1100
Planted Eco-Cultural Seedlings	paper birch	<i>Betula papyrifera</i>	270
	white spruce	<i>Picea glauca</i>	1200

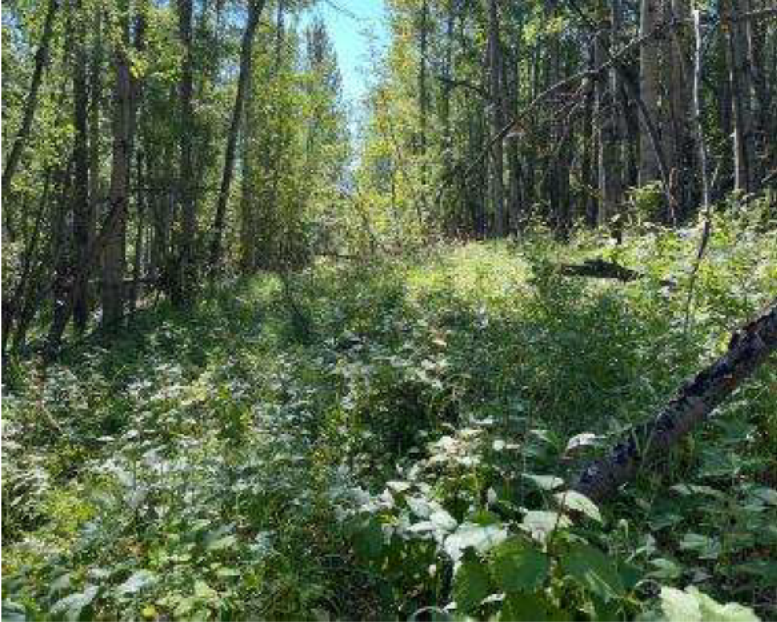
Figure 19. Legacy Seismic Line A16.

Length of Legacy Seismic Line	0.28 km
Approx. Width	3 m
OHV Trail Present	No
High-Density Staking at Line Access	No
Total Installed Stem Count	1260

Treatment	Common Name	Scientific Name	Quantity
Live Stakes	N/A	N/A	N/A
Planted Eco-Cultural Seedlings	trembling aspen	<i>Populus tremuloides</i>	1260

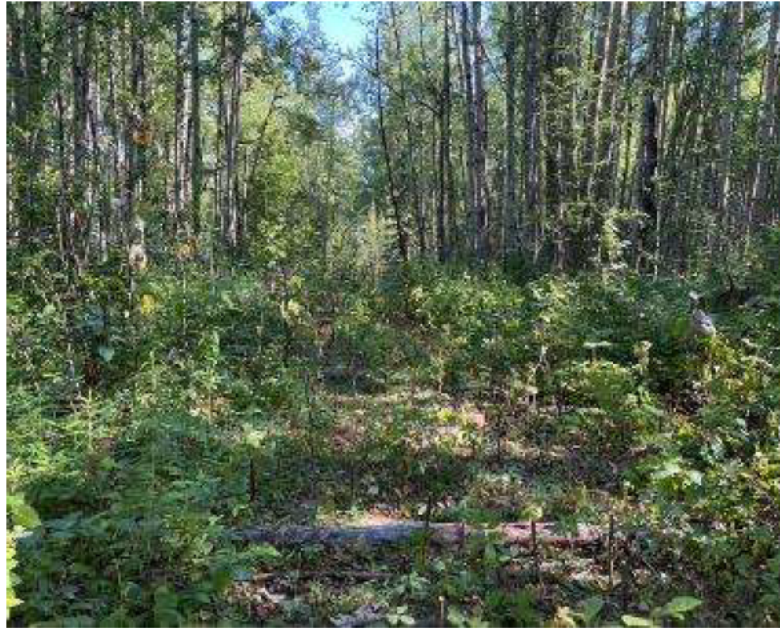
Figure 20. Legacy Seismic Line A17.

Length of Legacy Seismic Line	0.44 km
Approx. Width	5 m
OHV Trail Present	Yes
High-Density Staking at Line Access	Yes
Total Installed Stem Count	1750

Treatment	Common Name	Scientific Name	Quantity
Live Stakes	balsam poplar	<i>Populus balsamifera</i>	1750
Planted Eco-Cultural Seedlings	N/A	N/A	N/A

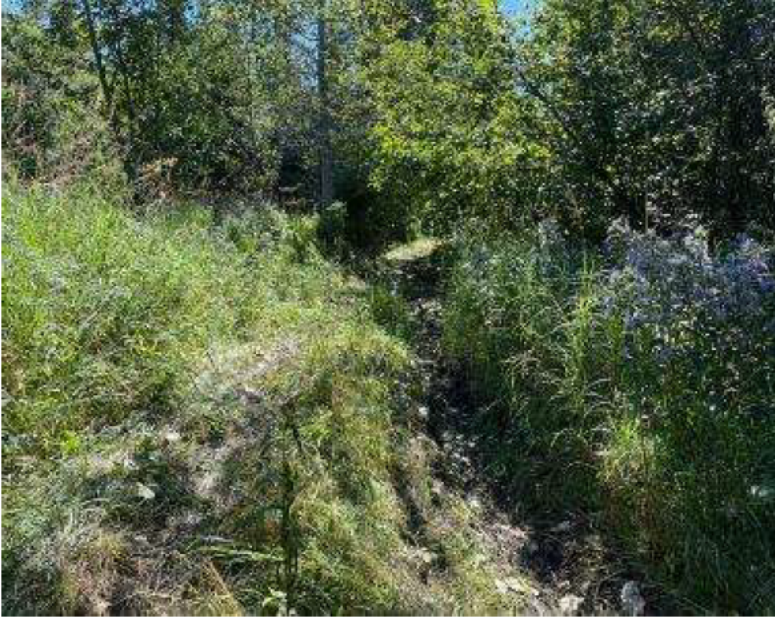
Figure 21. Legacy Seismic Line A18.

Length of Legacy Seismic Line	1.10 km
Approx. Width	3 m
OHV Trail Present	No
High-Density Staking at Line Access	No
Total Installed Stem Count	4860

Treatment	Common Name	Scientific Name	Quantity
Live Stakes	N/A	N/A	N/A
Planted Eco-Cultural Seedlings	red-osier dogwood	<i>Cornus sericea</i>	4860

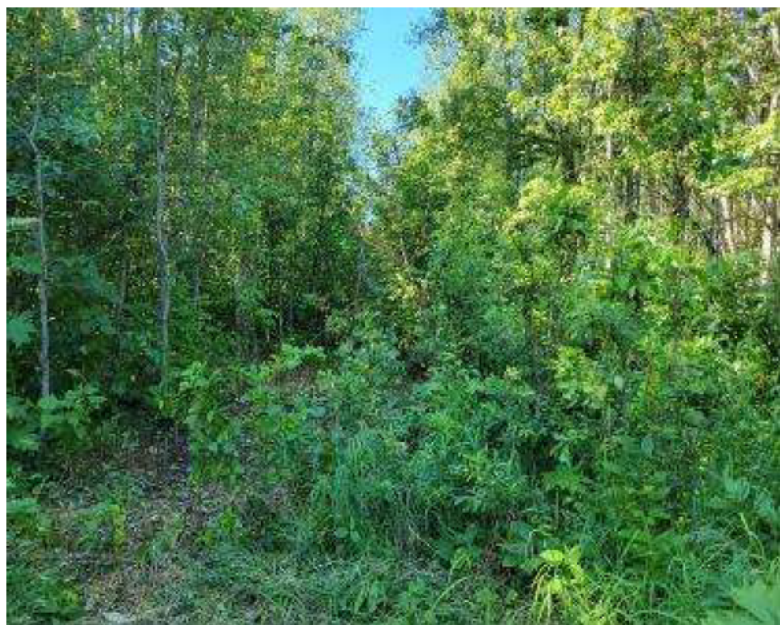
Figure 22. Legacy Seismic Line A19.

Length of Legacy Seismic Line	0.39 km
Approx. Width	3 m
OHV Trail Present	No
High-Density Staking at Line Access	Yes
Total Installed Stem Count	600

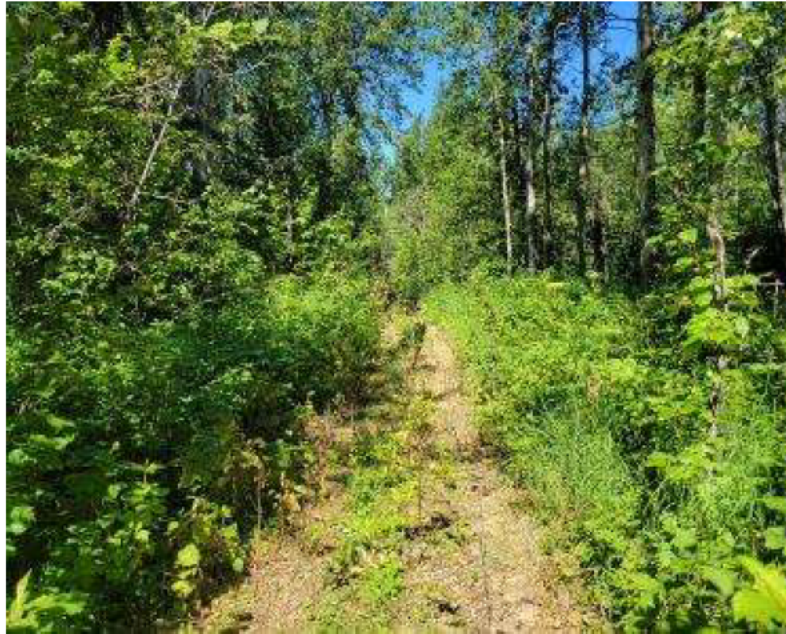
Figure 23. Legacy Seismic Line A20.

Length of Legacy Seismic Line	0.70 km
Approx. Width	10 m
OHV Trail Present	Yes
High-Density Staking at Line Access	Yes
Total Installed Stem Count	4150

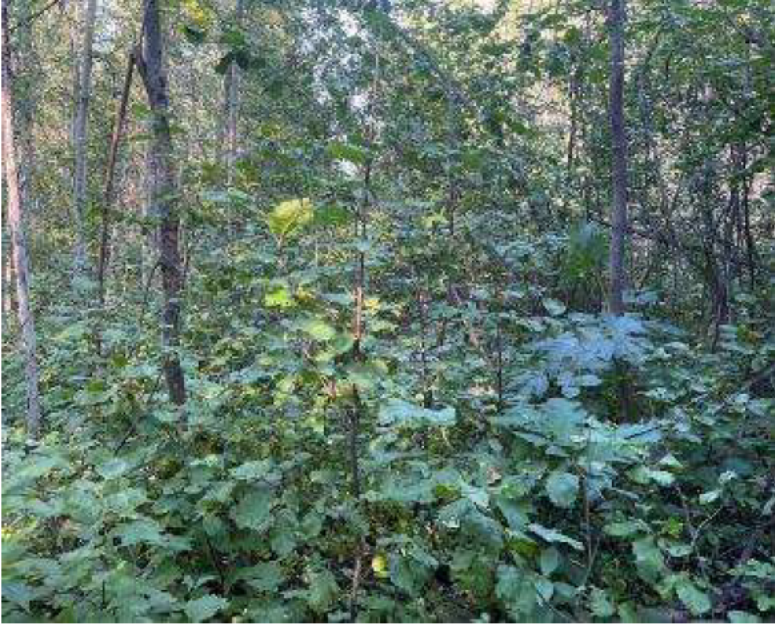
Figure 24. Legacy Seismic Line A21.

Length of Legacy Seismic Line	0.53 km
Approx. Width	5 m
OHV Trail Present	No
High-Density Staking at Line Access	No
Total Installed Stem Count	1800

Treatment	Common Name	Scientific Name	Quantity
Live Stakes	N/A	N/A	N/A
Planted Eco-Cultural Seedlings	mountain alder	<i>Alnus incana ssp. Tenuifolia</i>	450
	paper birch	<i>Betula papyrifera</i>	900
	Bebb's willow	<i>Salix bebbiana</i>	450

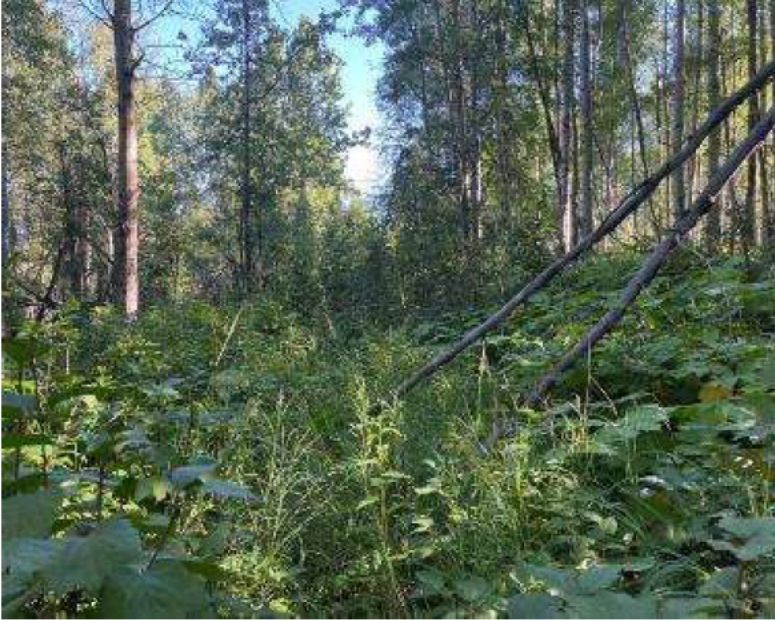
Figure 25. Legacy Seismic Line A22.

Length of Legacy Seismic Line	2.08 km
Approx. Width	5 m
OHV Trail Present	Yes
High-Density Staking at Line Access	Yes
Total Installed Stem Count	1950

Treatment	Common Name	Scientific Name	Quantity
Live Stakes	willow species	Salix spp.	1950
Planted Eco-Cultural Seedlings	N/A	N/A	N/A

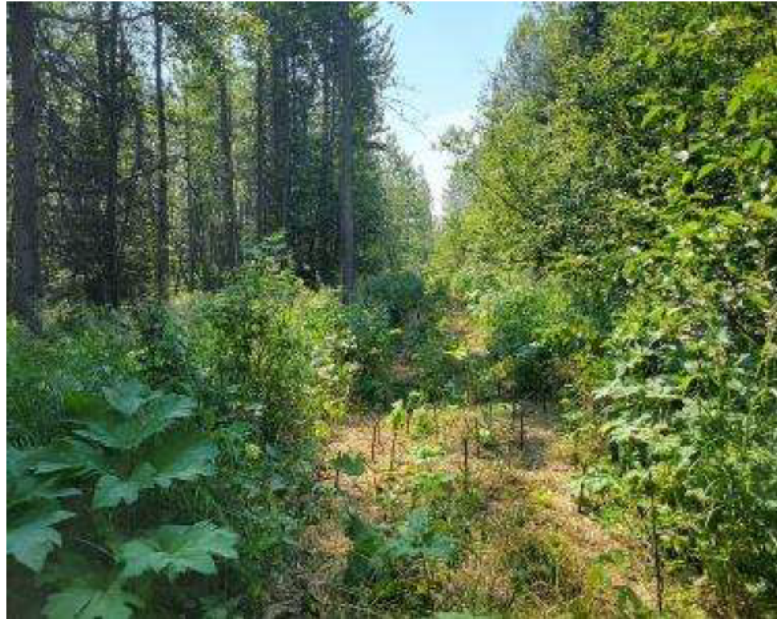
Figure 26. Legacy Seismic Line A25.

Length of Legacy Seismic Line	0.65 km
Approx. Width	3 m
OHV Trail Present	Yes
High-Density Staking at Line Access	Yes
Total Installed Stem Count	2940

Treatment	Common Name	Scientific Name	Quantity
Live Stakes	balsam poplar	<i>Populus balsamifera</i>	1500
Planted Eco-Cultural Seedlings	paper birch	<i>Betula papyrifera</i>	270
	white spruce	<i>Picea glauca</i>	900
	lodgepole pine	<i>Pinus contorta</i>	270

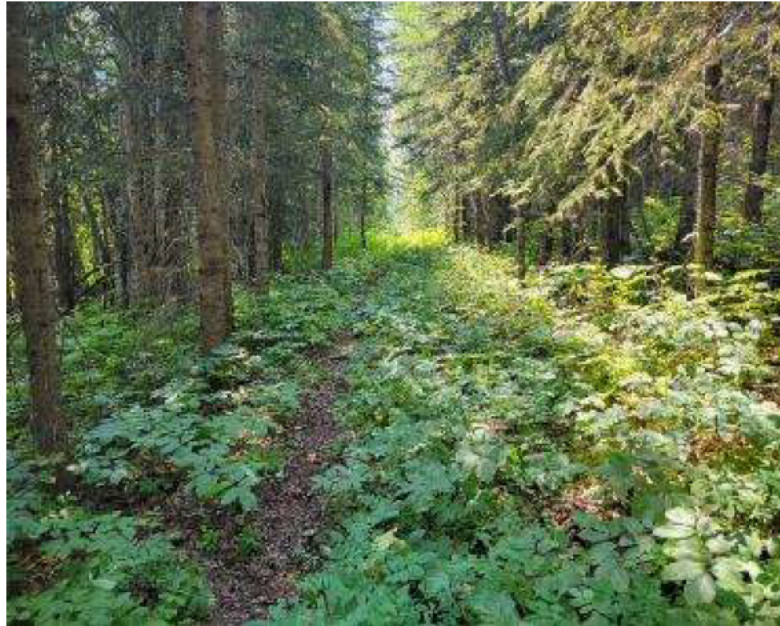
Figure 27. Legacy Seismic Line A26.

Length of Legacy Seismic Line	1.17 km
Approx. Width	3 m
OHV Trail Present	Yes
High-Density Staking at Line Access	No
Total Installed Stem Count	2016

Treatment	Common Name	Scientific Name	Quantity
Live Stakes	N/A	N/A	N/A
Planted Eco-Cultural Seedlings	white spruce	<i>Picea glauca</i>	2016

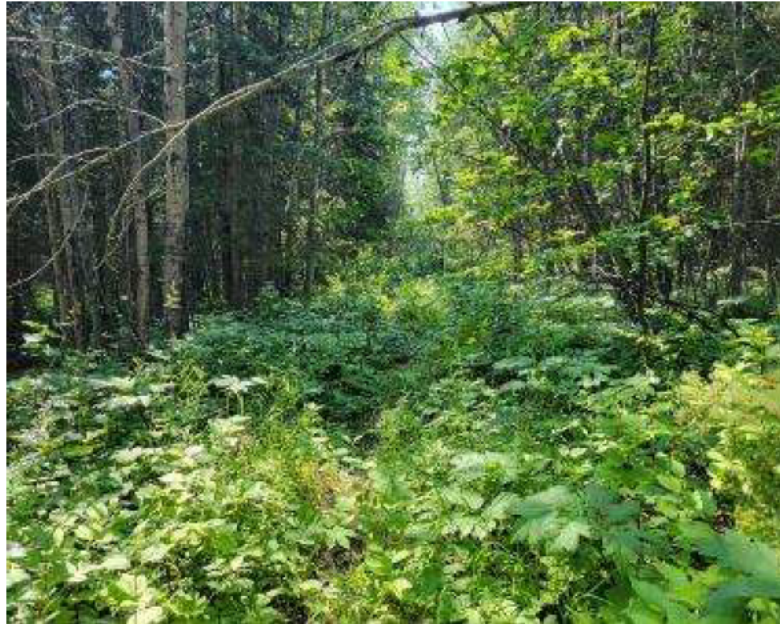
Figure 28. Legacy Seismic Line A27.

Length of Legacy Seismic Line	1.42 km
Approx. Width	3 m
OHV Trail Present	Yes
High-Density Staking at Line Access	No
Total Installed Stem Count	2016

Treatment	Common Name	Scientific Name	Quantity
Live Stakes	N/A	N/A	N/A
Planted Eco-Cultural Seedlings	white spruce	<i>Picea glauca</i>	2016

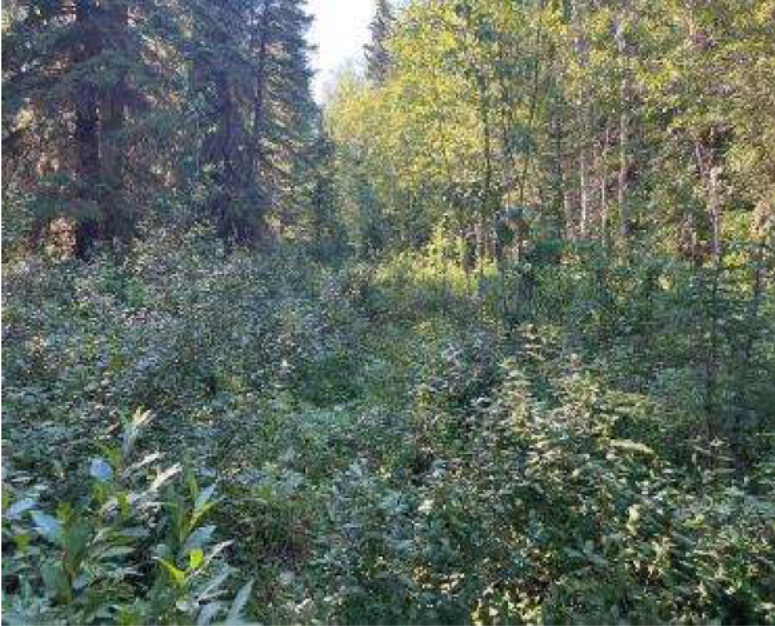
Figure 29. Legacy Seismic Line A28.

Length of Legacy Seismic Line	1.94 km
Approx. Width	3 m
OHV Trail Present	No
High-Density Staking at Line Access	No
Total Installed Stem Count	5040

Treatment	Common Name	Scientific Name	Quantity
Live Stakes	N/A	N/A	N/A
Planted Eco-Cultural Seedlings	Bebb's willow	<i>Salix bebbiana</i>	5040

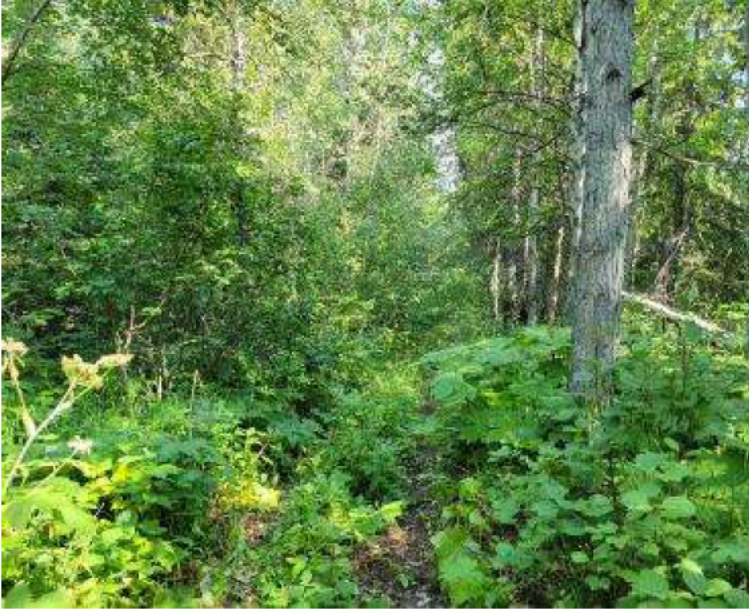
Figure 30. Legacy Seismic Line A29.

Length of Legacy Seismic Line	1.08 km
Approx. Width	3 m
OHV Trail Present	Yes
High-Density Staking at Line Access	Yes
Total Installed Stem Count	3018

Treatment	Common Name	Scientific Name	Quantity
Live Stakes	balsam poplar	<i>Populus balsamifera</i>	450
Planted Eco-Cultural Seedlings	white spruce	<i>Picea glauca</i>	1728
	lodgepole pine	<i>Pinus contorta</i>	840

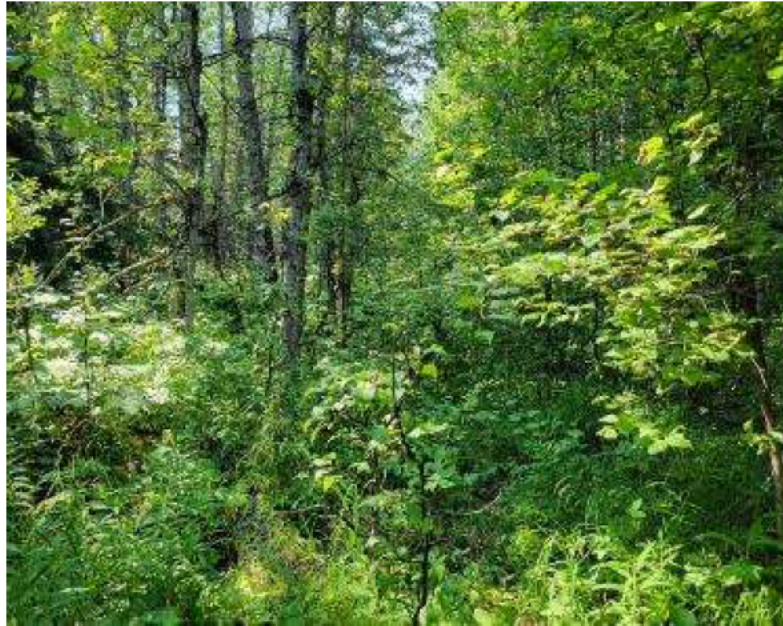
Figure 31. Legacy Seismic Line A30.

Length of Legacy Seismic Line	0.21 km
Approx. Width	3 m
OHV Trail Present	Yes
High-Density Staking at Line Access	Yes
Total Installed Stem Count	870

Treatment	Common Name	Scientific Name	Quantity
Live Stakes	balsam poplar	<i>Populus balsamifera</i>	450
Planted Eco-Cultural Seedlings	lodgepole pine	<i>Pinus contorta</i>	420

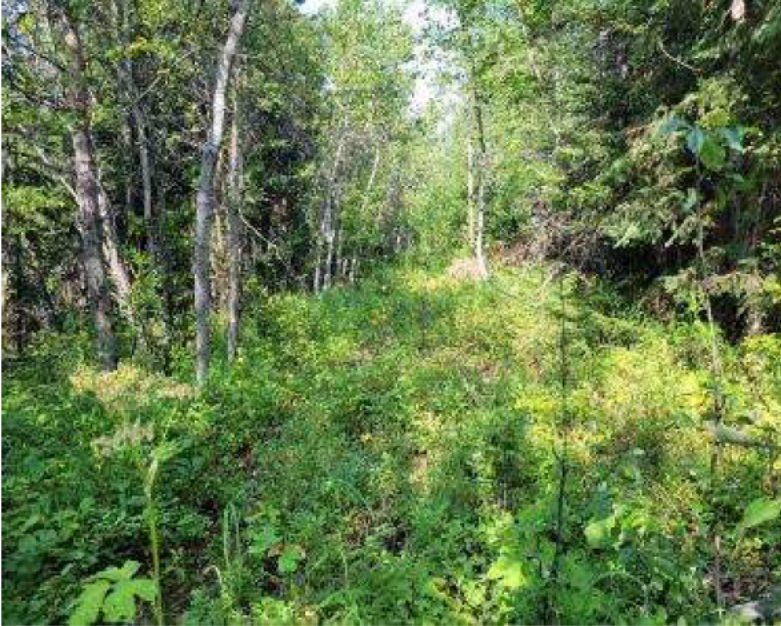
Figure 32. Legacy Seismic Line A31.

Length of Legacy Seismic Line	1.03 km
Approx. Width	3 m
OHV Trail Present	Yes
High-Density Staking at Line Access	No
Total Installed Stem Count	1680

Treatment	Common Name	Scientific Name	Quantity
Live Stakes	N/A	N/A	N/A
Planted Eco-Cultural Seedlings	lodgepole pine	<i>Pinus contorta</i>	1680

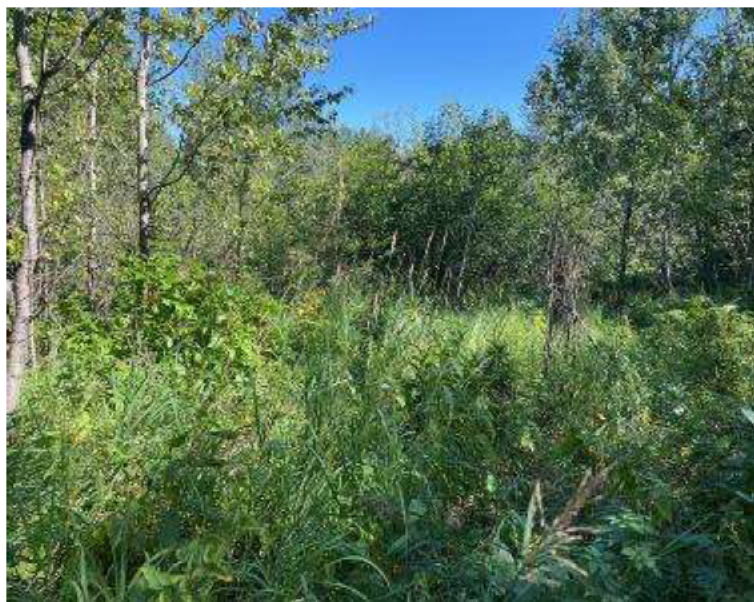
Figure 33. Legacy Seismic Line A32.

Length of Legacy Seismic Line	0.44 km
Approx. Width	5 m
OHV Trail Present	No
High-Density Staking at Line Access	No
Total Installed Stem Count	1800

Treatment	Common Name	Scientific Name	Quantity
Live Stakes	N/A	N/A	N/A
Planted Eco-Cultural Seedlings	trembling aspen	<i>Populus tremuloides</i>	1080
	Bebb's willow	<i>Salix bebbiana</i>	720

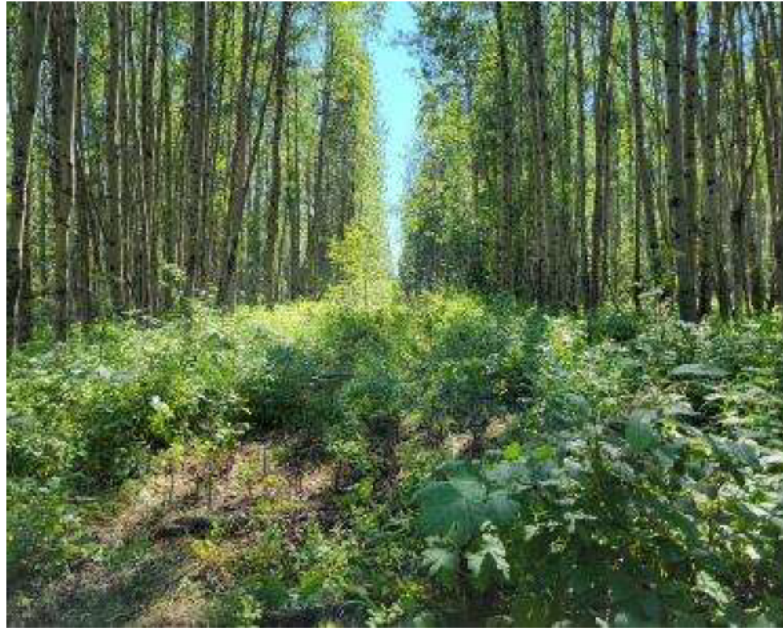
Figure 34. Legacy Seismic Line A33.

Length of Legacy Seismic Line	0.80 km
Approx. Width	5 m
OHV Trail Present	Yes
High-Density Staking at Line Access	No
Total Installed Stem Count	1220

Treatment	Common Name	Scientific Name	Quantity
Live Stakes	willow species	<i>Salix spp.</i>	500
Planted Eco-Cultural Seedlings	mountain alder	<i>Alnus incana ssp. Tenuifolia</i>	360
	trembling aspen	<i>Populus tremuloides</i>	360

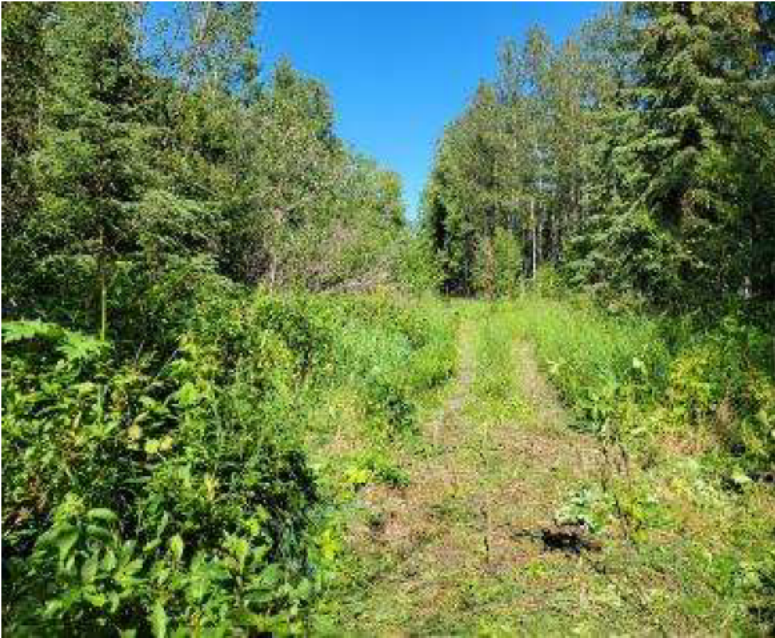
Figure 35. Legacy Seismic Line A34.

Length of Legacy Seismic Line	0.87 km
Approx. Width	8 m
OHV Trail Present	Yes
High-Density Staking at Line Access	Yes
Total Installed Stem Count	2450

Treatment	Common Name	Scientific Name	Quantity
Live Stakes	willow species	<i>Salix spp.</i>	2450
Planted Eco-Cultural Seedlings	N/A	N/A	N/A

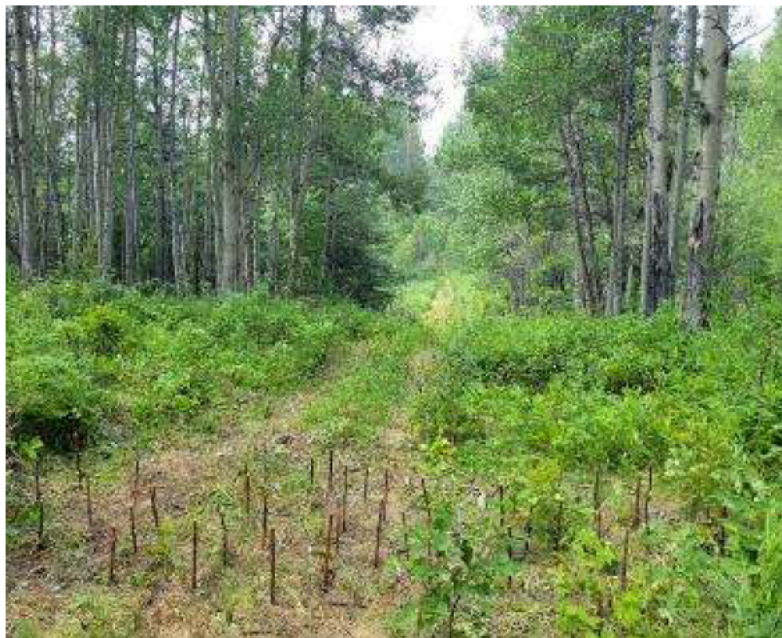
Figure 36. Legacy Seismic Line A35.

Length of Legacy Seismic Line	0.44 km
Approx. Width	10 m
OHV Trail Present	Yes
High-Density Staking at Line Access	Yes
Total Installed Stem Count	2400

Treatment	Common Name	Scientific Name	Quantity
Live Stakes	willow species	<i>Salix spp.</i>	2400
Planted Eco-Cultural Seedlings	N/A	N/A	N/A

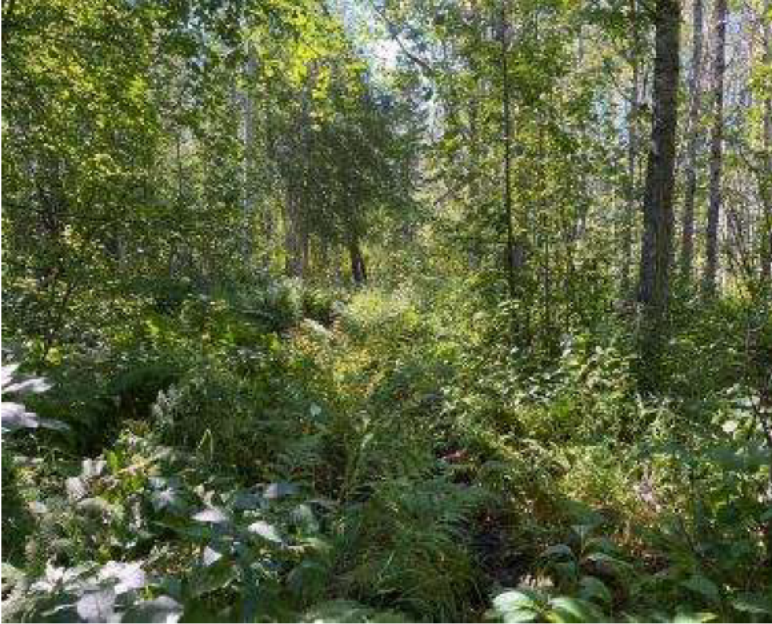
Figure 37. Legacy Seismic Line A37.

Length of Legacy Seismic Line	0.30 km
Approx. Width	3 m
OHV Trail Present	No
High-Density Staking at Line Access	No
Total Installed Stem Count	2280

Treatment	Common Name	Scientific Name	Quantity
Live Stakes	N/A	N/A	N/A
Planted Eco-Cultural Seedlings	mountain alder	<i>Alnus incana ssp. Tenufolia</i>	990
	red-osier dogwood	<i>Cornus sericea</i>	90
	white spruce	<i>Picea glauca</i>	300
	trembling aspen	<i>Populus tremuloides</i>	810
	Bebb's willow	<i>Salix bebbiana</i>	90

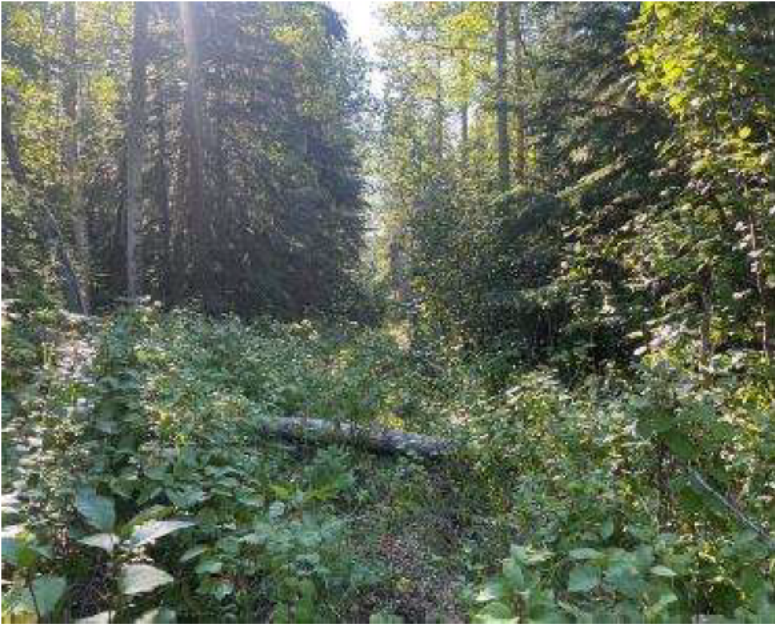
Figure 38. Legacy Seismic Line A38.

Length of Legacy Seismic Line	1.01 km
Approx. Width	3 m
OHV Trail Present	No
High-Density Staking at Line Access	No
Total Installed Stem Count	2610

Treatment	Common Name	Scientific Name	Quantity
Live Stakes	N/A	N/A	N/A
Planted Eco-Cultural Seedlings	mountain alder	<i>Alnus incana ssp. Tenufolia</i>	810
	balsam poplar	<i>Populus balsamifera</i>	990
	Bebb's willow	<i>Salix bebbiana</i>	810

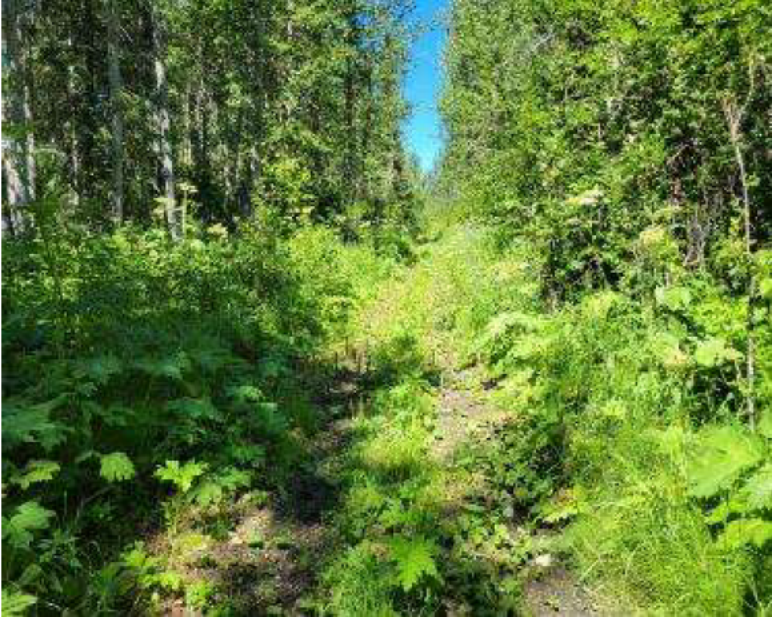
Figure 39. Legacy Seismic Line A39.

Length of Legacy Seismic Line	0.74 km
Approx. Width	3 m
OHV Trail Present	Yes
High-Density Staking at Line Access	Yes
Total Installed Stem Count	2170

Treatment	Common Name	Scientific Name	Quantity
Live Stakes	balsam poplar	<i>Populus balsamifera</i>	1000
Planted Eco-Cultural Seedlings	paper birch	<i>Betula papyrifera</i>	630
	Bebb's willow	<i>Salix bebbiana</i>	540

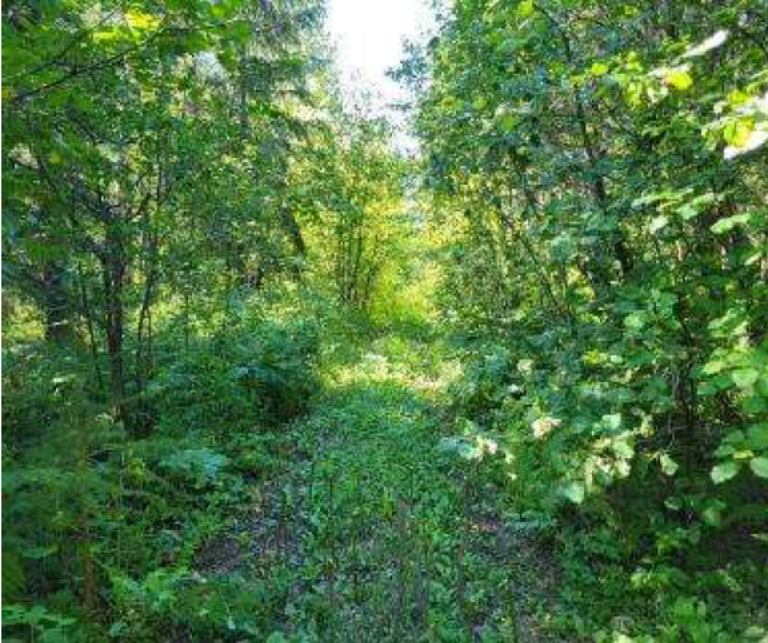
Figure 40. Legacy Seismic Line A40.

Length of Legacy Seismic Line	0.71 km
Approx. Width	3 m
OHV Trail Present	Yes
High-Density Staking at Line Access	Yes
Total Installed Stem Count	1800

Treatment	Common Name	Scientific Name	Quantity
Live Stakes	balsam poplar	<i>Populus balsamifera</i>	550
	willow species	<i>Salix spp.</i>	1250
Planted Eco-Cultural Seedlings	N/A	N/A	N/A
