# **PNG LEGACY SITE GROUND BIRCH-BRASSEY RESTORATION PROGRAM**

SUMMARY REPORT

SUBMITTED BY  
**ASKI RECLAMATION LP &  
SILVERBERRY PRO**

February 7, 2022

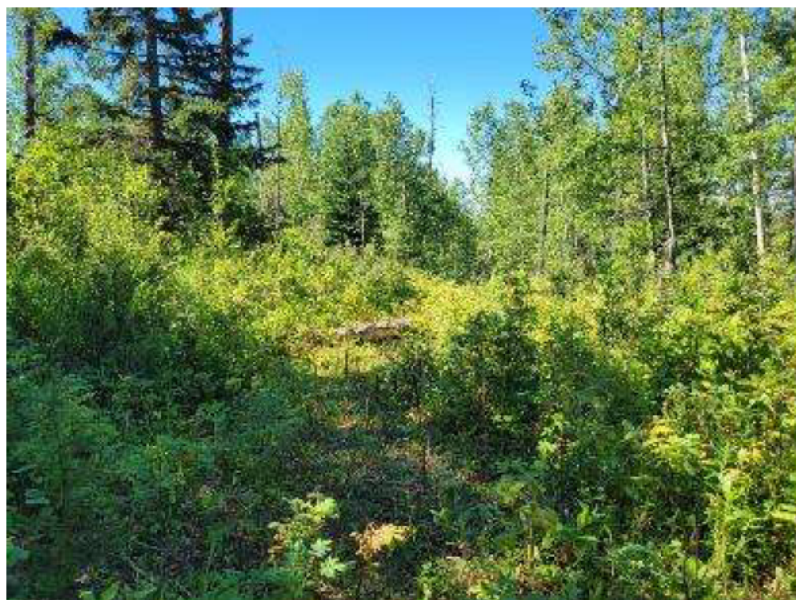
Figure 41. Legacy Seismic Line A41.

Length of Legacy Seismic Line	0.86 km
Approx. Width	3 m
OHV Trail Present	Yes
High-Density Staking at Line Access	Yes
Total Installed Stem Count	1800

Treatment	Common Name	Scientific Name	Quantity
Live Stakes	balsam poplar	<i>Populus balsamifera</i>	1800
Planted Eco-Cultural Seedlings	N/A	N/A	N/A

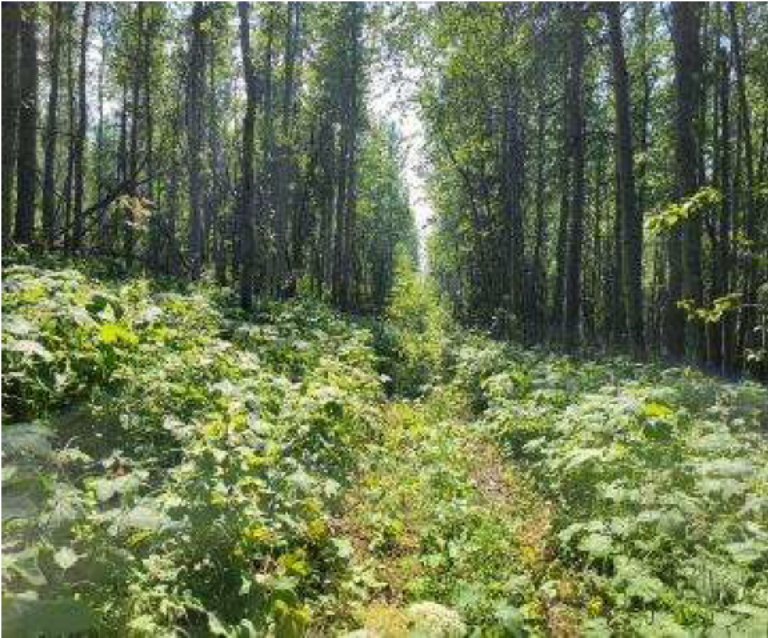
Figure 42. Legacy Seismic Line A42.

Length of Legacy Seismic Line	0.63 km
Approx. Width	3 m
OHV Trail Present	Yes
High-Density Staking at Line Access	Yes
Total Installed Stem Count	3390

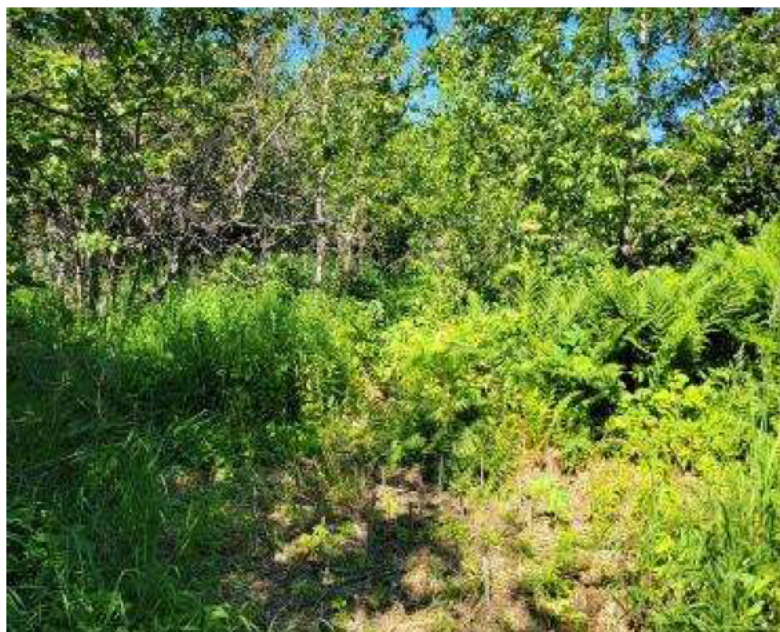
Figure 43. Legacy Seismic Line A44.

Length of Legacy Seismic Line	0.48 km
Approx. Width	5 m
OHV Trail Present	No
High-Density Staking at Line Access	Yes
Total Installed Stem Count	750

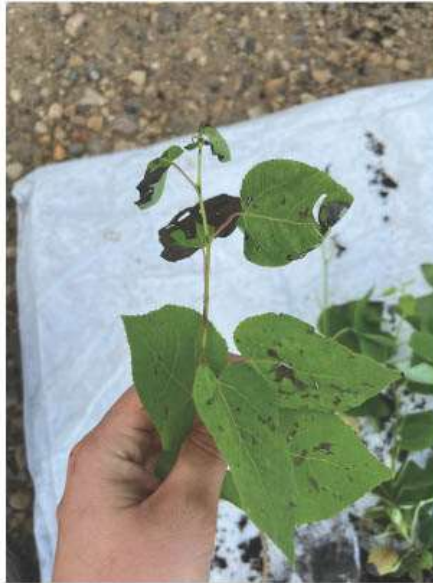
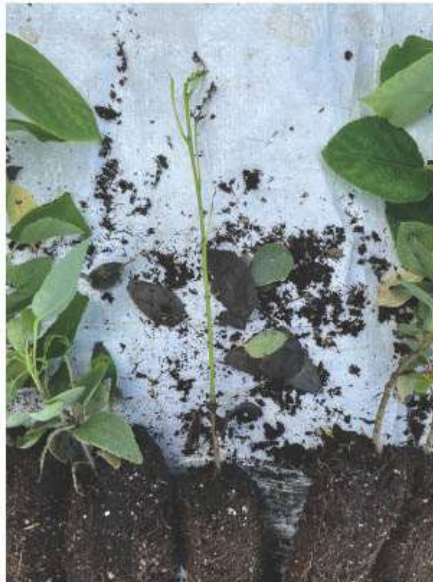
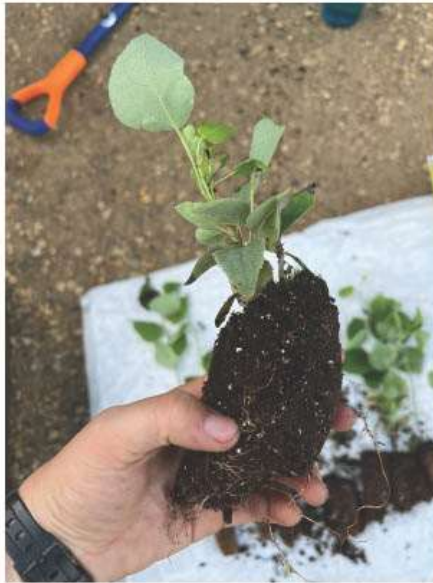
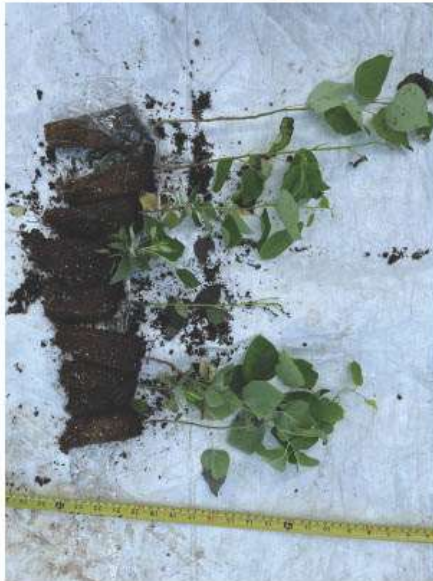
Weeds Present?	No
Photos

<b>2022-08-15</b>	
Created	2022-08-15 22:59:49 UTC by Nanette Richards
Updated	2022-08-15 23:03:39 UTC by Nanette Richards
Location	55.94991299630403, -120.75130663083407
<b>Inspection Information</b>	
Inspection Location	Sunset prairie
Time	15:59
Date	2022-08-15
Inspector	Rosheen Tetzlaff
<b>Stock Information</b>	
Nursery	Twin Sisters Native Plants Nursery
Seedlings Brokered from a Sub Nursery?	No
Species	Populus tremuloides (trembling aspen)
Number of Boxes	38
Seedlings Bundled?	Yes
Number of Seedlings per Bundle	10
Number of Bundles per Box	9
Seedling Age	6
Seedlings Overwintered?	No
<b>1</b>	
Select the most representative seedlings from each box and record the following characteristics.	
Box Number	999
Container Volume	1
Stem Diameter	3
Shoot Height	30
Rootbound Plugs	Slightly rootbound
Foliar Color	Spotted, Chlorotic, Deformed, Brown, Pale-green
Form	Healthy
Moisture	Moist
Mold Present?	No
Pests or Pest Damage Present?	No

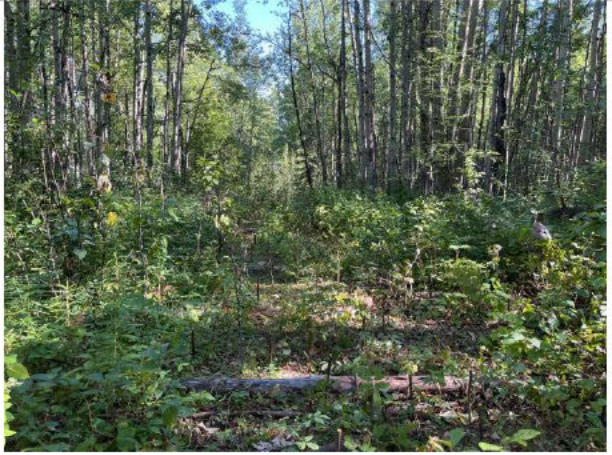
<p>Plot A17-1</p> <p>Access Point: Intersection of the legacy seismic line and the road Right-of-Way</p>	 
<p>Plot A17-2</p> <p>Treatment Point: View up the legacy seismic line (away from the access point) of the plant installation treatment</p>
