Blueberry River First Nations Pink Mountain Reciprocal Restoration Program

Linear Seismic Restoration

December 2, 2022

BC OGRIS Project File Number: [RMC-2022-05]

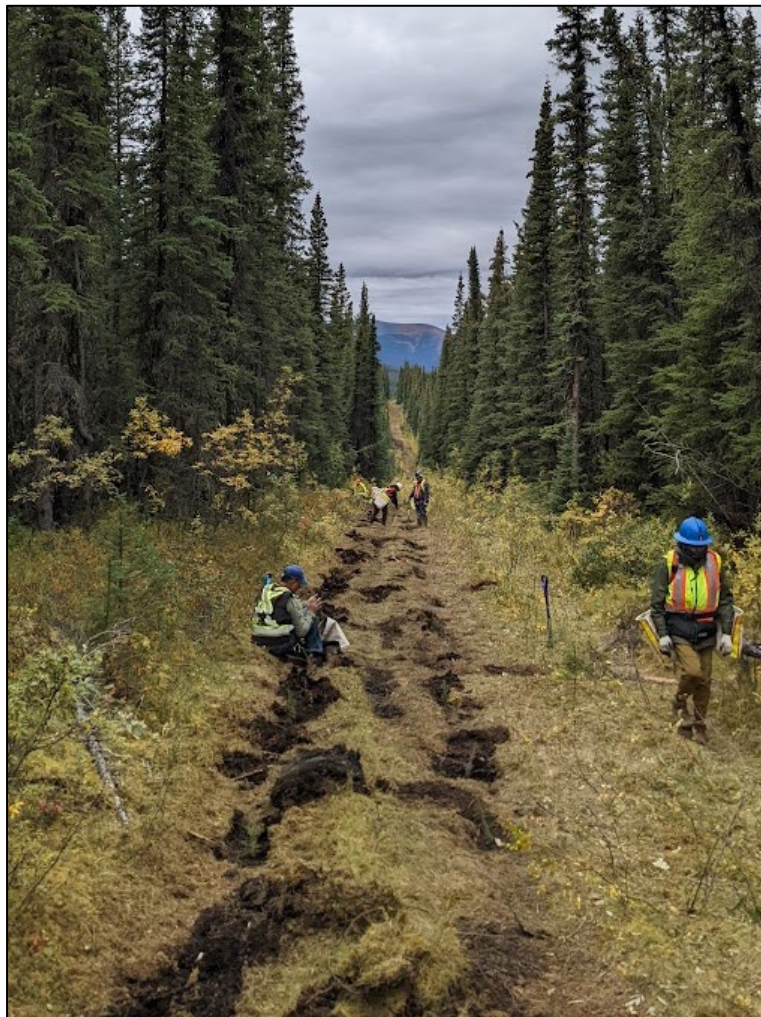
Figure 3. Mechanical Screening

Golden Base Contracting Ltd. carried out mechanical site preparation using a Bobcat 323 tracked mini-excavator. The excavator completed 1.84 km of mechanical screening (Figure 3) and 2.22 km of mounding (Figure 4). There are variances in predicted vs. actuals as a large portion of the restoration was difficult to access and in-field decisions were made to change the prescriptions. BRFN elected to reduce the amount of prescriptions on the north side of Halfway River because of ongoing discussions with Recreation Sites and Trails BC. The excavator utilized large timbers to span watercourses and wet areas to reach treatment areas and avoid damaging bed or bank or sensitive sites.

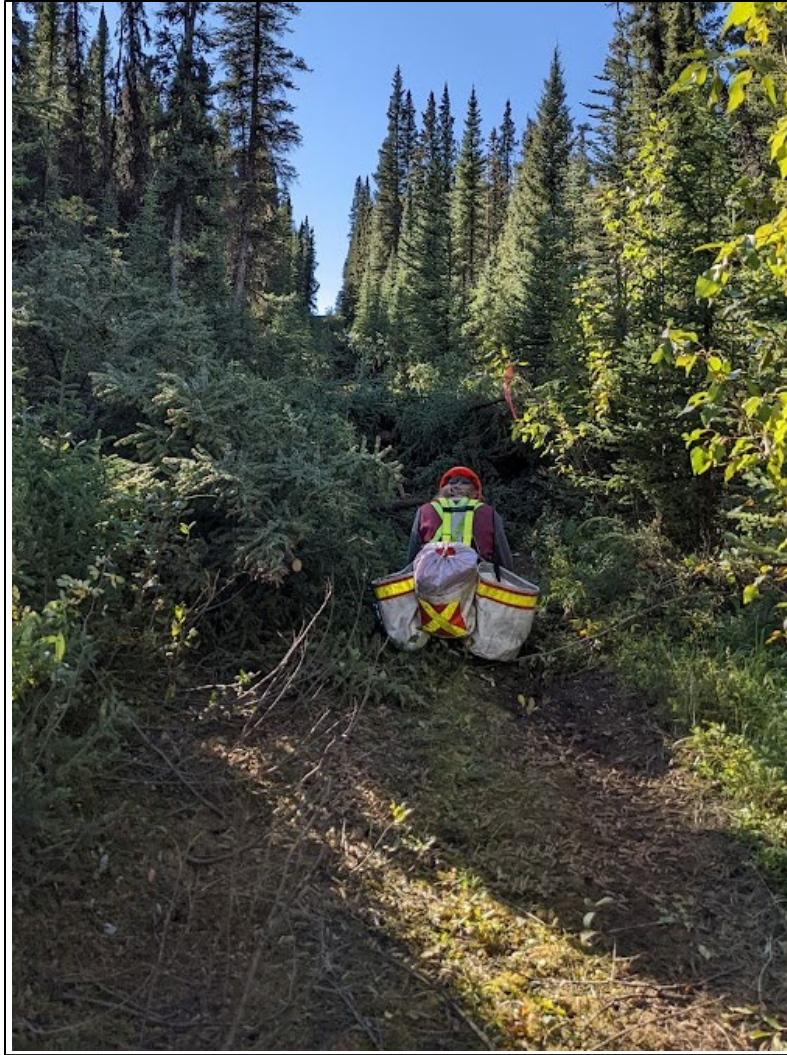
Figure 5. Tree barriers

Tree felling occurred in conjunction with tree planting on 11.46 km of the treatment lines. Tree felling took the form of felling trees across the width of the seismic lines to create a visual and movement barrier about 1.5m in height and 5m wide every 30 to 50m along the lines (Figure 5). The smallest trees that would span the lines were chosen where possible. Tree fellers also cleared access routes of danger trees and constructed corduroy crossings of wet spots to aid access and protect sensitive soils.

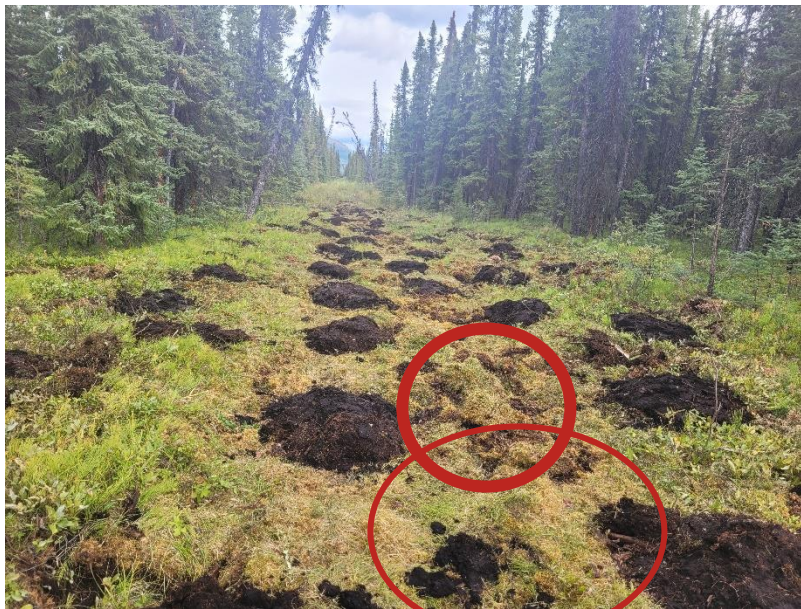
On 5 September 22 an auditor from WSP-Golder began his assessment by visiting a seismic line where mounding was being performed for ground preparation. Mounds were smaller and further spaced than practical for the purposes of the program (Figure 1). The pits were also being refilled with the organic moss layer. WSP-Golder instructed the crew to refrain from filling the pits in with the organic layer of moss and forbs as it contradicted the intent of pits, which is to reduce the ability of animals and humans to travel down the seismic lines. The organic materials also did not fill the pits fully but made them appear to be level with the ground surface. This made them a hazard to walk down as they formed a tripping hazard. WSP-Golder spoke with the operator and construction foreman and operator to explain the process and the intent of the activity as outlined in the restoration plan (the Plan).

Figure 1: *The mounds being excavated when WSP-Golder arrived. Mounds were too small and too far apart to achieve the goals of hindering movement of animals and humans down the seismic line. The red circles shows where the moss layer was being put back into the pits forming a tripping hazard.*

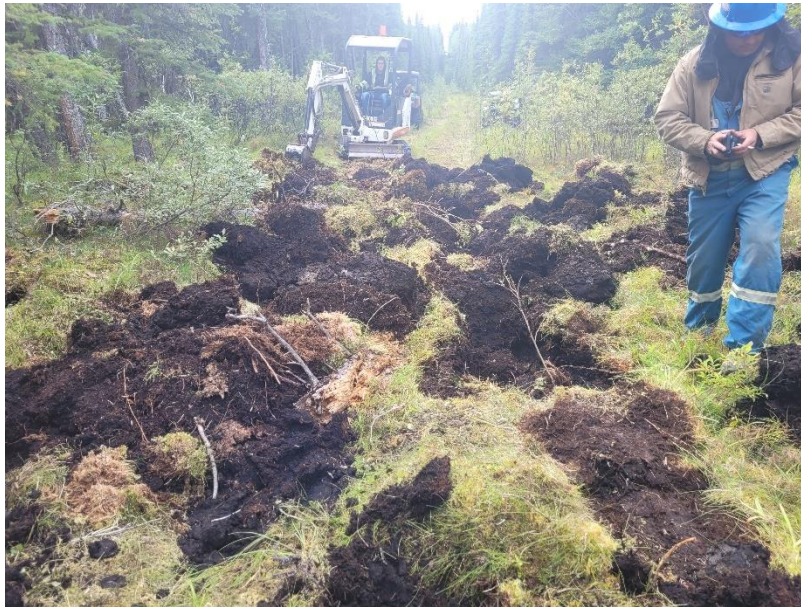
The operator was using a small machine (Bobcat 323) to enable easier movement across the different landscapes, but the smaller machine required more effort to dig the size of pits and mounds required (Figure 2). Once the crew was redirected to not fill the pits back in, and to create larger deeper holes they were able to be less technical in moving the earth and speed up the process. Pits and mounds were created across the width of line adjusting for tree and shrub growth along the edges (Figure 3).

Figure 2: *The operator practicing different techniques to dig the appropriate size and number of pits and mounds using the smaller machine.*

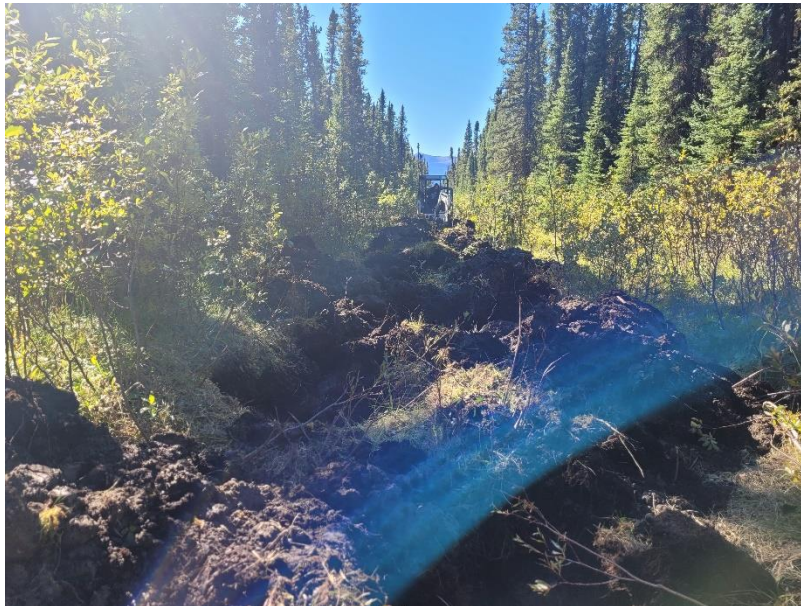
Figure 3 : *Mounding on a seismic line after the crew was informed and practiced in the technique. Mounds are across the line with some variation to accommodate for tree and shrub growth along the edges of the seismic line*

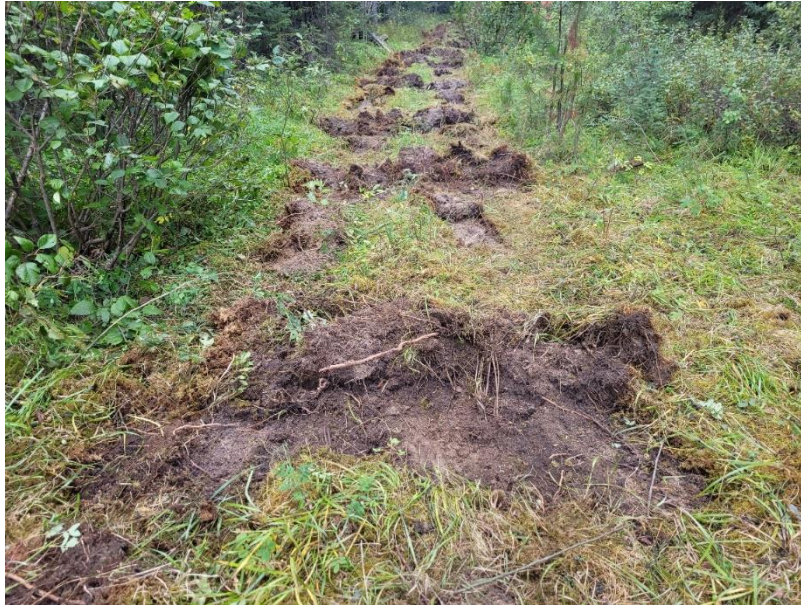
Figure 4: An example of screening on a seismic line.

When the crew arrived at a section where screening was required a few different methods were tried out to determine what worked best for the machine on the substrate. The machine was not able to drag the bucket across the line in a perpendicular fashion and ended up using a technique of pulling back the organic layer in rows and patches to expose the mineral soil (Figure 4).

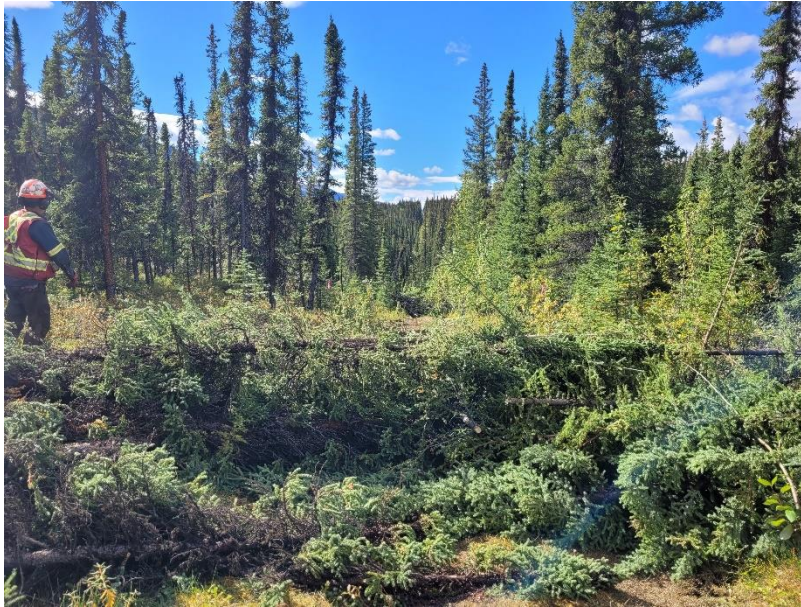
On 6 September 2022 WSP-Golder made his first visit to a tree felling crew. It was observed that the tree fellers were falling the trees in quantities that were not sufficient to provide a satisfactory barrier sufficient to impede a predator and provide coarse woody debris to support seedling establishment (Figure 5). WSP-Golder discussed with the tree fellers how to determine which sections of seismic line should have tree felling focussing on areas that have trees large enough to cross the seismic line and enough trees to build a pile that impedes an animal's ability to move through the area. Sections that have sparse tree cover on either side of the seismic line can be left and space between tree felling increased as appropriate to achieve the purpose of felling trees. Discussions also included felling trees in such a way that they didn't just cross the seismic line, but also push slightly into the forest, which would cause an animal to enter the forest deeper to get around the brush pile. When WSP-Golder returned to the tree felling crews on subsequent days the brush piles were generally of an adequate height and width and made getting around them very difficult forcing WSP-Golder into the forest (Figure 6).

Figure 5: Trees dropped in a pile across the seismic line that was unsatisfactory as it was easy to climb over and unlikely to prevent the movement of animals down the line.

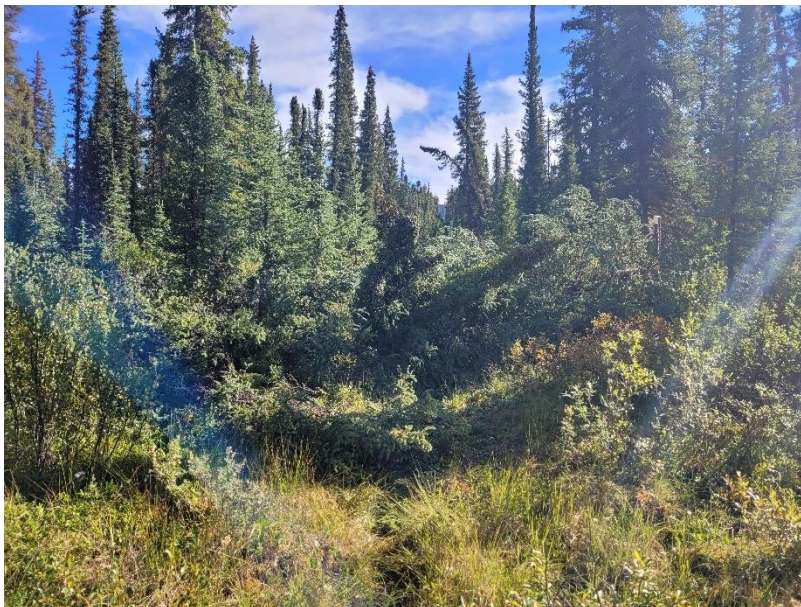
Figure 6: Trees dropped in a pile across the seismic line that easy to climb over and unlikely to prevent the movement of animals down the line.

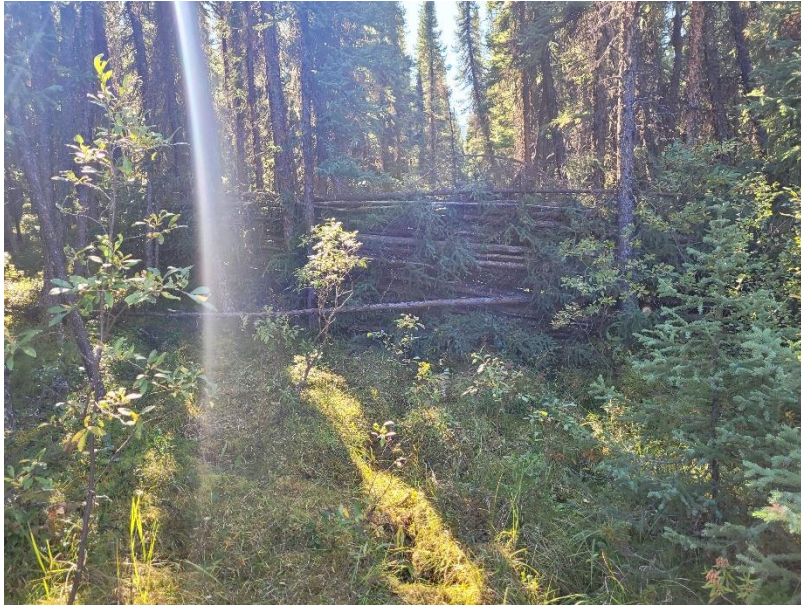
One brush fence was installed at the time of WSP-Golder’s visit (*Figure 7*). The fence was approximately 1.7 m high and went across the width of the seismic line. The fence was dense enough that one could not see through it. It appeared to be stable in construction and it used standing trees to help stabilize it. The fence appeared as though it would stand up to weather events and disturbance from animals.

Figure 7: The completed brush fence spanned the width of the line, was densely built and hard to see through, and was installed using trees on either side to aid stability.

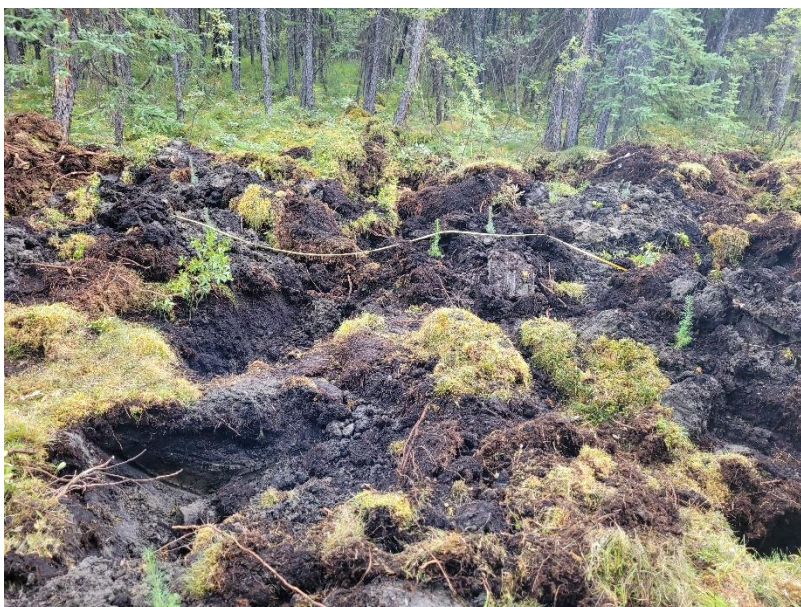
In general, the seedlings were well planted with none of them being loose in the soil. During the span of WSP-Golder's visit areas that were mounded (Figure 8) or had no ground treatment were planted, but at the time of the visit no sections of machine screening had been planted yet. In the areas with no ground treatment, straight planting with boot screening (i.e., exposing mineral soil by removing the organic layer with a boot) was employed (Figure 9).

Figure 8: Trees planted in a section of seismic line that was mounded as a site preparation prior to planting.

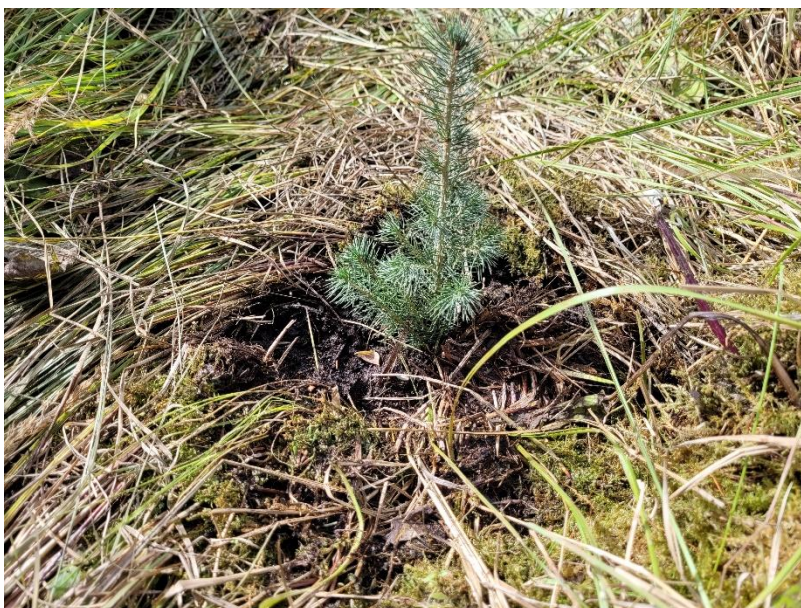
Figure 9: A white spruce planted using a boot screef method.
