**Evaluation of a Low-Cost Drone
for Monitoring Restoration of Well Pads**

**submitted to
BC Oil and Gas Research and Innovation Society**

**by
Dwayne Tannant and Kalie Smith**

January 15, 2018

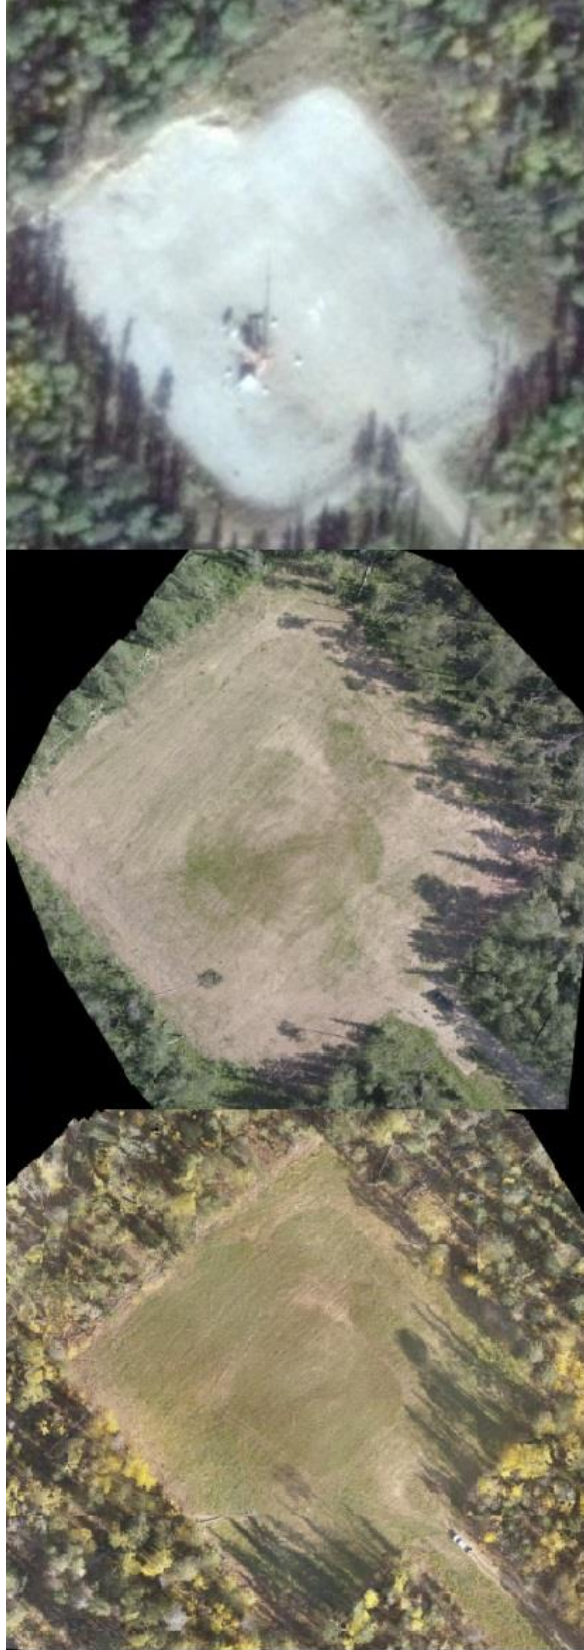
Figure 13 Restoration progress of well pad 23947 (2012, July 2017, and September 2017)

As of September 2017, this well pad has an approximate surface area of 0.98 ha. This well pad is shown in Figure 13 before reclamation began (top) in 2012, and after reclamation in July 2017 (middle) and September 2017 (bottom).

There is no visible slope movement, slumping, subsidence, or tension cracks on or around the well pad, and there are no remaining cut and fill slopes.

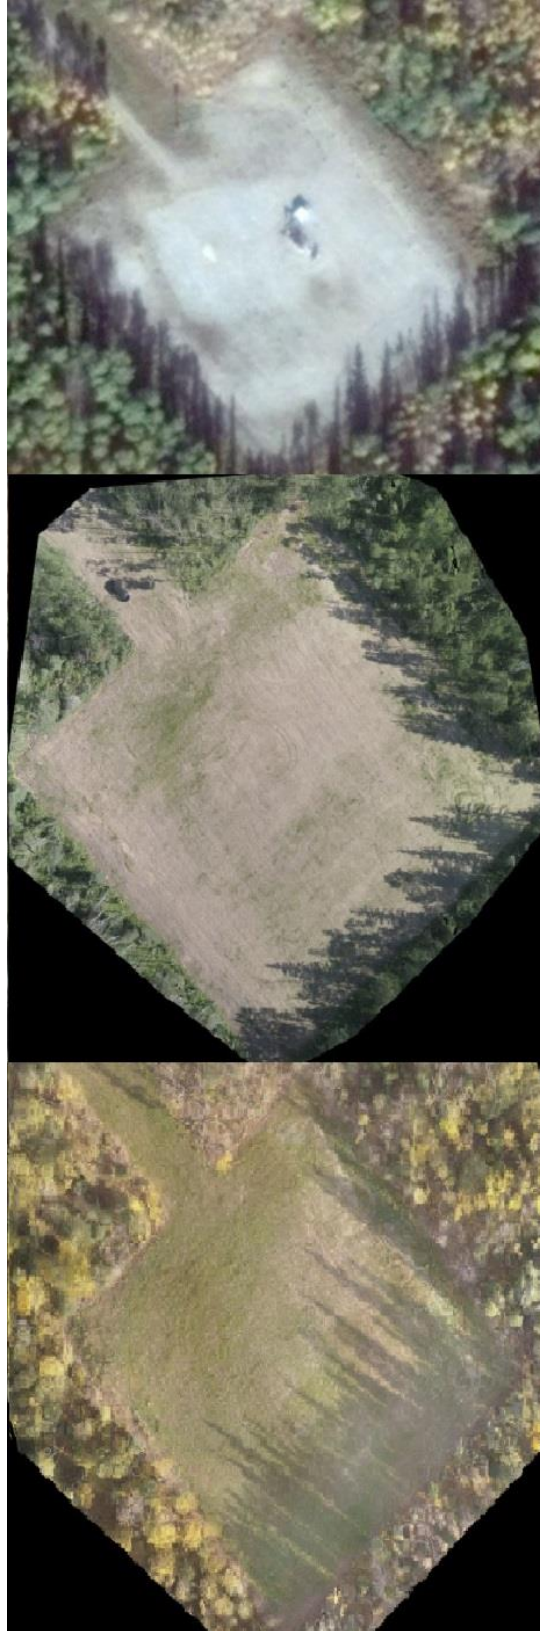
Figure 21 Restoration progress of well pad 24004 (2012, July 2017, and September 2017)

The surface area for this well pad is approximately 1.04 ha based on analysis in 2017. This well pad is shown in Figure 21 for September 2012, July 2017, and September 2017 from top to bottom, respectively.

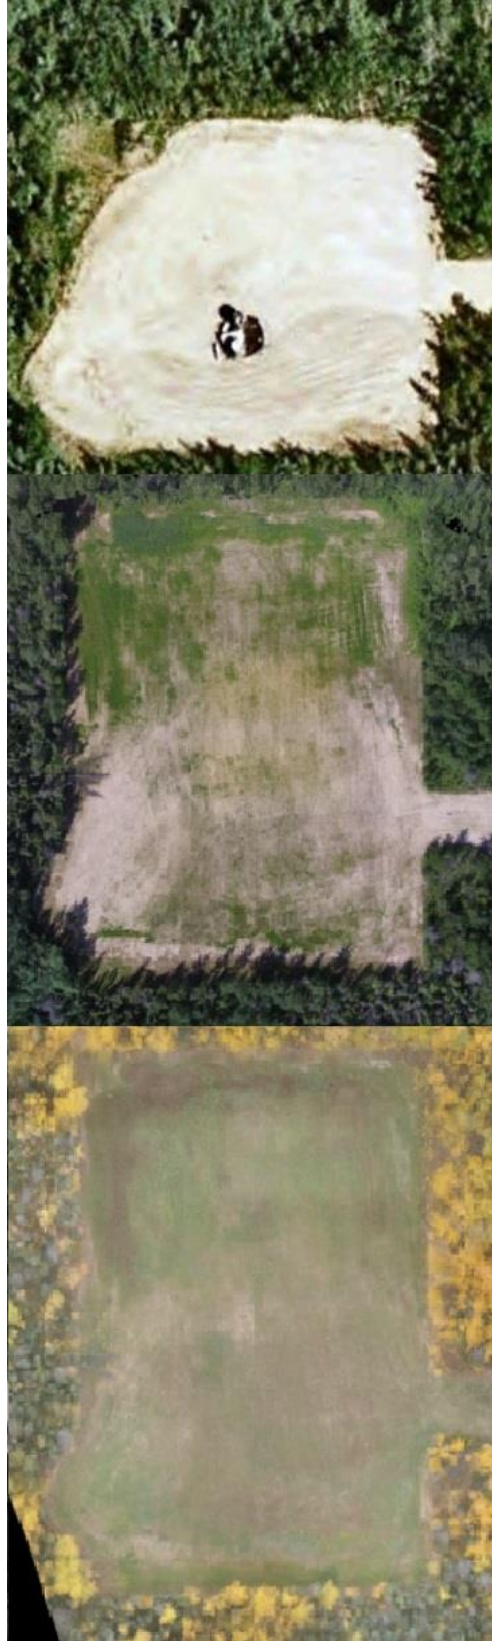
Figure 29 Restoration progress of well pad 24673 (2012, July 2017, and September 2017)

This well pad had an approximate surface area of 1.81 ha in July 2017, and appears to have been expanded as seen in a comparison between photographs taken 2012 and 2017. Photographs taken in September 2012, July 2017, and September 2017 are shown from top to bottom, respectively, in Figure 29.

Although there is a significant increase in vegetation density on the well pad between July and September 2017 as seen in Figure 29. The vegetation density is not uniform, and there is a wide variety of plant species present.

Despite the lack of uniformity in vegetation density and type, examination of the September 2017 orthomosaic in Figure 29 shows that the 80% vegetation coverage requirement to warrant a Certificate of Restoration has been met.

The 2012 GoogleEarth image in Figure 29 does not show any salvaged soil piled around the site, so it is possible that any soil removed from the surface was removed from the site and not replaced throughout the site after decommissioning.

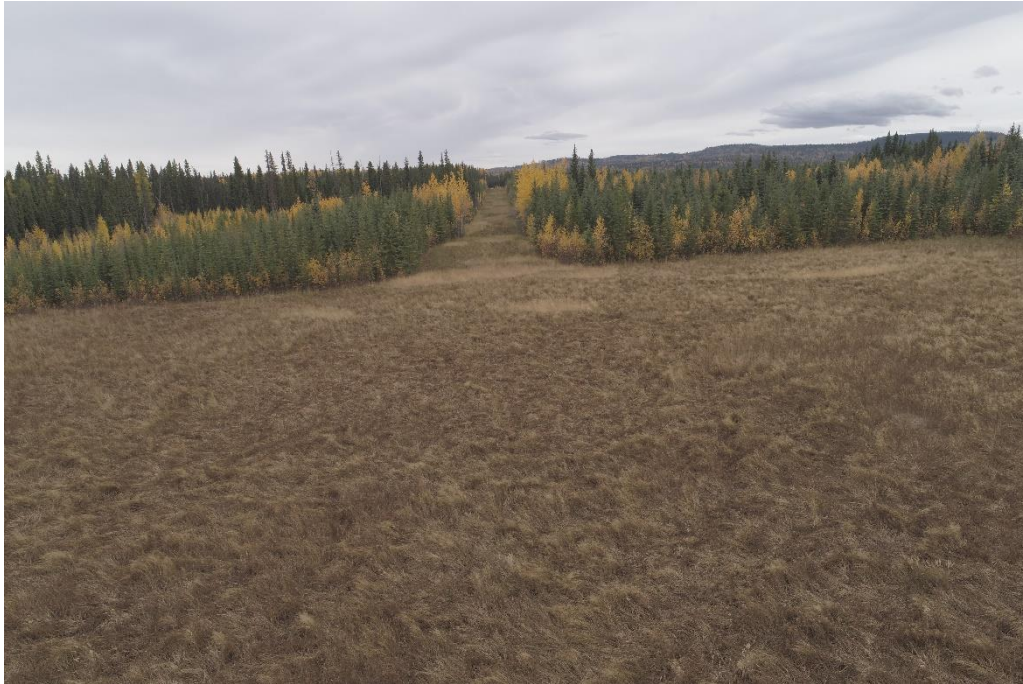
Figure 37 Access road for well pad 21726 viewed from a location above the well pad

The drone was flown a short distance manually along the reclaimed access road and into the well pad. The drone was then flown over the well pad to capture photographs manually. An oblique photograph taken from above the well pad showing its access route is seen in Figure 37.

In comparison with the other well pads, 21726 has a much greater slope of approximately 9%. However, the well pad drains uniformly to the northeast. There are no drainage ditches remaining either around the well pad edges or along the access road, suggesting that the drainage pattern has been restored to the condition prior to alteration, or at least to a drainage pattern that is compatible with the surrounding area and land uses. There are no areas of potential ponding or erosion seen in the photographs or landscape models. The uniformity in vegetation height likely contributes to the uniformity in the land slope shown in Figure 43 and Figure 44, as vegetation is included in the point cloud. Figure 37 shows that the land is sloping as suggested by these figures.

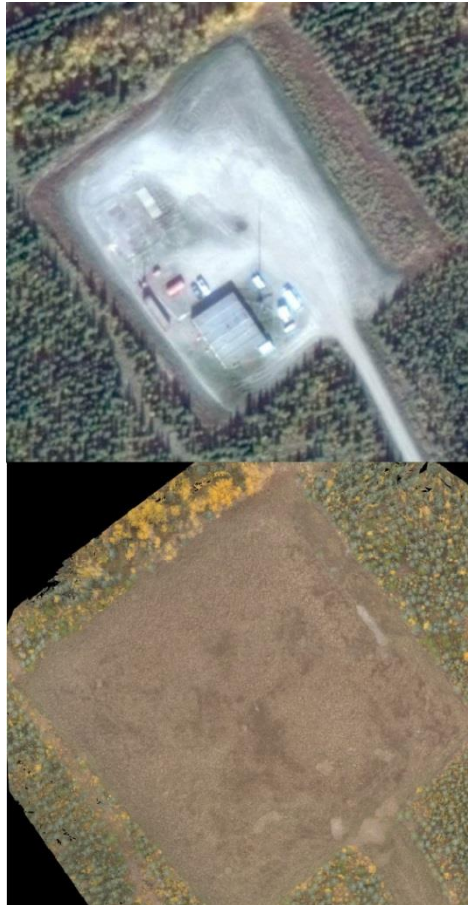
Figure 38 Well pad 21726 in September 2012 (top) and September 2017 (bottom)

The surface area for this well pad is approximately 1.42 ha based on the 2017 flight data, excluding the access road. This well pad is shown in Figure 38 in September 2012 (top) and September 2017 (bottom). In the September 2012 photo, equipment can still be seen on the well pad and soil piled on the eastern side, although at the time of this photograph the well had an abandoned status.

There does not appear to be a connection between vegetation growth or health and where equipment had been located on the well pad, shown in the top photograph of Figure 38. The vegetation appears to be dominated by just one or a few species on the well pad. Although this does not necessarily mean that a mixture of species was not planted, it may indicate that some species from the seed mixture are not growing successfully. Examining the orthomosaic of the well pad it is clear that the surface area of the well pad is more than 80% covered by vegetation. Therefore, this criterion would be met for a Certificate of Restoration for this well pad.

However, note that there are distinct patches or spots on the well pad which are not bare, but where the vegetation is visibly different from most of the surface area. These areas do not appear to have any correlation to where equipment was located on the well pad in 2012. They also do not appear to be areas where ponding occurs, as no low areas were observed in the surface model. These patches be seen from the orthomosaic in Figure 38 and also from the oblique photograph in Figure 37 and the aerial photograph in Figure 45.

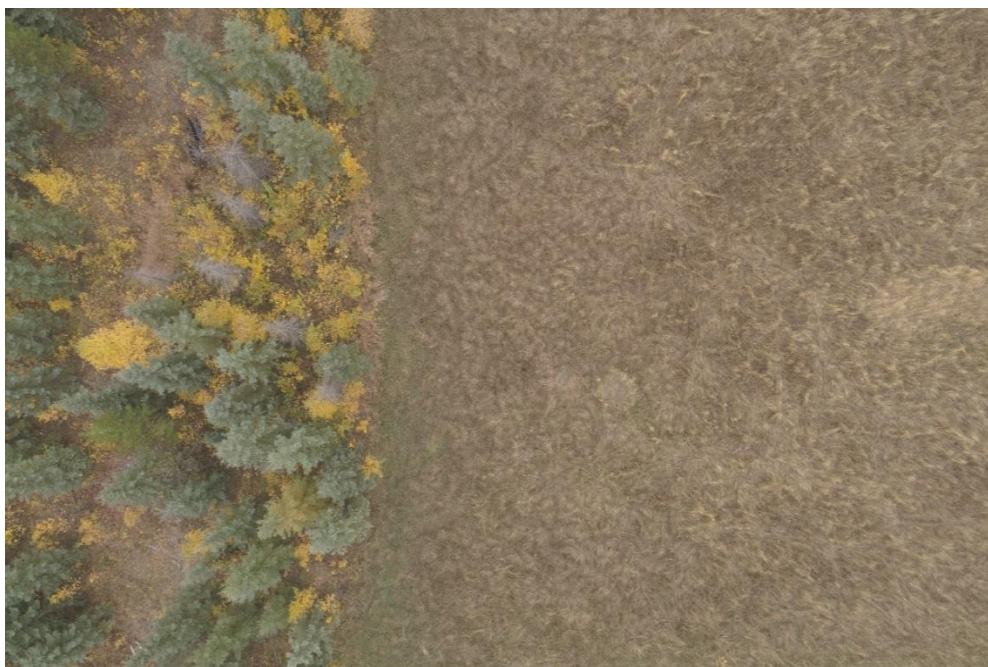
Figure 41 Green vegetation at the edges of the well pad

The vegetation appears uniform in terms of both density and colour. There does not appear to be any infestation of weeds. The vegetation growing on this well pad is mostly brown, appearing slightly greener near the edges of the well pad, closer to where coniferous trees are growing. This is highlighted in Figure 41. Additionally, there are some shrubs growing on the eastern side as shown in Figure 42, which may or may not be part of the planted seed mixture.
