## INVESTIGATION OF REPORTED FISH KILL TSINHIA LAKE – SUMMER 2003

Date: December 31, 2003

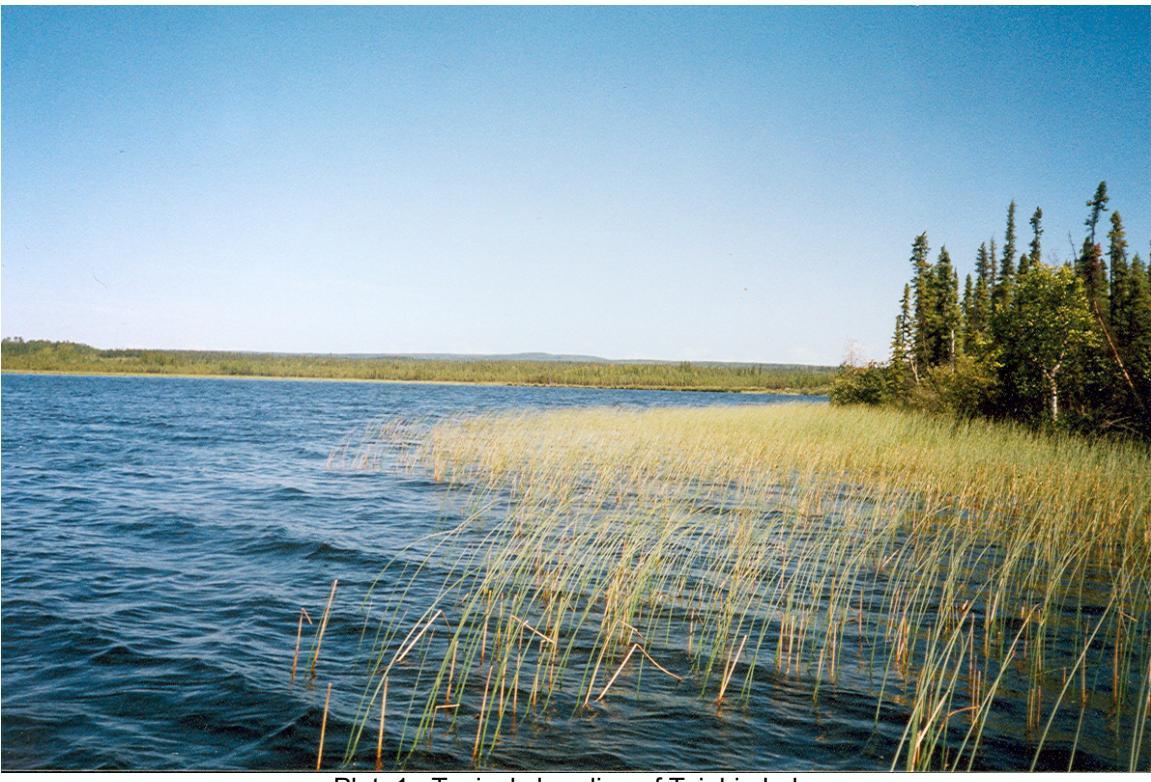
Plate1: Typical shoreline of Tsinhia Lake

During the July 11 investigation, Mr. Bedine accompanied Diversified staff on a reconnaissance of the entire shoreline of the lake (plate 1), including the primary inlet (plate 2) and outlet. Relatively low numbers of dead and dying fish, representing all three species, were noted in all areas of the lake, but appeared to be more numerous along the northeast shoreline. Although this area contains the mouth of the primary inlet, it is also the shoreline most exposed to prevailing winds. Schools of apparently healthy brook stickleback were also observed along this shoreline, in the vicinity of the lake inlet.

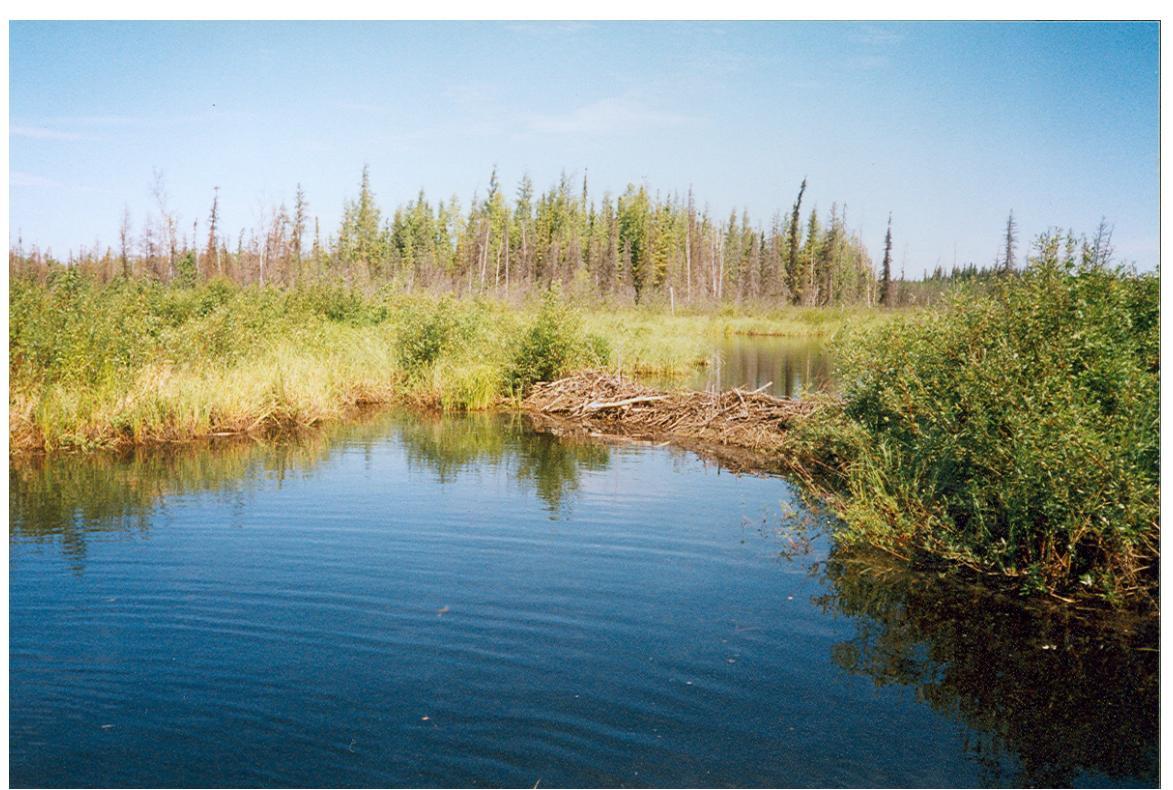
Plate 2: Mouth of primary inlet to Tsinhia Lake (back-flooded back beaver dams and impoundments); view upstream.

Mr. Bedine expressed concern at the presence of an "oil-like" sheen on the surface of the water in sheltered portions of the lake margin, in the vicinity of the inlet, and wondered if this might be related to a recently completed gas well located approximately 300 m from the north shoreline of the lake or an associated tie-in pipeline crossing of the inlet stream located approximately 1000 m upstream of the lake inlet.

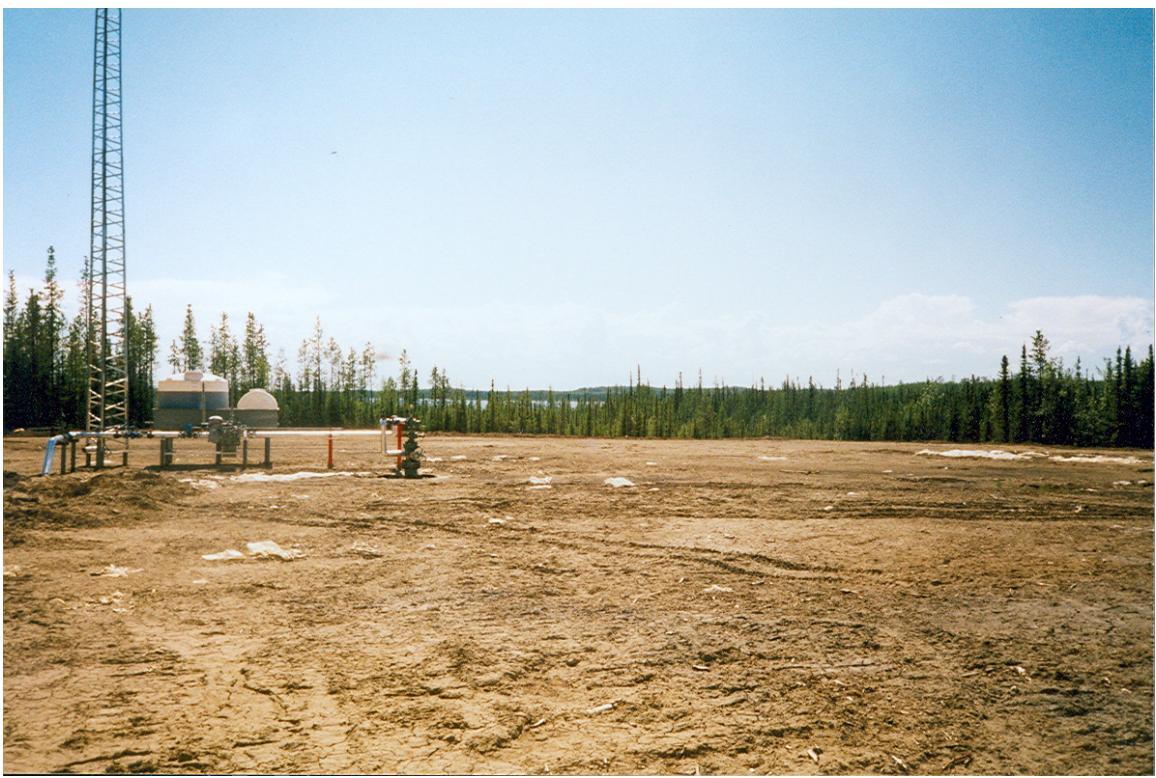
Plate 3: Recently drilled gas well located immediately north of Tsinhia Lake (Tsinhia Lake visible in background).

A ground inspection of the lease site and associated tie-in pipeline ROW was conducted (plate 3). No evidence of potential surface contamination from either the wellsite or the nearby directionally-drilled tie-in pipeline crossing under the primary inlet stream was noted.

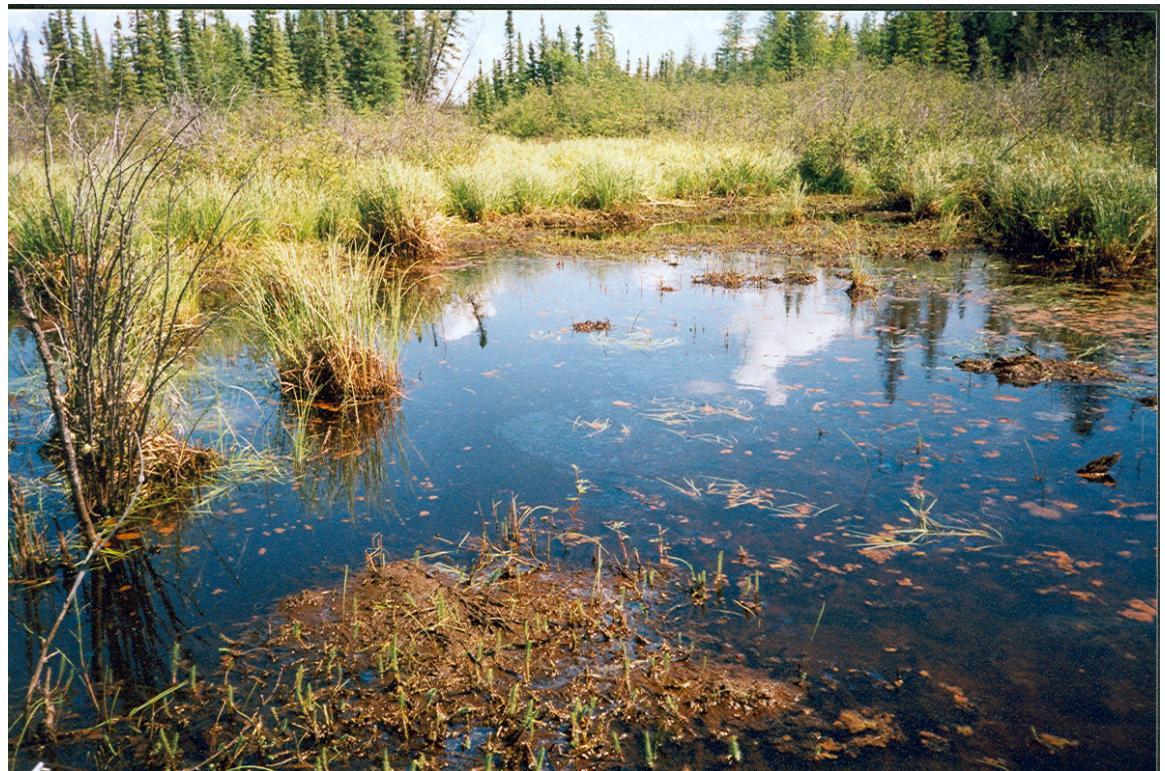
A mineral sheen, similar to that noted near the lake inlet, was observed on the surface of stagnant pools of the inlet stream, both upstream and downstream of the pipeline crossing (plate 4). This was believed to be a natural phenomenon which is commonly observed in similar "muskeg" seepage areas where surface discharge is low, and mineral concentrations and water temperatures are high.

High concentrations of aluminum, however, are common in naturally acidified waterbodies such as bog lakes. High levels of iron likely contributed to the metallic surface film noted in and near the primary inlet.

Plate 4: Upper Tsinhia Creek at tie-in pipeline crossing approximately 1000 m upstream of Tsinhia Lake (note metallic surface film).
